Lebalelo Water User Association
SE2 pipeline and associated infrastructure
Fifth Construction Environmental Audit Report
DFFE Reference Number: 14/12/16/3/3/1/2442

SE2 pipeline and associated infrastructure

Fifth Construction Environmental Audit Report

February 2023

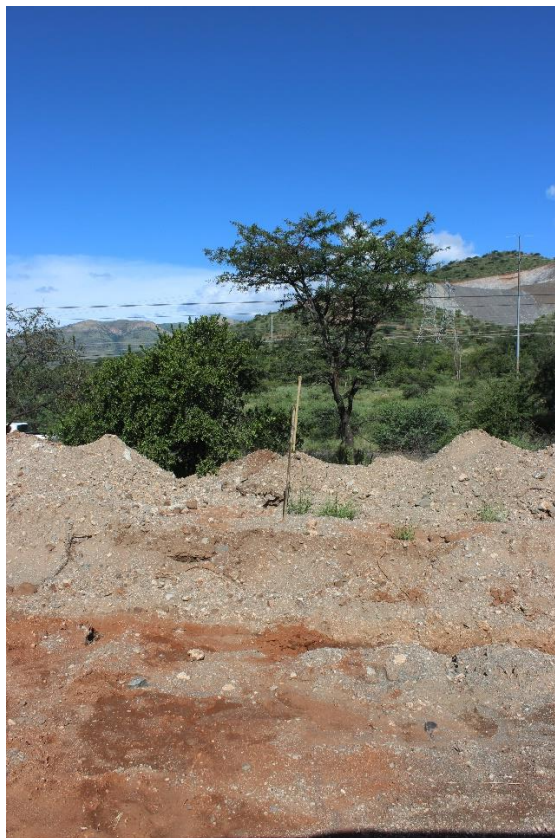
Photo 11: Micro-siting / pegging of the pipeline route

| Audit Findings of the Environmental Authorisation | | | | |
|---|--|---|--|--|
| 35 | The micro-siting / pegging of the route for the Lebalelo raw water pipeline must be undertaken prior to commencement with construction activities. This final walk through of the pipeline route must be undertaken by a botanical specialists to identify any protected and endangered plants and trees for a search and rescue operations. The findings of this undertaking must inform the final layout plan per condition 12 and 13 above. | 2 | At the time of this audit (February 2023) it was confirmed that micro pegging of the route has been undertaken. Photographic evidence can be found in Annexure C: Photo 11. The Biodiversity Company undertook a final botanical walkdown on 1 and 2 June 2022. A letter informing the Department of such was sent on 15 June 2022. A protected trees permit was granted by the DFFE on 7 November 2022, Licence LP-SDM - 0004-2022-23. All protected trees have been marked with danger tape and will only be removed if necessary. A record of all protected trees that have been removed was provided to the audit team. At the time of this audit 5 Marula trees have been removed. Photographic evidence can be found in Annexure C: Photo 12 and 13. | It is recommended that the botanical walkdown report and Protect Trees Permit be kept within the on-site compliance file. |

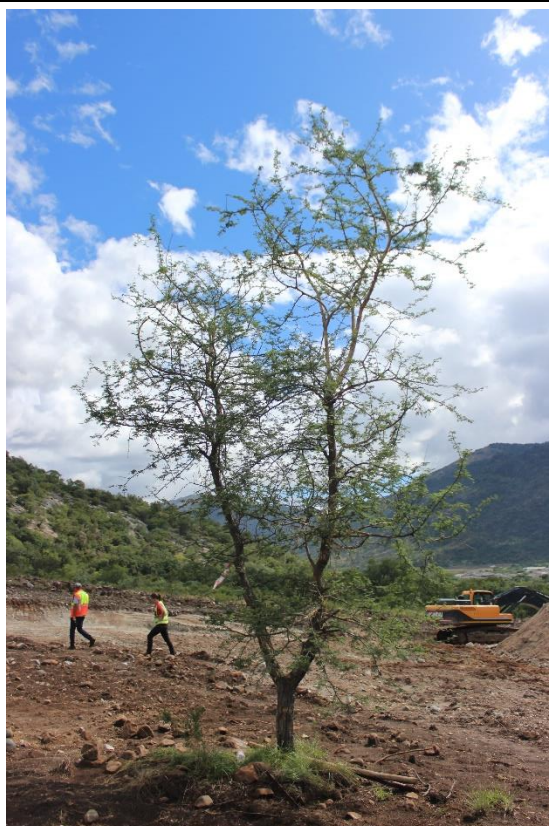
Photo 12: Protected tree marked with danger tape

| Audit Findings of the Environmental Authorisation | | | | |
|---|--|---|--|--|
| 37 | High visibility flags must be placed near any threatened / protected plants in order to avoid any damage or destruction of the species | 2 | A protected trees permit was granted by the DFFE on 7 November 2022, Licence LP-SDM - 0004-2022-23. Protected trees have been marked with danger tape and will only be removed if necessary. A record of all protected trees that have been removed was provided to the audit team. At the time of this audit 5 Marula trees have been destroyed. Photographic evidence can be found in Annexure C: Photo 12 and 13. | LWUA to take cognisance that any threatened or protected plants need to be flagged to avoid damage or destruction to the species. |

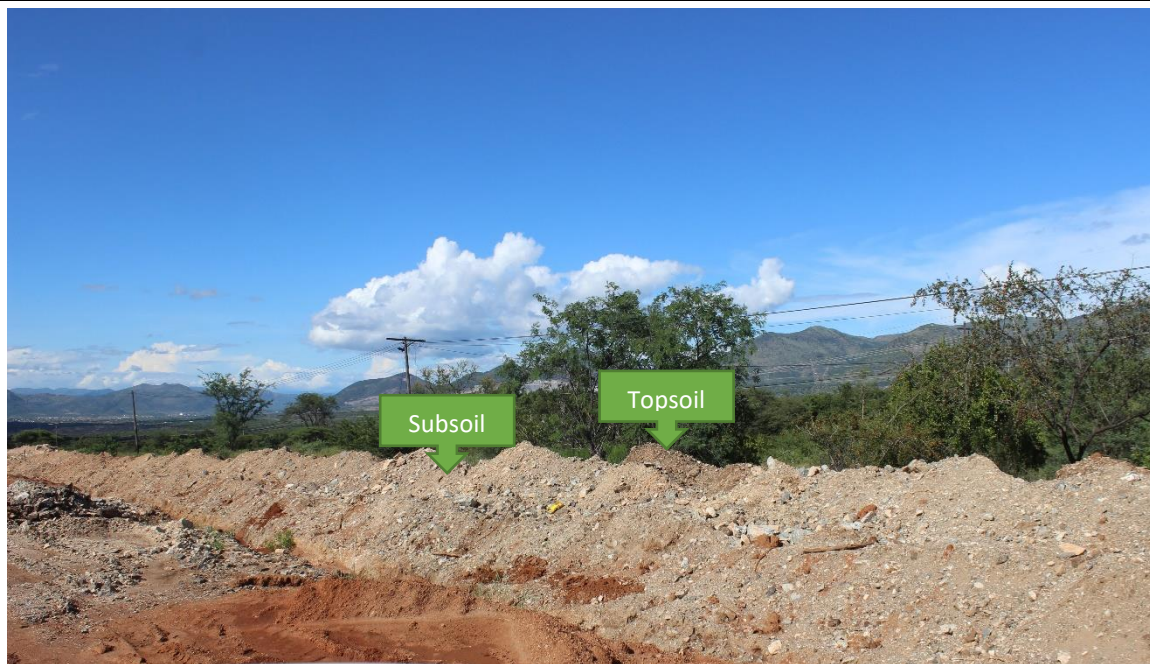
Photo 15: Stockpiles of soil on site.

| Audit Findings of the EMP | | | | | | |
|---|--|--|---|---|---|--|
| 3 | | | The proposed pipeline system must be divided up into 100 m intervals. Each interval's soil must be stockpiled and filled back up (in the correct order) to avoid long periods of stockpiling. | 2 | The excavation of the pipeline route has commenced and soil excavated are stored adjacent to the trench. Topsoil and subsoil are stored separately. Backfilling of soil has commenced on site at the portion of the pipeline near the Steelpoort Industrial Park. Photographic evidence can be found in Annexure C: Photo 14 and 15. | None |

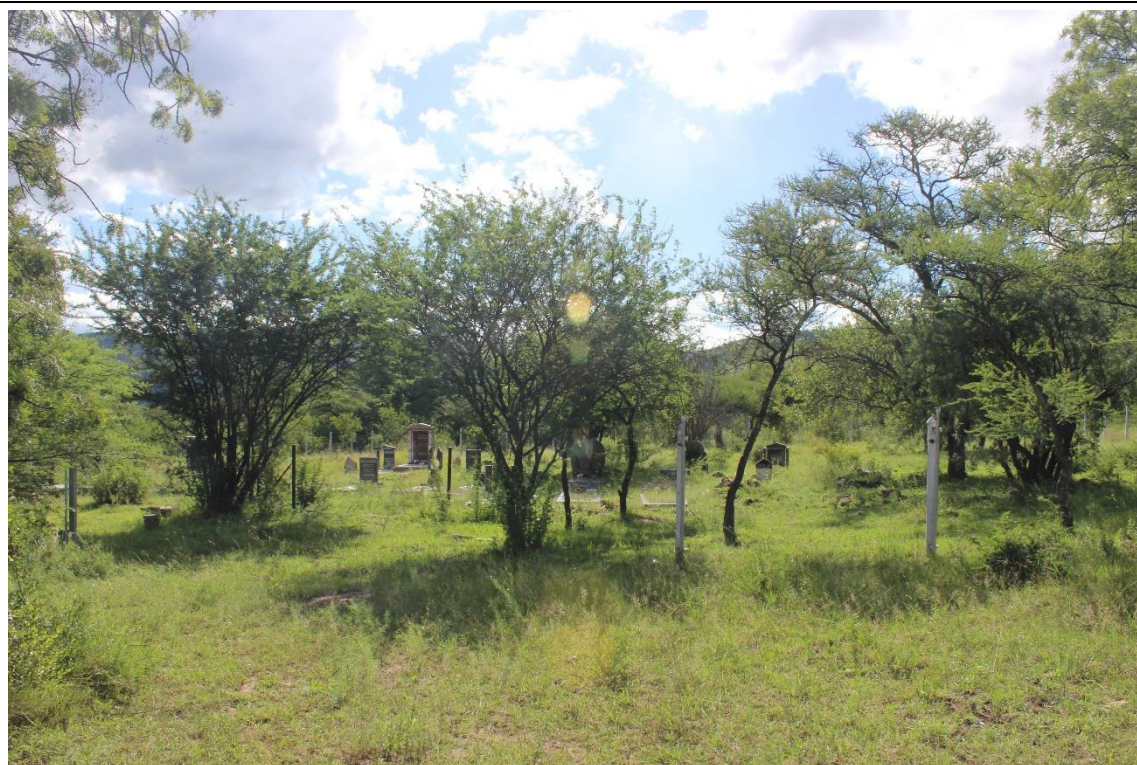
Photo 16: LWUA 2 – Graveyard boundary area

| Audit Findings of the Environmental Authorisation | | | | |
|---|---|---|---|--|
| 42 | Identified Burial sites (LWUA 1, 2, 3) must be cleared of vegetation to establish the boundaries of the sites as the possibility of unmarked graves exists. | 2 | Burial site LWUA 3 has not yet been cleared as construction activities are not taking place within close proximity of the burial site yet. Graveyard LWUA 2 and Burial site LWUA 1 has been cleared of vegetation and construction activities are taking place outside the boundary of these sites. Photographic evidence can be found in Annexure C: Photo 16. | None |

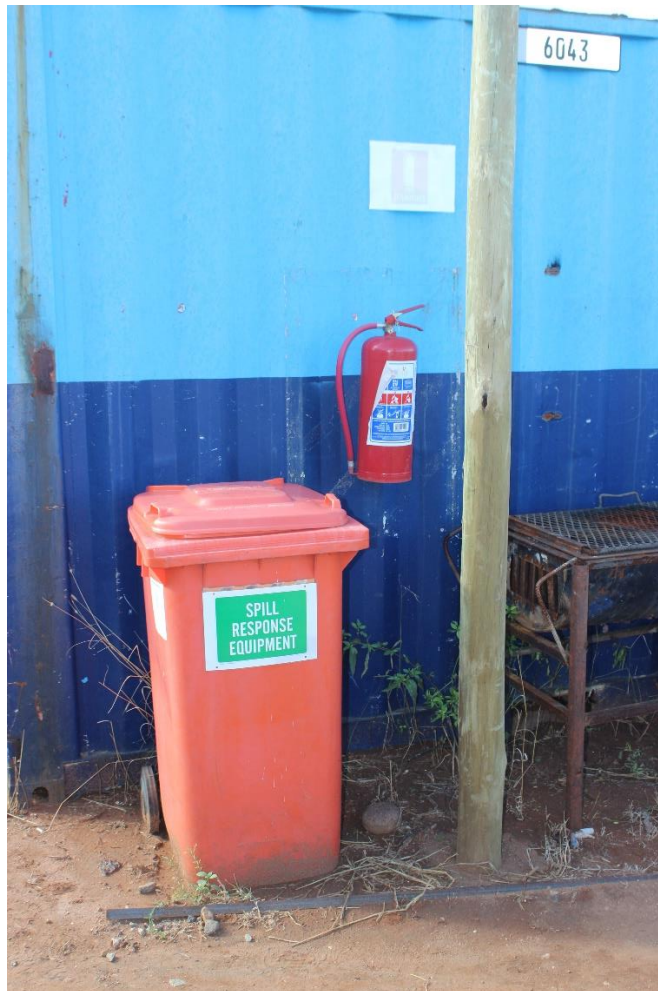
Photo 20: Hydrocarbon spill kit at the Spitskop Pump Station

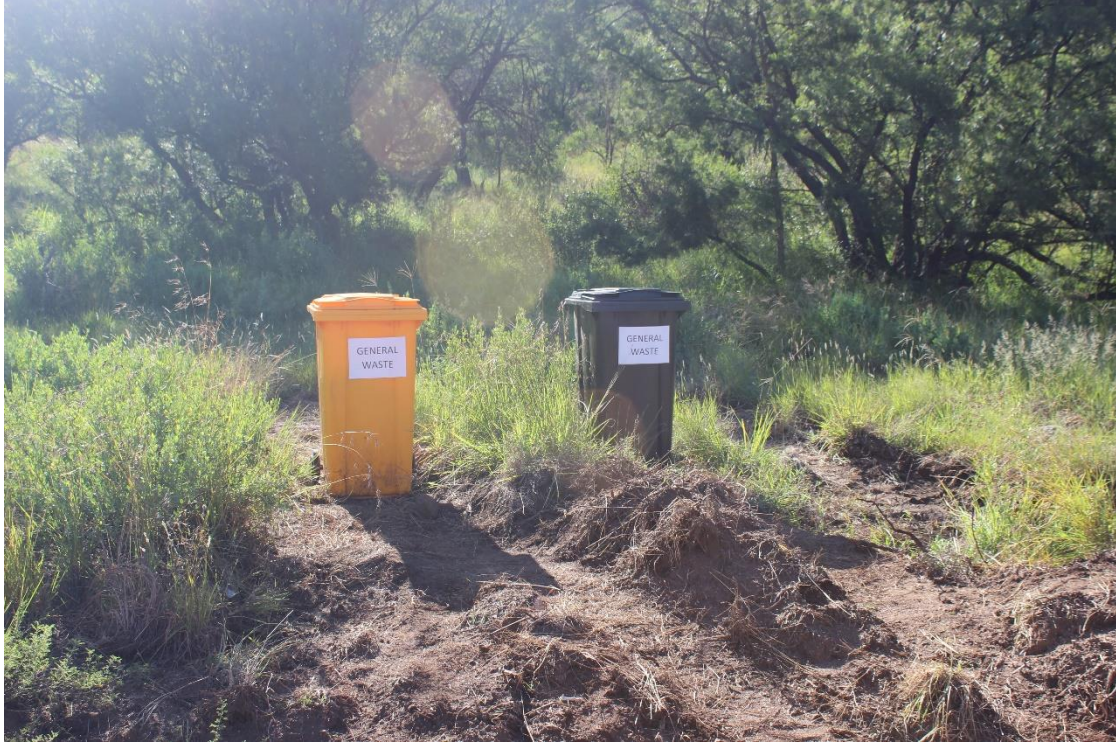
Photo 21: Waste Management along the Pipeline Route

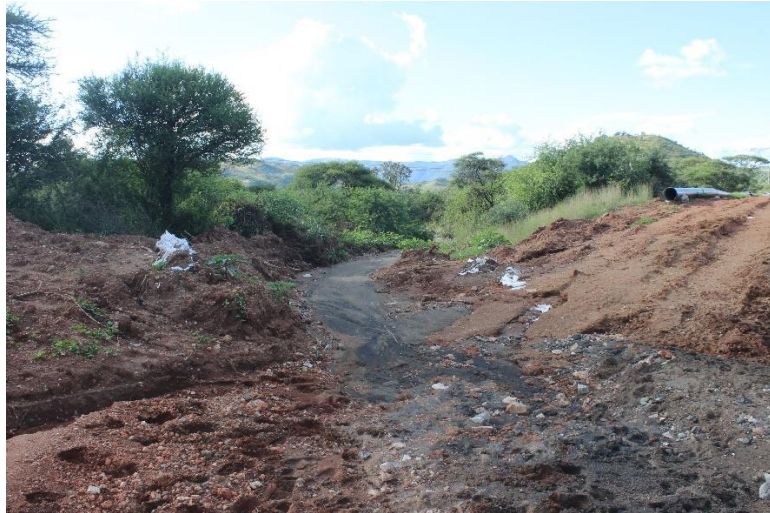
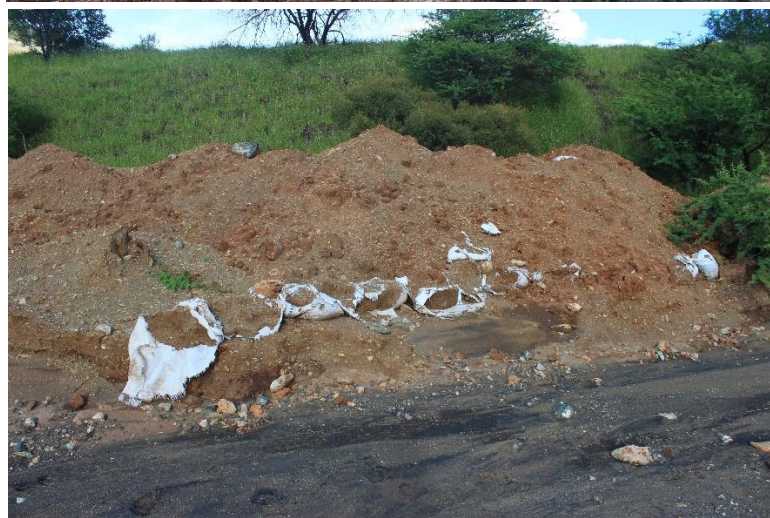
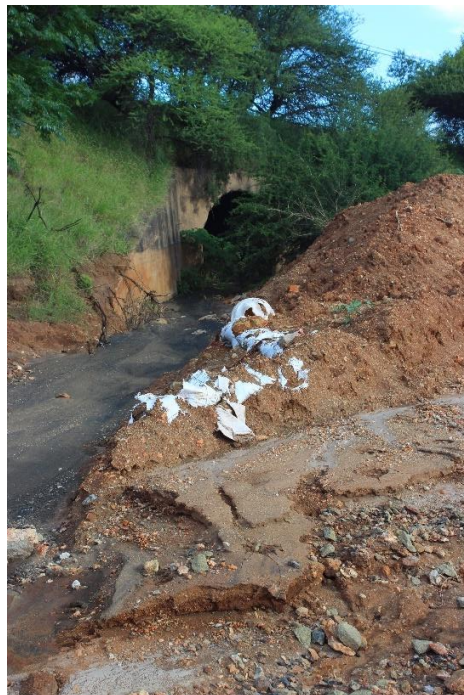
- During the December and January audit it was observed that topsoil was stockpiled within drainage lines. The contractor has implemented erosion protection measures such as sandbags along the drainage line. During the current (February) audit, topsoil was found to still be within the floodline, and the sandbags were washed away by the heavy rainfall in January/February. The contractor was informed to adhere to its method statement for Stream/river crossings, Document Number: MET-ENV-188, Revision 3.

Photo 23: Soil stored in the drainageline and sandbags washed away

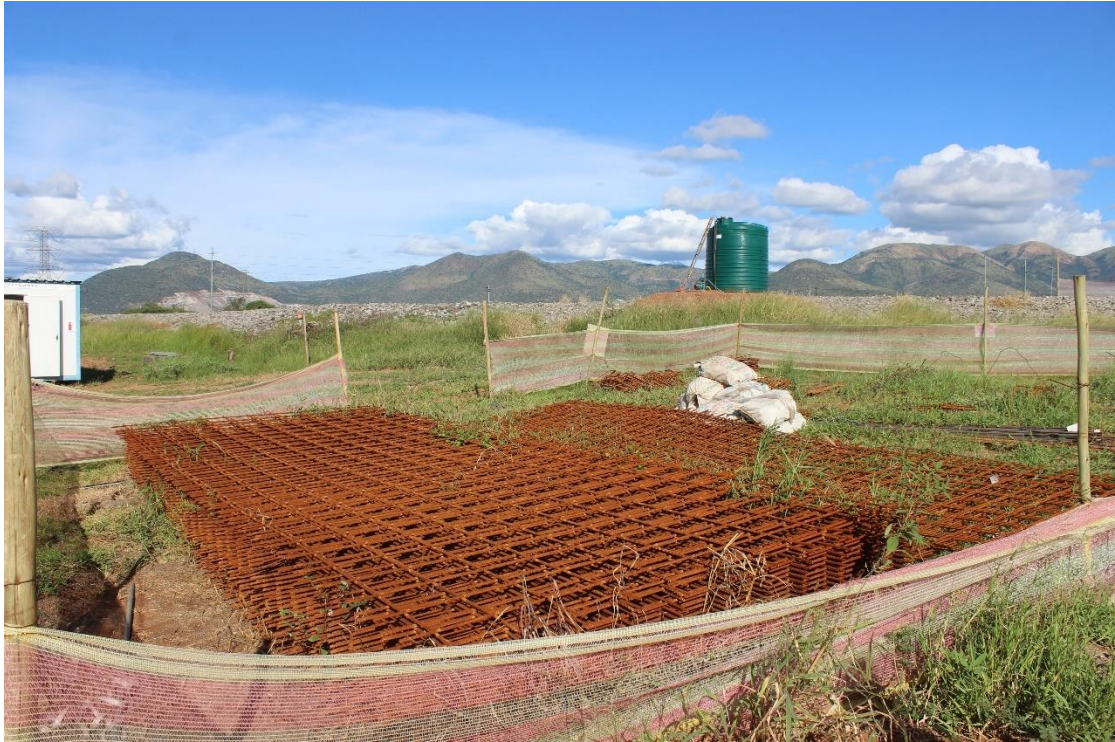
Photo 26: Construction footprint areas demarcated with reflector netting

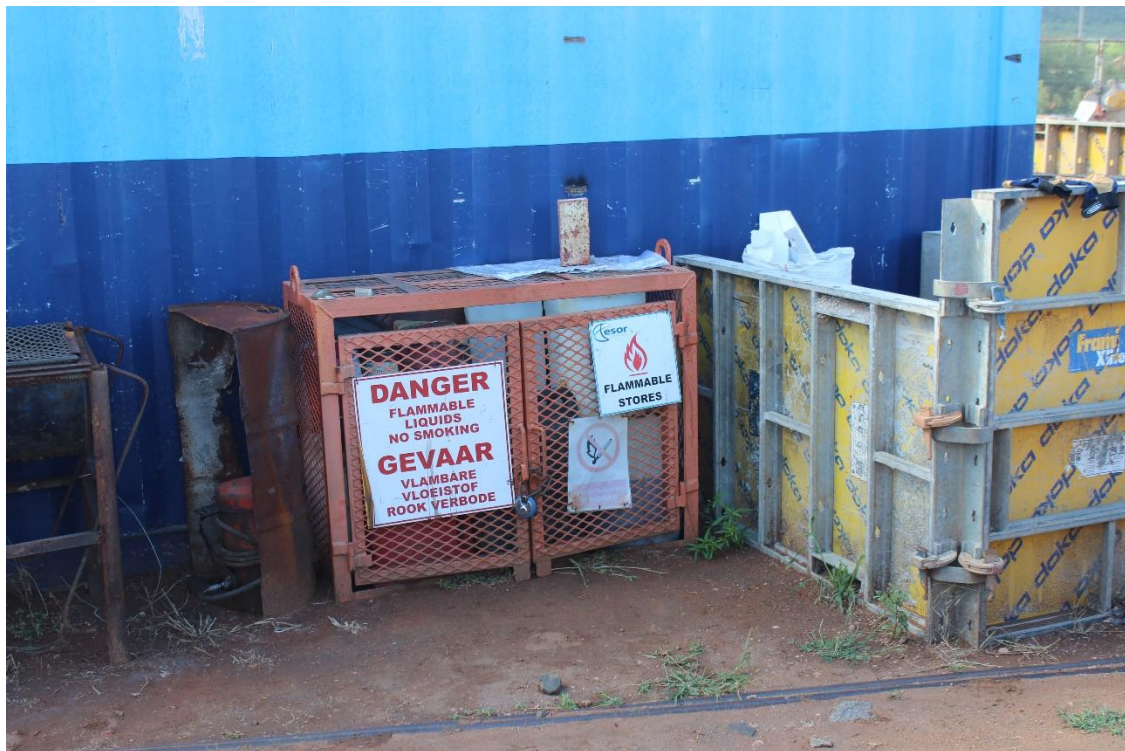
- Incorrect handling and storage of chemical substances, the chemical storage cage was found to be locked at the Spitskop Pump Station and diesel cans storing fuel were not placed in drip trays along the pipeline route.

Photo 29: Chemical Storage Cage Locked

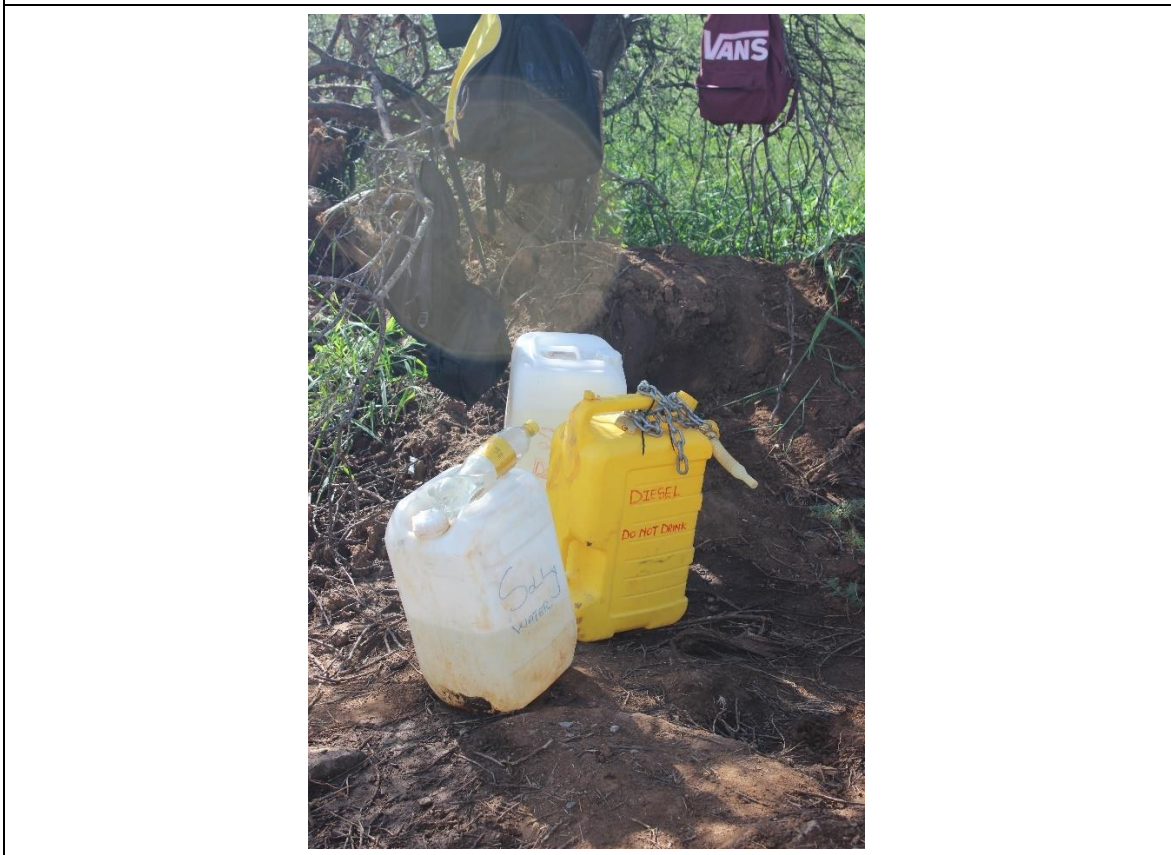
Photo 31: Incorrect Handling Jerry Can along the pipeline route.

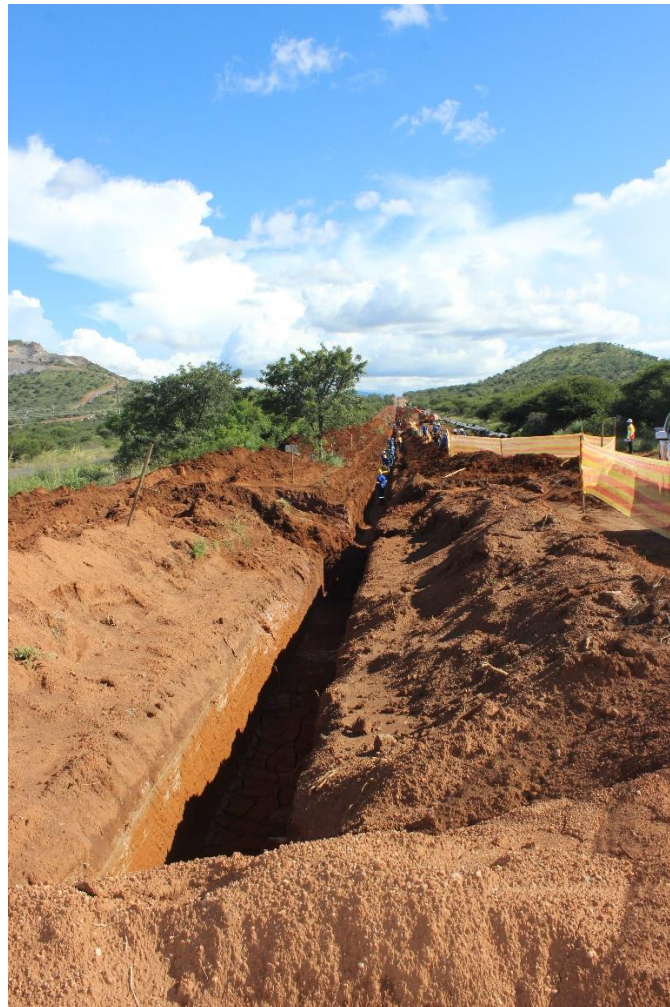
Photo 35: Pipeline Trench

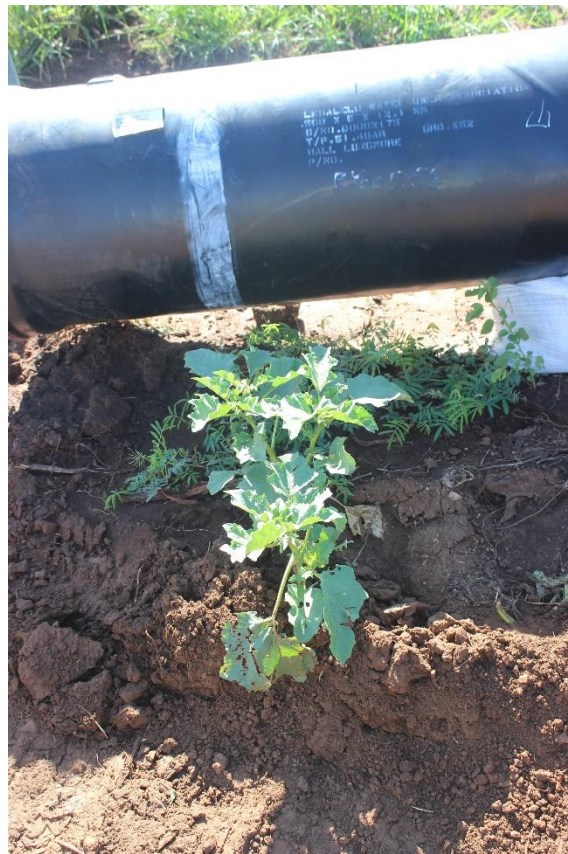
- Alien and Invasive species were found along the pipeline route as well as at the Spitskop Pump Station.
- There are ablution facilities at the Steelpoort Industrial Park, and chemical toilets are available at the Spitskop Pump Station. Chemical toilets were observed along the pipeline route currently being constructed. The construction team should note to move the ablution facilities as construction move along the pipeline to ensure construction workers do not have to walk a distance to reach the facility. These chemical toilets are located outside sensitive areas.

Photo 38: Alien and Invasive Species along pipeline route

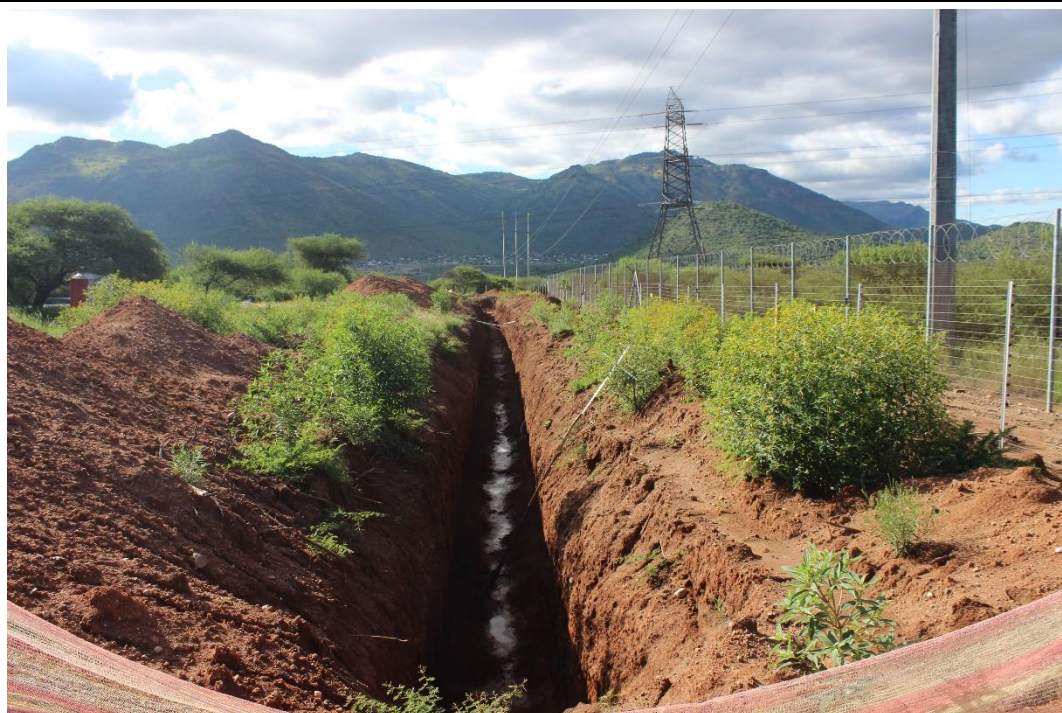
Photo 39: Alien and Invasive Species at Spitskop Pump Station
