Lebalelo Water User Association
SE2 pipeline and associated infrastructure
Sixth Construction Environmental Audit Report
DFFE Reference Number: 14/12/16/3/3/1/2442

Lebalelo Water User Association

SE2 pipeline and associated infrastructure

Sixth Construction Environmental Audit Report

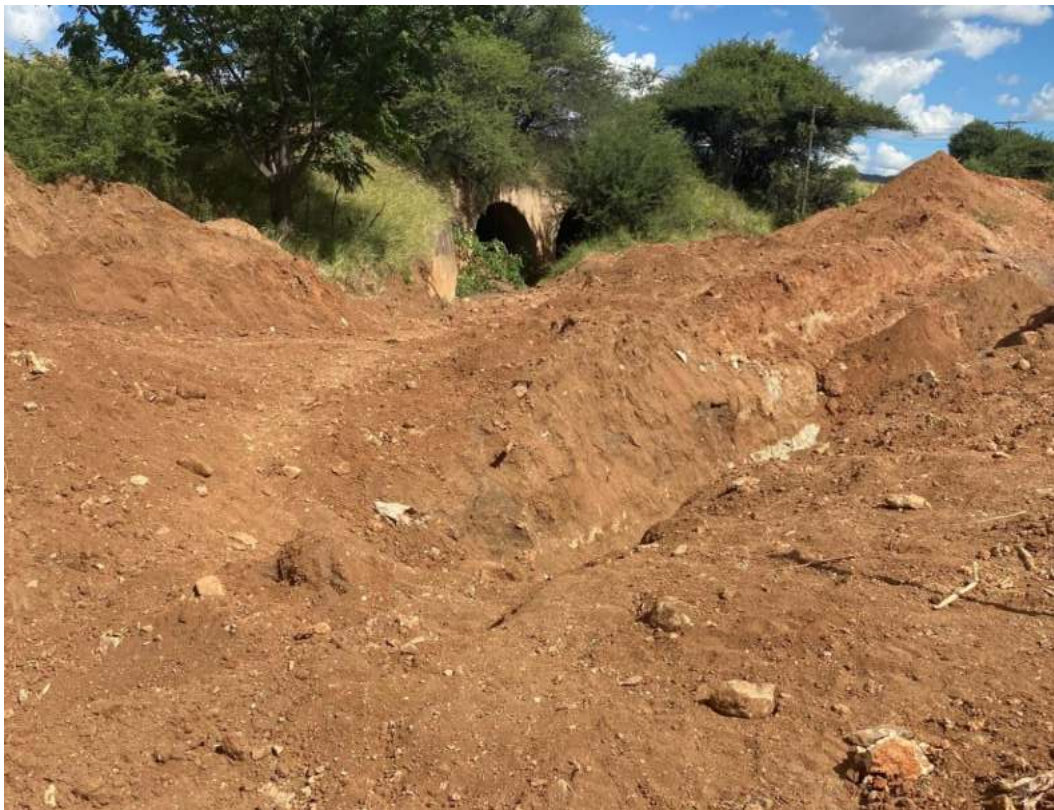
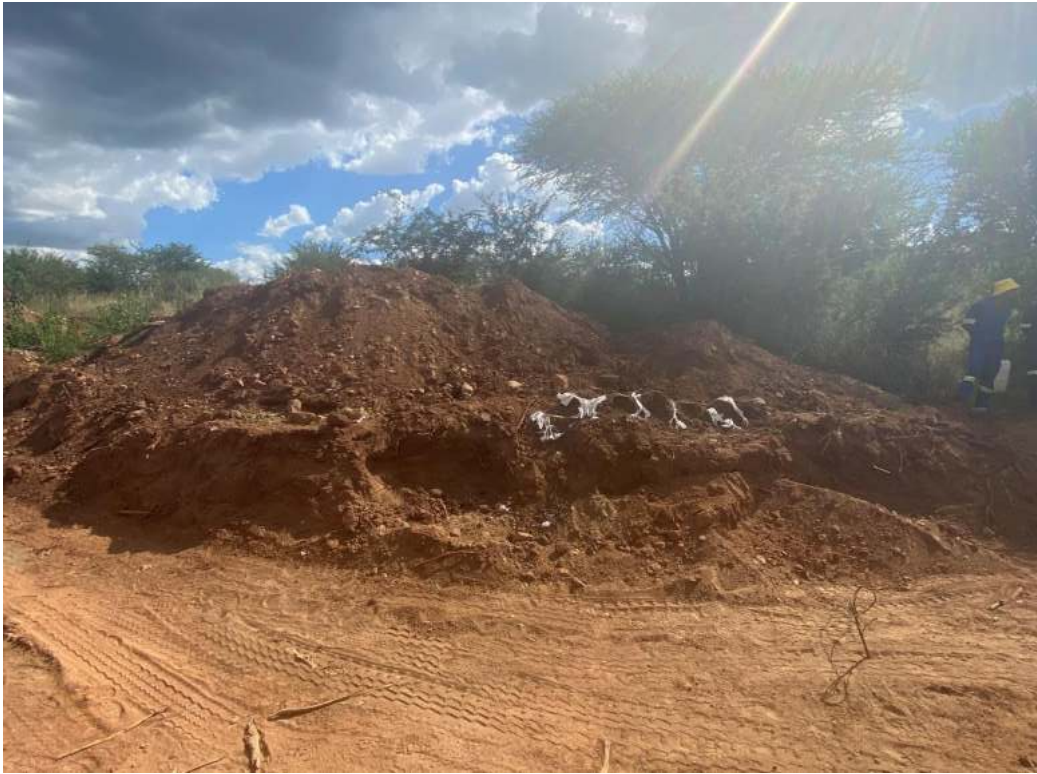
- During the December, January, February and this audit (March) it was observed that topsoil was stockpiled within drainage lines. The contractor has implemented erosion protection measures such as sandbags along the drainage line. During the February audit, topsoil was found to still be within the floodline and the sandbags were washed away by the heavy rainfall in January/February. During this audit (March 2023), topsoil was found to be stored within the drainage line and no erosion protection measures are in place. The contractor informed the audit team that rehabilitation of this section will commence within the upcoming days as the pump test was undertaken successfully at this section of the pipeline. All soil will be backfilled and rehabilitated accordingly, and this area will not be disturbed further once rehabilitation is complete.

Photo 23: Soil stored in the drainageline and sandbags washed away
