**Lebalelo Water User Association**  
**SE2 pipeline and associated infrastructure**  
**Seventh Construction Environmental Audit Report**  
**DFFE Reference Number: 14/12/16/3/3/1/2442**

### Seventh Construction Environmental Audit Report

April 2023

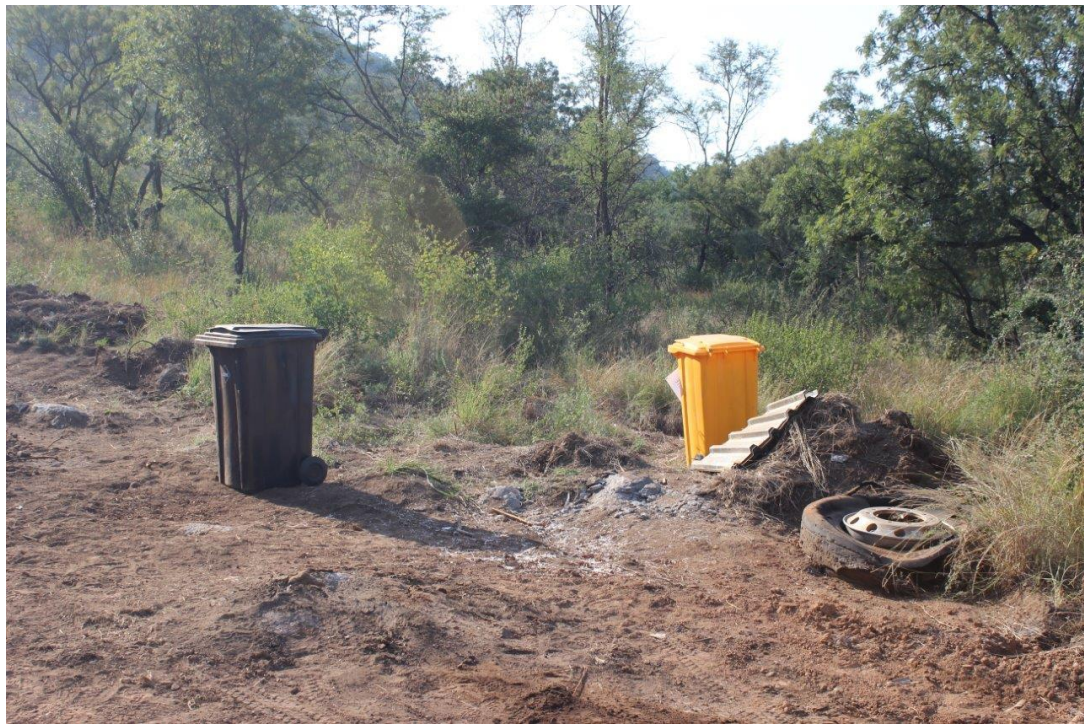
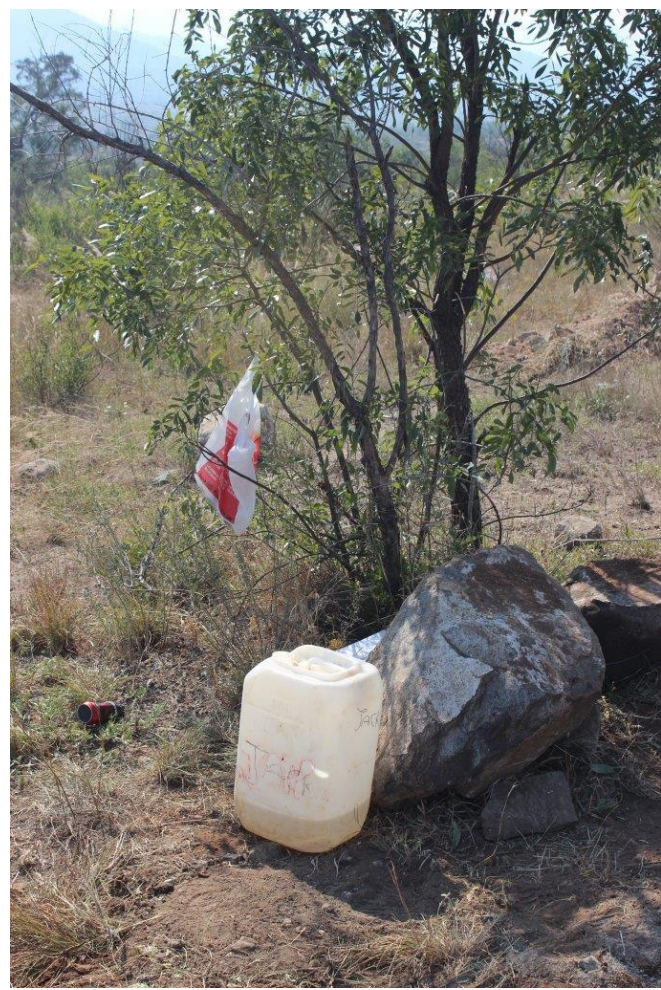
Photo 21: Waste Management along the Pipeline Route

- Housekeeping in terms of waste management needs improvement. Plastic bottles and a tyre were observed on the pipeline route. It is suggested that a wheeliebin is provided at each active construction area for waste management.
- Alien invasive species were found along the pipeline route as well as at the Spitskop pump station. The removal of alien and invasive species was noted as a work in progress, no alien and invasive species was found along the pipeline trench however small clusters could be found at the pipes that have not yet been installed.
- Ablution facilities were observed to be away from where active construction is taking place. These facilities must be moved to where construction workers are actively working.

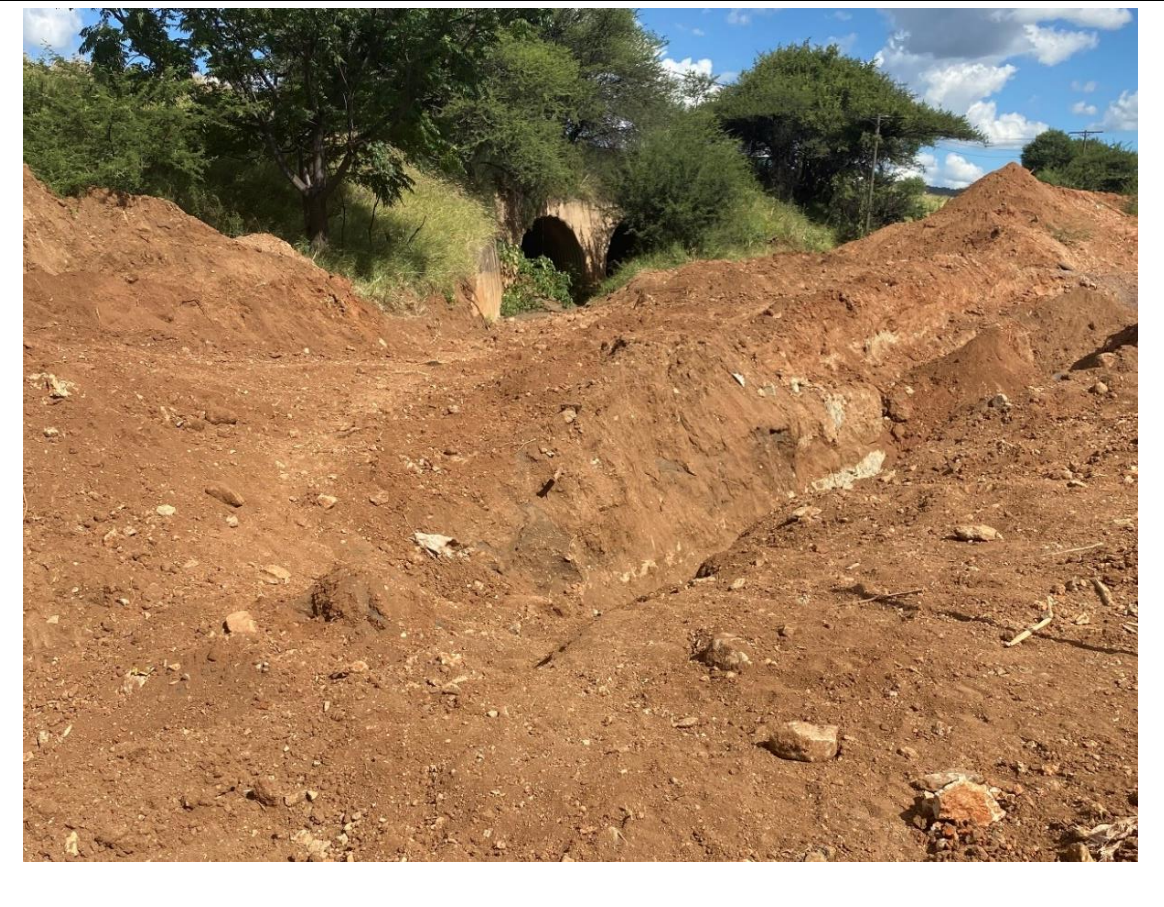
Photo 23: Soil stored in the drainageline and sandbags washed away

- During the December, January, February, March and this audit (April) it was observed that topsoil was stockpiled within drainage lines. The contractor has implemented erosion protection measures such as sandbags along the drainage line. During the February audit, topsoil was found to still be within the floodline and the sandbags were washed away by the heavy rainfall in January/February. During this audit (April 2023), topsoil was found to be stored within the drainage line and no erosion protection measures are in place. The contractor informed the audit team that rehabilitation of this section will commence within the upcoming days as the pump test was undertaken successfully at this section of the pipeline. All soil will be backfilled and rehabilitated accordingly, and this area will not be disturbed further once rehabilitation is complete.

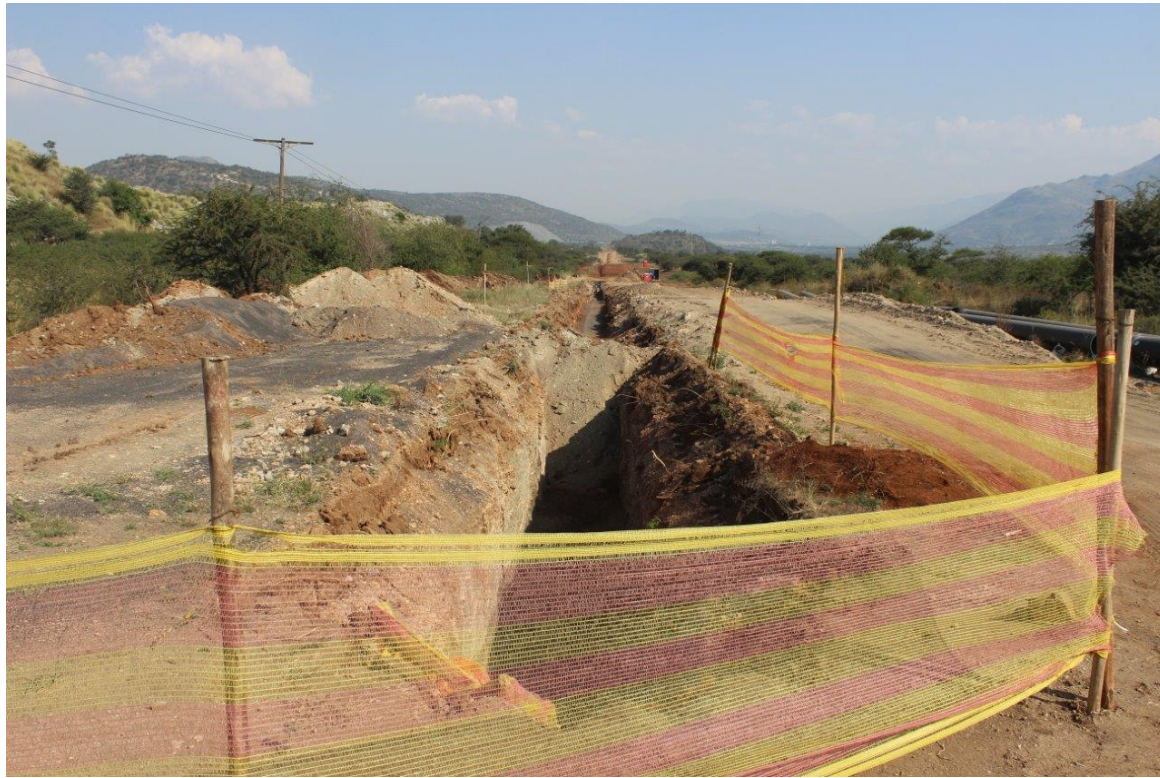
**Photo 24: Construction activities within pipeline servitude**

7			These designated stockpile areas must be viewed as temporary and kept for backfill material.	2	<p>At the time of this audit (April 2023) backfilling activities have commenced on site at the portion of the pipeline near the Steelpoort Industrial Park.</p> <p>Photographic evidence can be found in Annexure C: Photo 15.</p>	LWUA to take cognisance that stockpiles are only temporary and must be used as backfill material.
8			Maintain soil quality and minimise damage to the soil structure during the time the material is stockpiled.	2	<p>Soil stockpiles were intact and no driving has taken place on topsoil stockpiles.</p> <p>Photographic evidence can be found in Annexure C: Photo 14, 15 and 23.</p>	LWUA to take cognisance that soil quality must be maintained and measures implemented to minimise damage to the soil structure during the time the material is stockpiled.
9			All construction access must make use of the existing roads that can be found in and around the project area.	2	<p>Access to the Spitskop Pump Station and the Pipeline Route is done using existing roads.</p> <p>Construction activities along the pipeline route is done within the pipeline servitude.</p> <p>No new roads were identified at the time of this audit (April 2023).</p> <p>Photographic evidence can be found in Annexure C: Photo 24.</p>	LWUA to take cognisance that existing roads must be used.

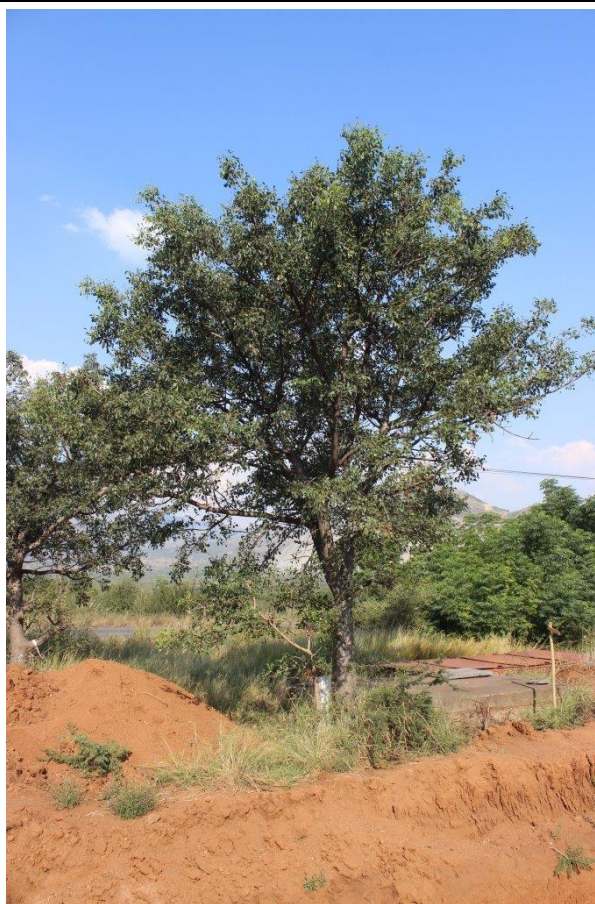
**Photo 40: Unmarked Marula Tree along pipeline route**

- Protected trees were marked at the onset of the construction of the SE2 pipeline route (September/October 2022). Some of these markers (danger tape) are still visible, but some Marula Trees were observed that were not marked. Refer to Photo 40. It is recommended that another walkdown is undertaken and protected trees/plants clearly marked with high visibility flags/danger tape to ensure that the protected trees/plants are clearly visible.
