Lebalelo Water User Association
SE2 pipeline and associated infrastructure
Eighth Construction Environmental Audit Report
DFFE Reference Number: 14/12/16/3/3/1/2442

Eighth Construction Environmental Audit Report

May 2023

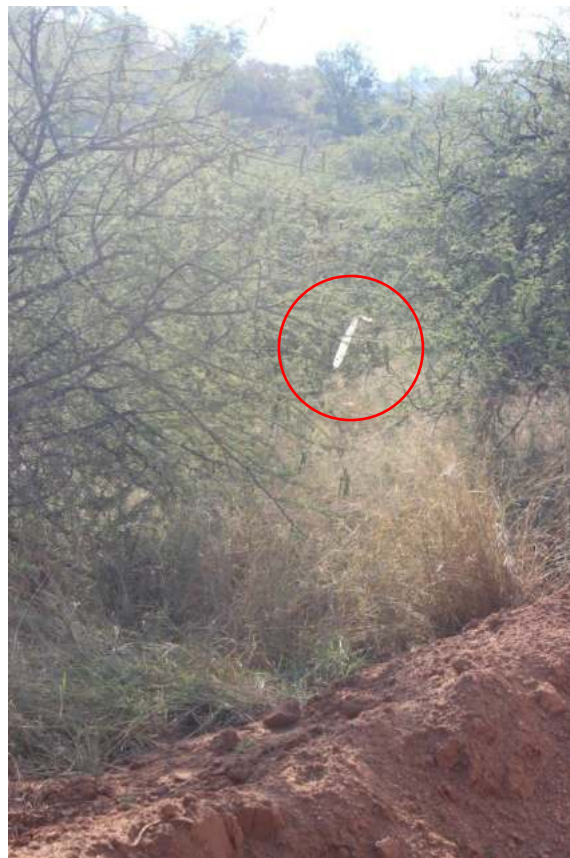
Photo 12: Protected tree marked with danger tape

- Protected trees were marked at the onset of the construction of the SE2 pipeline route (September/October 2022). Some of these markers (danger tape) are still visible, but some Marula Trees were observed that were not marked. Refer to Photo 42. It is recommended that another walkdown is undertaken and protected trees/plants clearly marked with high visibility flags/danger tape to ensure that the protected trees/plants are clearly visible.

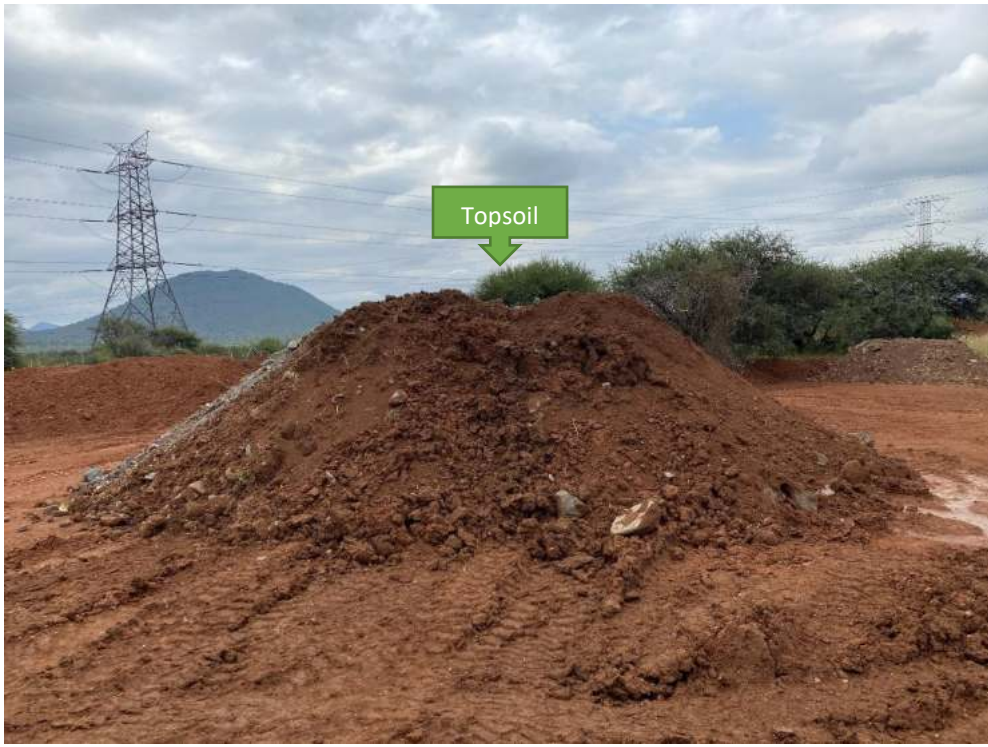
Photo 14: Stockpile of topsoil on site.

2			The first 300 mm of soil must be stockpiled separate from the soil excavated deeper than 300 mm	2	<p>Excavated soil is stored adjacent to the pipeline trench. Topsoil and subsoil are stored separately. Backfilling of soil has commenced on site at the portion of the pipeline near the Steelpoort Industrial Park.</p> <p>Photographic evidence can be found in Annexure C: Photo 14 and 15.</p>	LWUA to take cognisance that all topsoil and subsoil must be stockpiled separately on either side of the trench and backfilled in the correct order.
3			The proposed pipeline system must be divided up into 100 m intervals. Each interval's soil must be stockpiled and filled back up (in the correct order) to avoid long periods of stockpiling.	2	<p>Topsoil and subsoil are stored separately. Backfilling of soil has commenced on site at the portion of the pipeline near the Steelpoort Industrial Park.</p> <p>Photographic evidence can be found in Annexure C: Photo 14 and 15.</p>	None

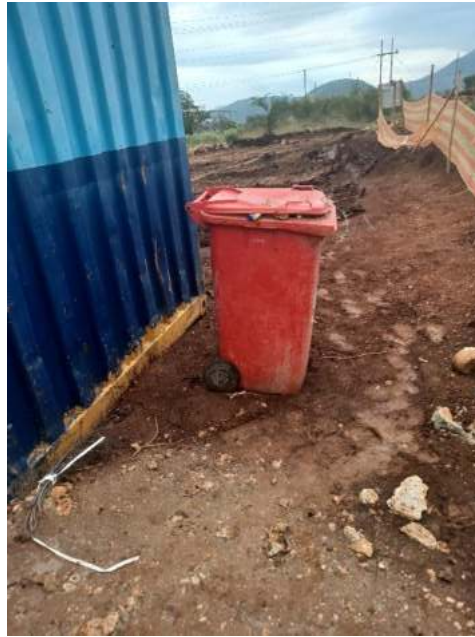
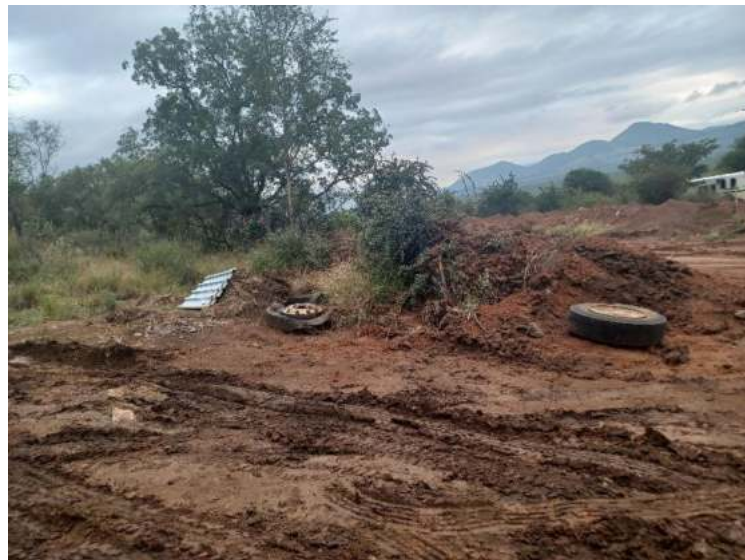
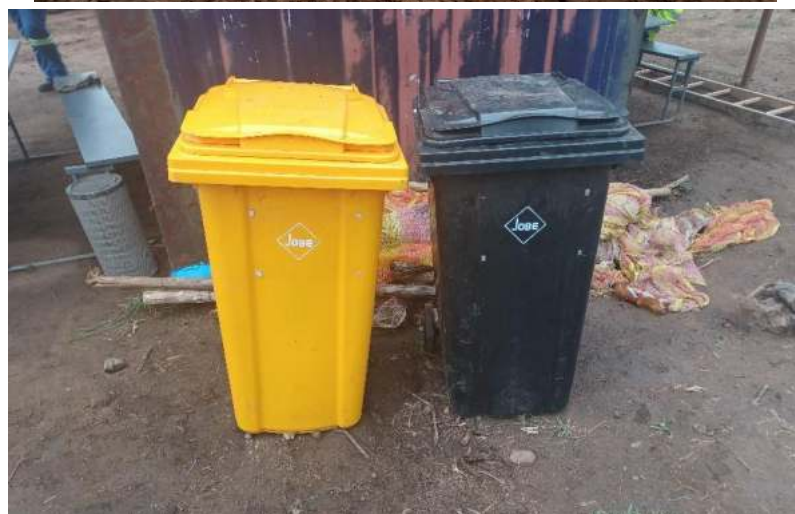
Photo 22: Waste Management along the Pipeline Route

- Housekeeping in terms of waste management was noted to be an improvement, however tyres were observed on the pipeline route. It is suggested that all waste be removed from site and disposed of appropriately.

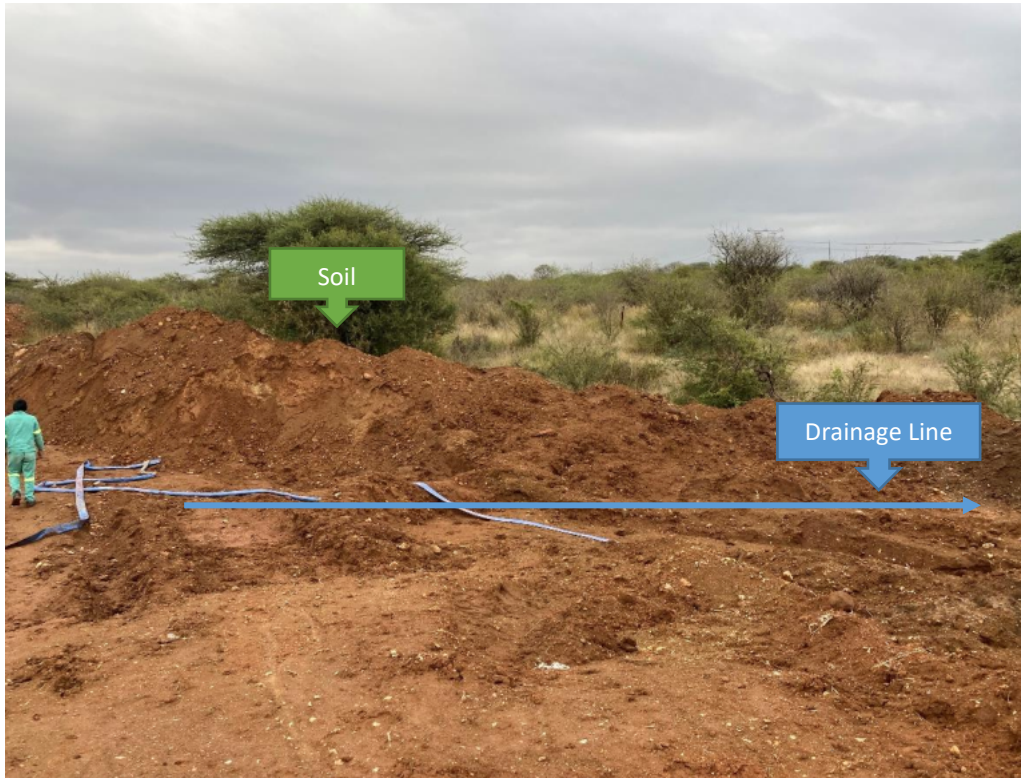
Photo 24: Soil stored in the drainageline and sandbags washed away

- During the December, January, February, March, April and this audit (May) it was observed that topsoil was stockpiled within drainage lines. The contractor implemented erosion protection measures such as sandbags along the drainage line in January/February. During this audit (May 2023), topsoil was found to be still be stored within the drainage line and no erosion protection measures such as sandbags are in place. The contractor was informed he must adhere to its method statement for Stream/river crossings, Document Number: MET-ENV-188, Revision 3. The contractor informed the audit team that due to the heavy rainfall experience during May 2023 they have not been able to complete construction in this area. All soil will be backfilled and rehabilitated accordingly once the construction is completed and this area will not be disturbed further once rehabilitation is complete.

Audit Findings of the EMP						
NR	ACTIVITY THAT MAY CAUSE AN IMPACT	MANAGEMENT OUTCOME	EMP COMMITMENT	COMPLIANCE STATUS	OBSERVATION IN MAY 2023 AUDIT	RECOMMENDATIONS BY AUDITOR
					drainage lines. The contractor implemented erosion protection measures such as sandbags along the drainage line in January/February. During this audit (May 2023), topsoil was found to be still be stored within the drainage line and no erosion protection measures such as sandbags are in place. The contractor was informed he must adhere to its method statement for Stream/river crossings, Document Number: MET-ENV-188, Revision 3. The contractor informed the audit team that due to the heavy rainfall experience during May 2023 they have not been able to complete construction in this area. All soil will be backfilled and rehabilitated accordingly once the construction is completed and this area will not be disturbed further once rehabilitation is complete. Photographic evidence can be found in Annexure C: Photo 24.

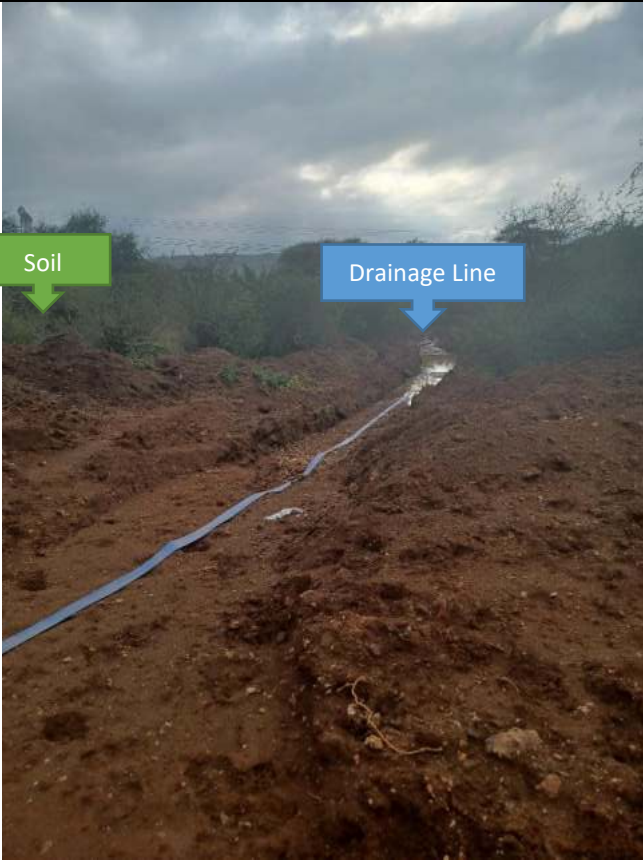
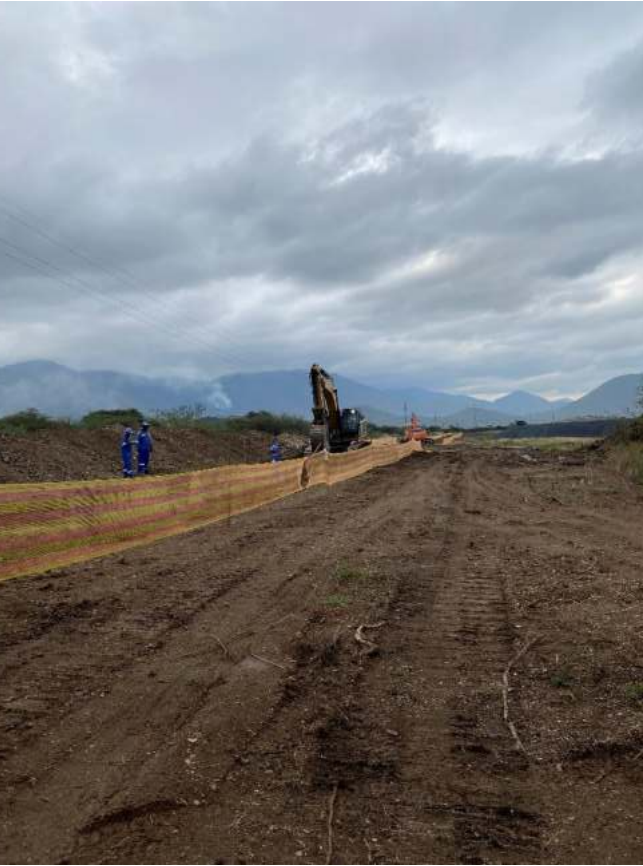
Photo 25: Construction activities within pipeline servitude

7			These designated stockpile areas must be viewed as temporary and kept for backfill material.	2	At the time of this audit (May 2023) backfilling activities have commenced on site at the portion of the pipeline near the Steelpoort Industrial Park. Photographic evidence can be found in Annexure C: Photo 15.	LWUA to take cognisance that stockpiles are only temporary and must be used as backfill material.
8			Maintain soil quality and minimise damage to the soil structure during the time the material is stockpiled.	2	Soil stockpiles were intact and no driving has taken place on topsoil stockpiles. Photographic evidence can be found in Annexure C: Photo 14 and 15.	LWUA to take cognisance that soil quality must be maintained and measures implemented to minimise damage to the soil structure during the time the material is stockpiled.
9			All construction access must make use of the existing roads that can be found in and around the project area.	2	Access to the Spitskop Pump Station and the Pipeline Route is done using existing roads. Construction activities along the pipeline route is done within the pipeline servitude. No new roads were identified at the time of this audit (May 2023). Photographic evidence can be found in Annexure C: Photo 25.	LWUA to take cognisance that existing roads must be used.

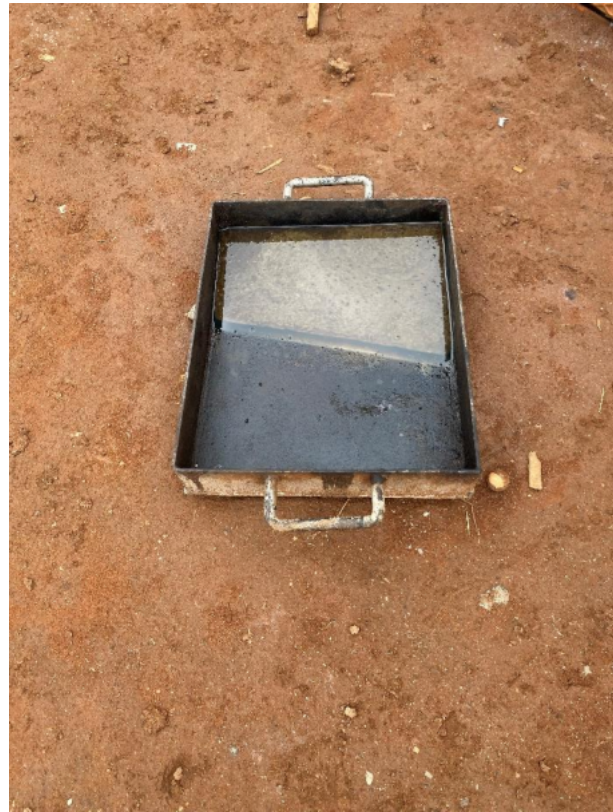
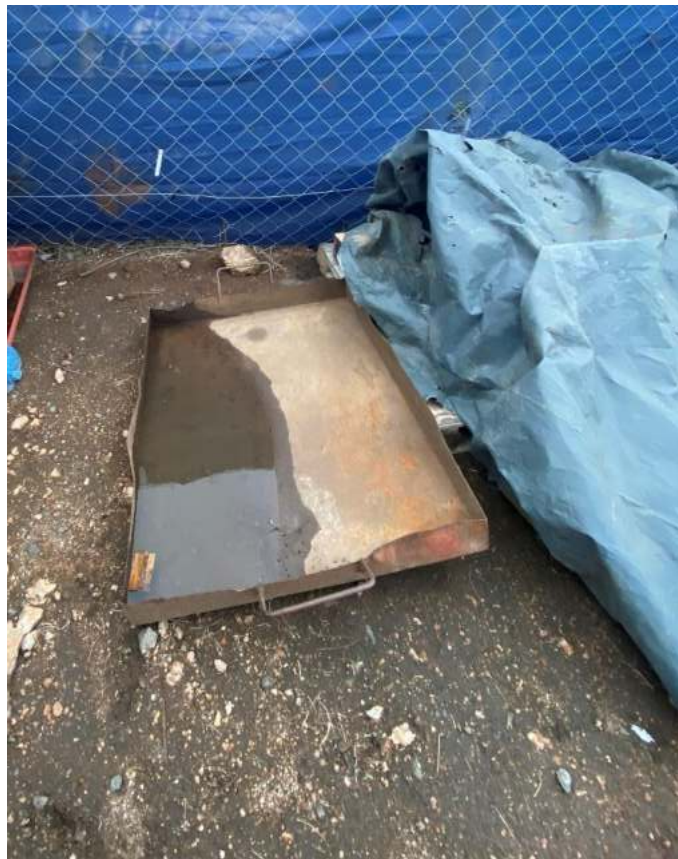
Photo 27: Inappropriate storage of Drip-Trays

- It was observed that drip-trays are placed under machinery. However, drip-trays not in use were found to be inappropriately stored, these trays were left outside and the collection of contaminated stormwater was observed.

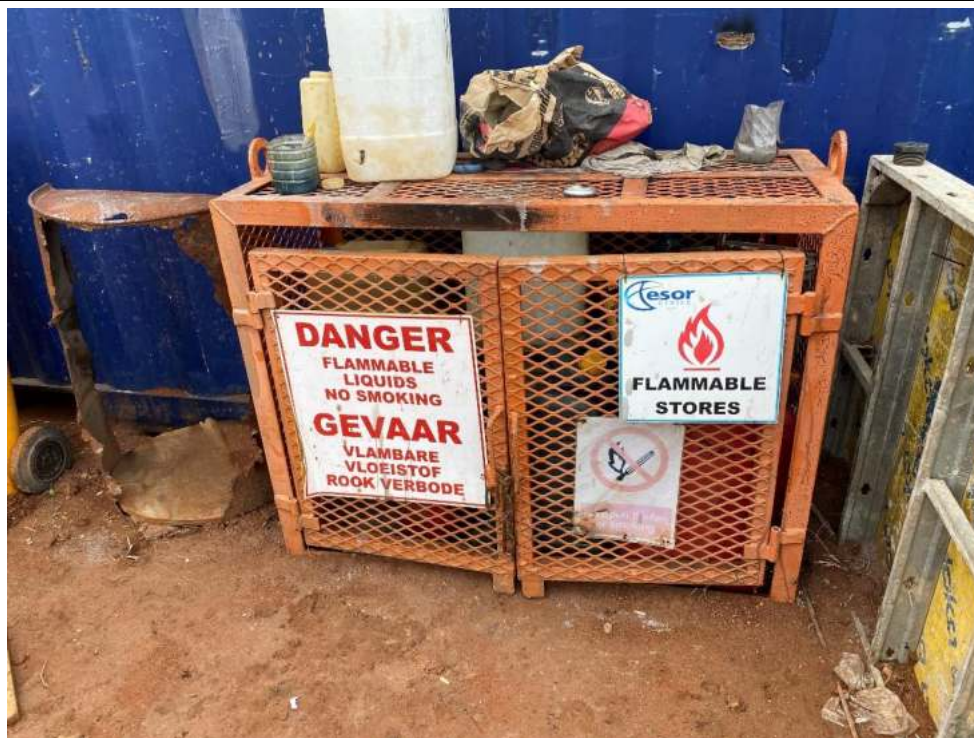
Photo 31: Chemical Storage Cage Unlocked

- The chemical storage cage was found to be unlocked at the Spitskop Pump Station, and an MSDS sheet is kept on site to keep a record of all chemicals stored and used. Safety signages are clearly visible on the cage.

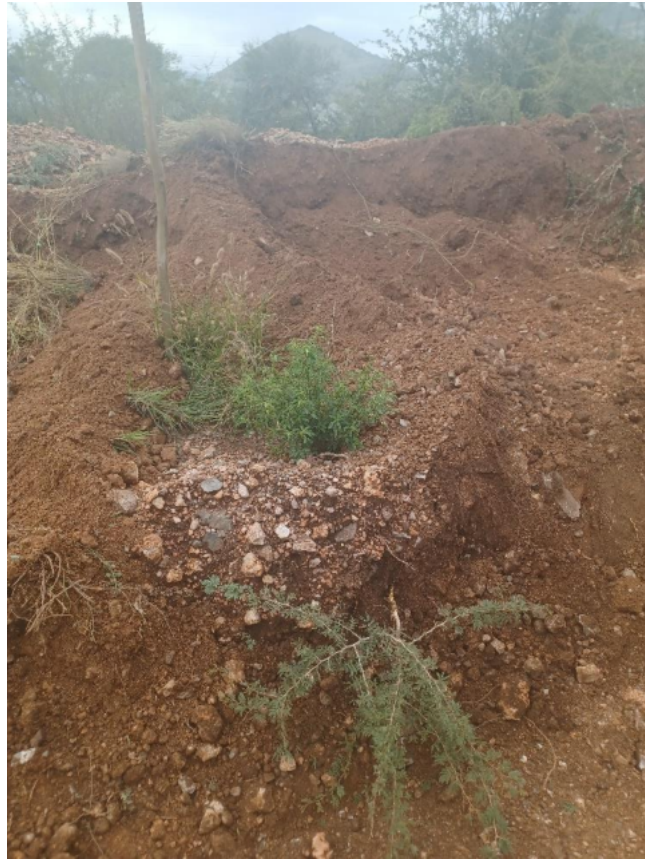
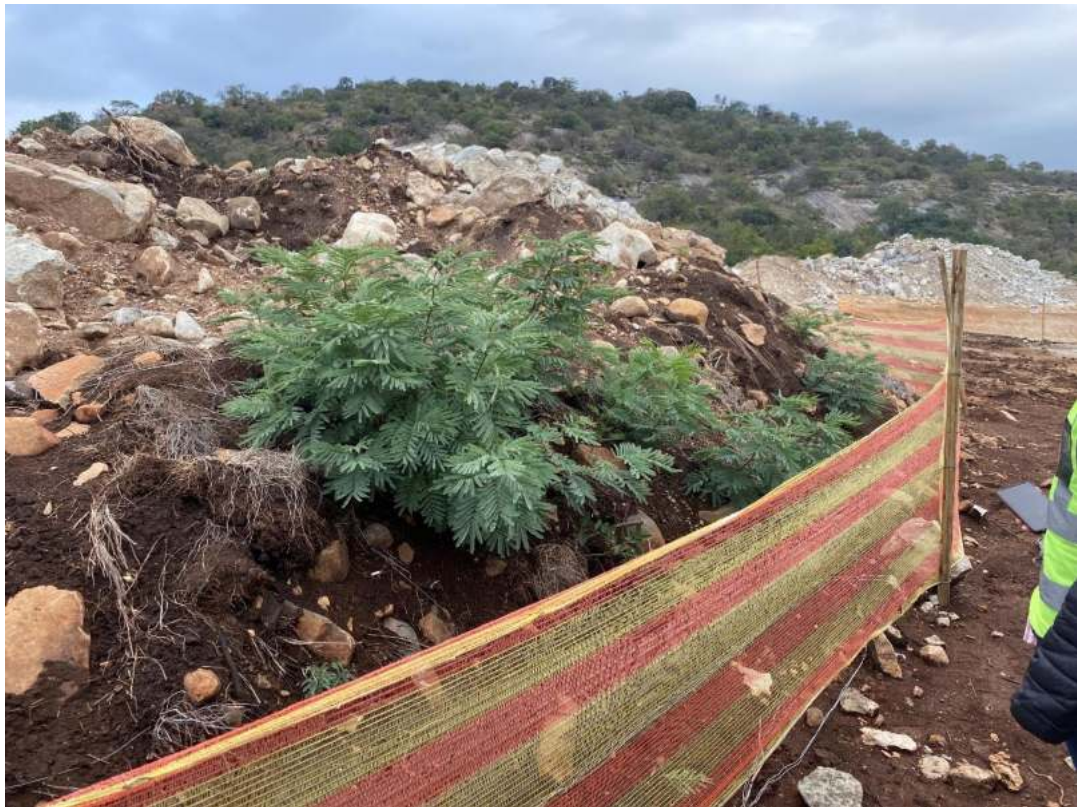
Photo 41: Minimal Alien and Invasive Species found

- During the audit undertaken in May 2023 minimal Alien and Invasive species were found along the pipeline route as well as at the Spitskop Pump Station. The removal of alien and invasive species was noted as a work in progress, no alien and invasive species was found along the pipeline trench however small clusters could be found at the pipes that have not yet been installed.
