Lebalelo Water User Association
SE2 pipeline and associated infrastructure
Ninth Construction Environmental Audit Report
DFFE Reference Number: 14/12/16/3/3/1/2442

Lebalelo Water User Association

SE2 pipeline and associated infrastructure

Ninth Construction Environmental Audit Report

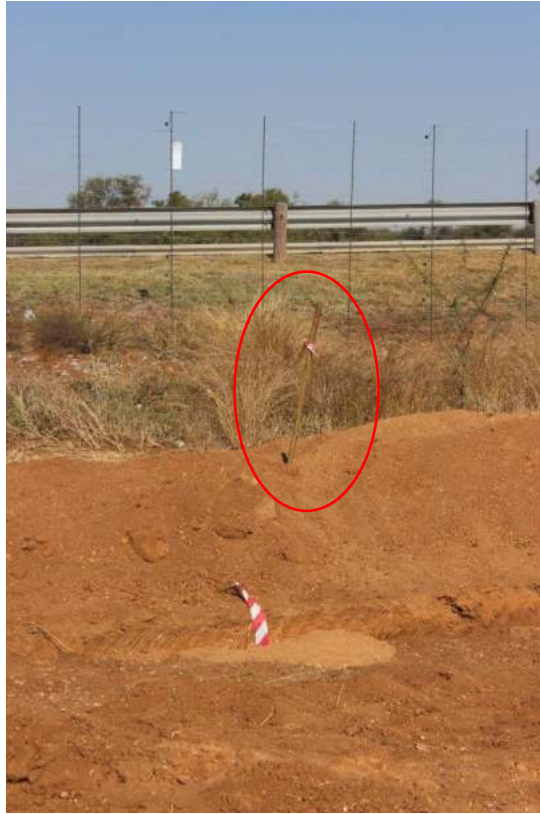
Audit Findings of the Environmental Authorisation				
NR	ENVIRONMENTAL AUTHORISATION CONDITION	COMPLIANCE STATEMENT	OBSERVATION IN JUNE 2023 AUDIT	RECOMMENDATIONS BY AUDITOR
35	The micro-siting / pegging of the route for the Lebalelo raw water pipeline must be undertaken prior to commencement with construction activities. This final walk through of the pipeline route must be undertaken by a botanical specialists to identify any protected and endangered plants and trees for a search and rescue operations. The findings of this undertaking must inform the final layout plan per condition 12 and 13 above.	2	<p>At the time of this audit (June 2023) it was confirmed that micro pegging has taken place. Photographic evidence can be found in Annexure C: Photo 11.</p> <p>The Biodiversity Company undertook a final botanical walkdown on 1 and 2 June 2022. A letter informing the Department of such was sent on 15 June 2022. A protected trees permit was granted by the DFFE on 7 November 2022, Licence LP-SDM - 0004-2022-23. All protected trees have been marked with danger tape and will only be removed if necessary. A record of all protected trees that have been removed was provided to the audit team. At the time of this audit 5 Marula trees have been removed. Photographic evidence can be found in Annexure C: Photo 12 and 13.</p>	<p>It is recommended that the botanical walkdown report and Protect Trees Permit be kept within the on-site compliance file.</p> <p>It is also recommended that the trees be re-marked with danger tape as some tape have been exposed to weather conditions for quite a while, and is not as visible any longer.</p>

Photo 11: Micro-siting / pegging of the pipeline route

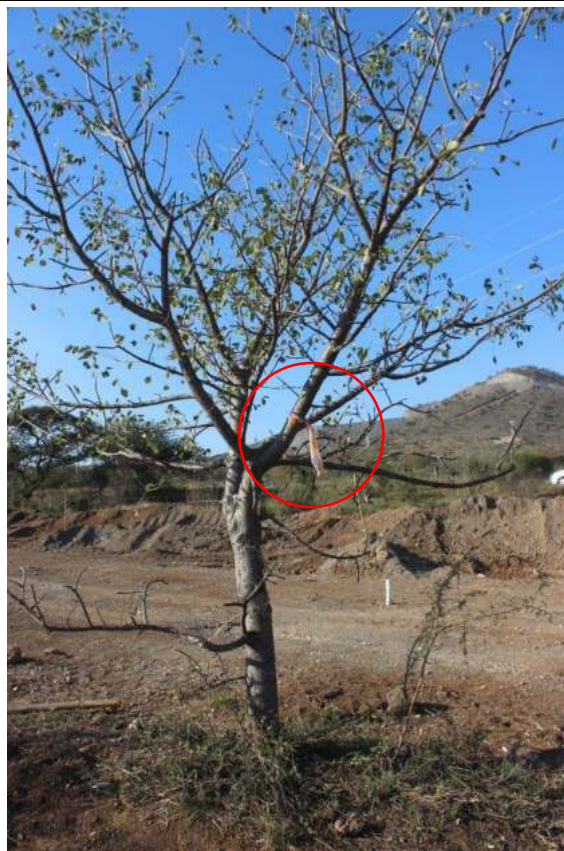
Photo 12: Protected tree marked with danger tape

36	Where the pipeline is planned to be buried all topsoil must be separated from subsoil and stored separately, when backfilled the soil should be replaced in the correct order.	2	The excavation of the pipeline route has commenced and soil excavated are stored adjacent to the excavation. A portion of the pipeline has been backfilled and soil was noted to be placed correctly. Photographic evidence can be found in Annexure C: Photo 14 and 15.	LWUA to take cognisance that topsoil and subsoil must be stored within separate stockpiles and replaced in the correct order.
37	High visibility flags must be placed near any threatened / protected plants in order to avoid any damage or destruction of the species	2	Protected trees were marked at the onset of the construction of the SE2 pipeline route (September/October 2022). In the April and May 2023 audits, it was noted that some of these markers (danger tape) are still visible, but some Marula Trees were observed to be not marked. In the June Audit it was noted that protected trees were clearly marked and no un-marked protected trees were observed. Photographic evidence can be found in Annexure C: Photo 42.	<p>LWUA to take cognisance that any threatened or protected plants need to be flagged to avoid damage or destruction to the species.</p> <p>It is recommended that another walkdown is undertaken by the Contractor and protected trees/plants clearly marked with high visibility flags/danger tape to ensure that the protected trees/plants are clearly visible.</p>

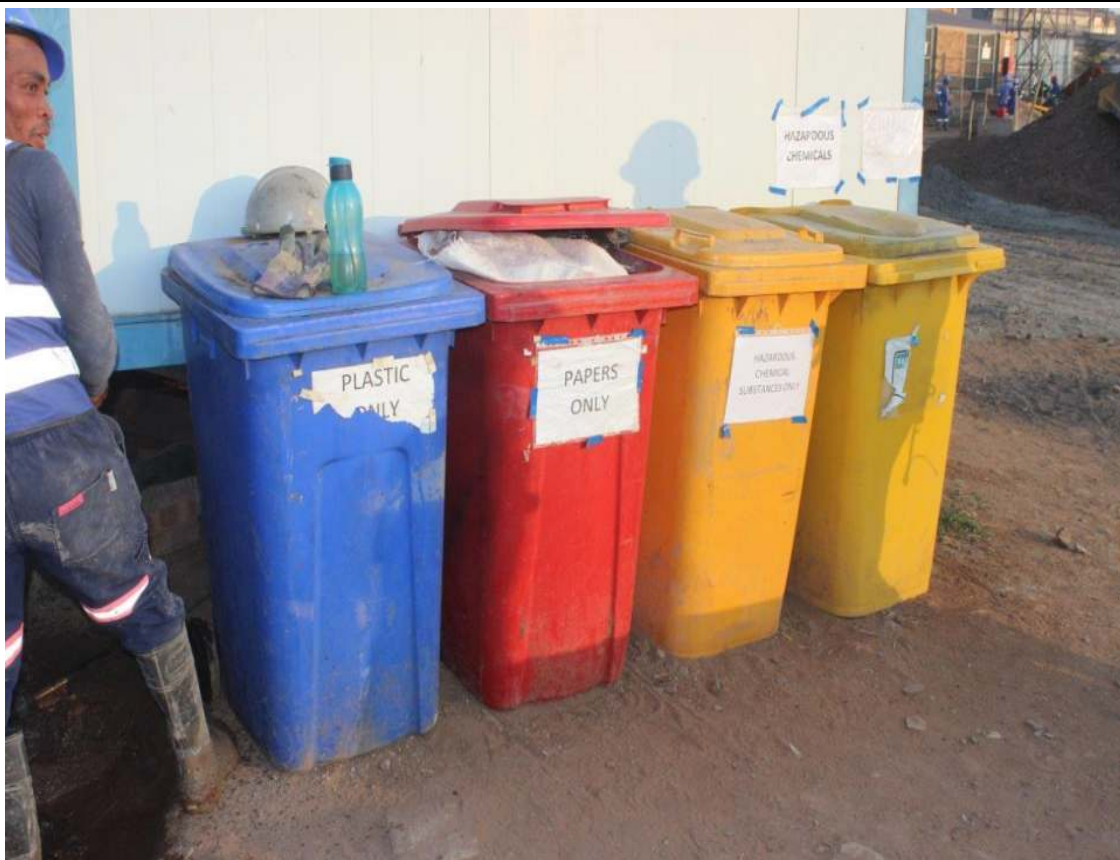
- Waste bins have been provided at the Spitskop Pump Station, along the SE2 pipeline route and at the Reservoir Site. These bins have been marked for a specific waste stream as to ensure re-cycling and reuse where possible. During the May and June 2023 audit, wear and tear on the signages of the waste bins was noted, the audit team recommended that these signs are replaced as to ensure all labels are easily identifiable. The waste bins at the Spitskop Pumpstation were found to be overflowing.

Photo 18: Spitskop Pump Station Waste Management

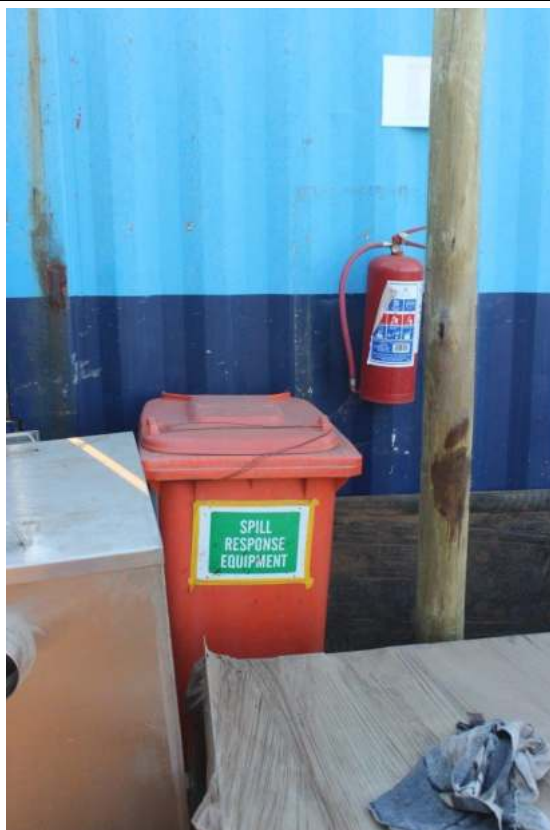
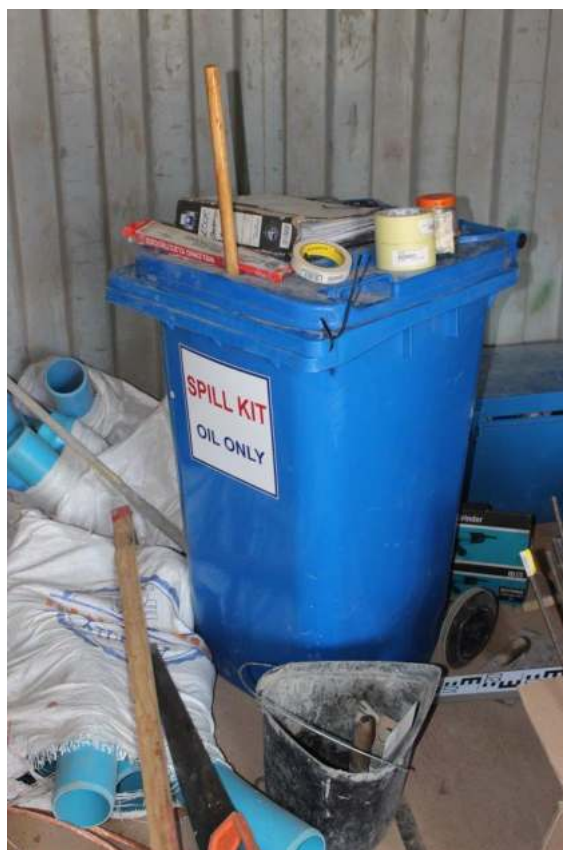
Photo 21: Hydrocarbon spill kits on site

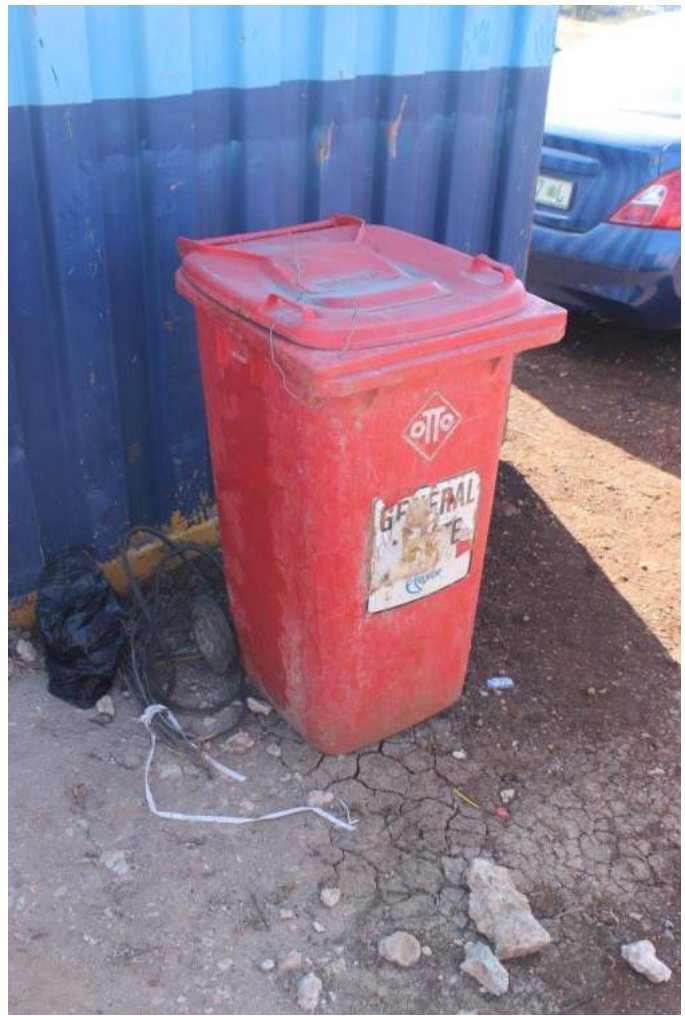
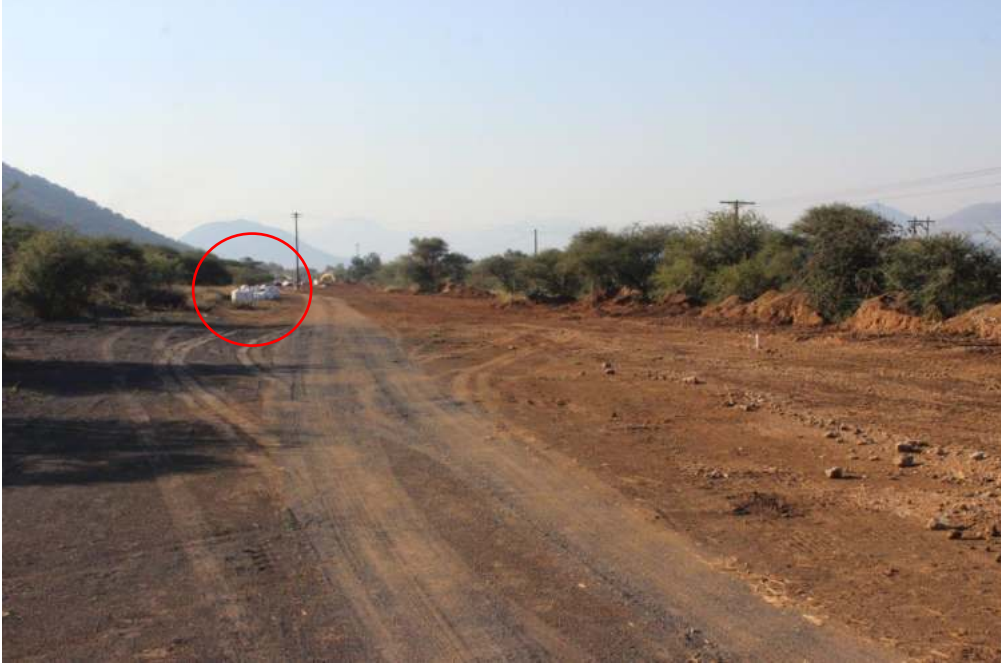
- Housekeeping in terms of waste management was noted to be an improvement, however sandbags were observed on the pipeline route. It is suggested that all waste be removed from site and disposed of appropriately.

Photo 22: Waste Management along the Pipeline Route

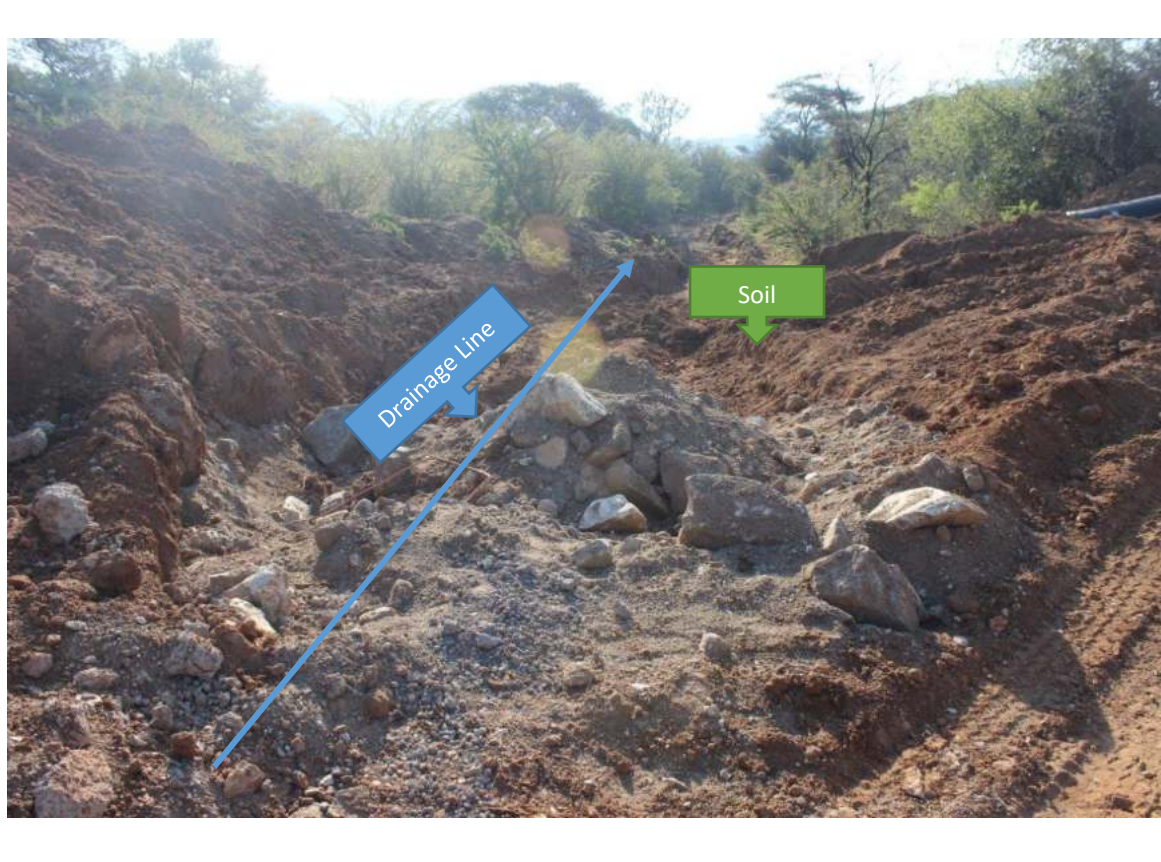
- During the December, January, February, March, April, May and this audit (June) it was observed that topsoil was stockpiled within drainage lines. The contractor implemented erosion protection measures such as sandbags along the drainage line in January/February. During this audit (June 2023), topsoil was found to be still be stored within the drainage line and no erosion protection measures such as sandbags are in place. The contractor was informed he must adhere to its method statement for Stream/river crossings, Document Number: MET-ENV-188, Revision 3. The contractor informed the audit team that due to the heavy rainfall experience during May 2023 they have not been able to complete construction in this area. All soil will be backfilled and rehabilitated accordingly once the construction is completed and this area will not be disturbed further once rehabilitation is complete.

Photo 24: Soil stored in the drainageline and sandbags washed away

4			All removed soil and material stockpiles must be protected from erosion, stored on flat areas where run-off will be minimised, and be surrounded by bunds.	0	Most topsoil have been stored on flat areas where run-off will be minimal. During the December, January, February, March, April, May and this audit (June) it was observed that topsoil was stockpiled within drainage lines. The contractor implemented erosion protection measures such as sandbags along the drainage line in January/February. During this audit (June 2023), topsoil was found to be stored within the drainage line and no erosion protection measures such as sandbags are in place. The contractor was informed he must adhere to its method statement for Stream/river crossings, Document Number: MET-ENV-188, Revision 3. The contractor informed the audit team that due to the heavy rainfall experience during May 2023 they have not been able to complete construction in this area. All soil will be backfilled and rehabilitated accordingly once the construction is completed and this area will not be disturbed further once rehabilitation is complete. Photographic evidence can be found in Annexure C: Photo 24.	LWUA to take cognisance that stockpiles must be protected from erosion, placed on flat areas and surrounded by bunds

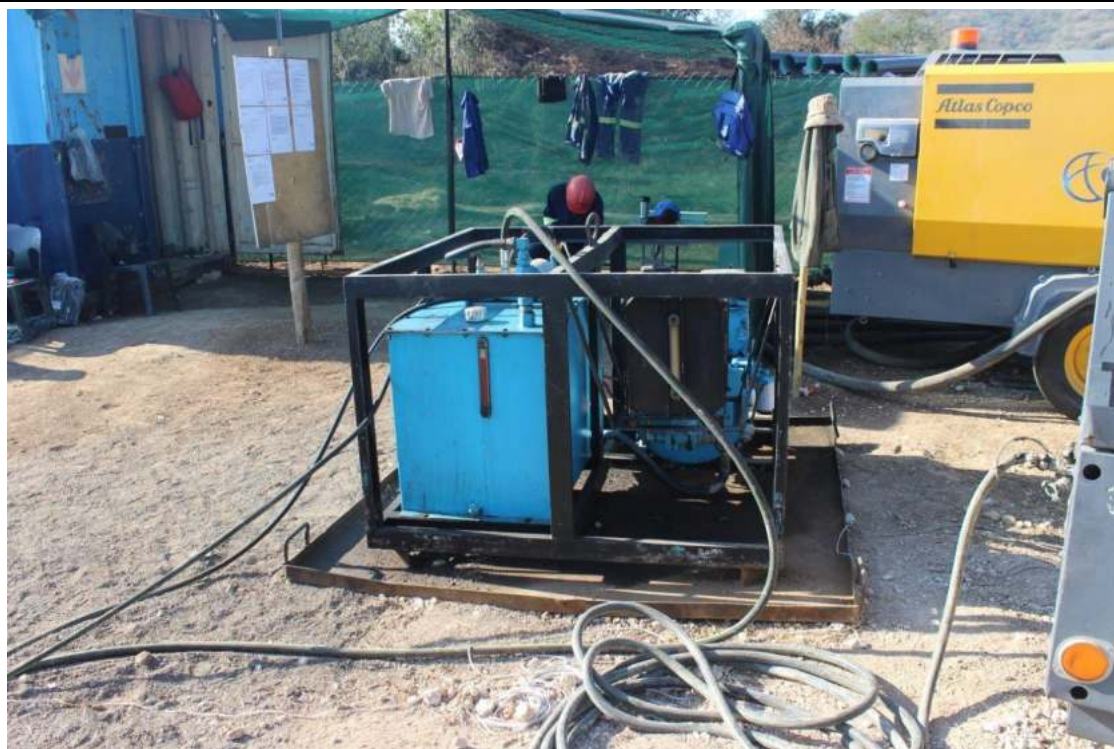
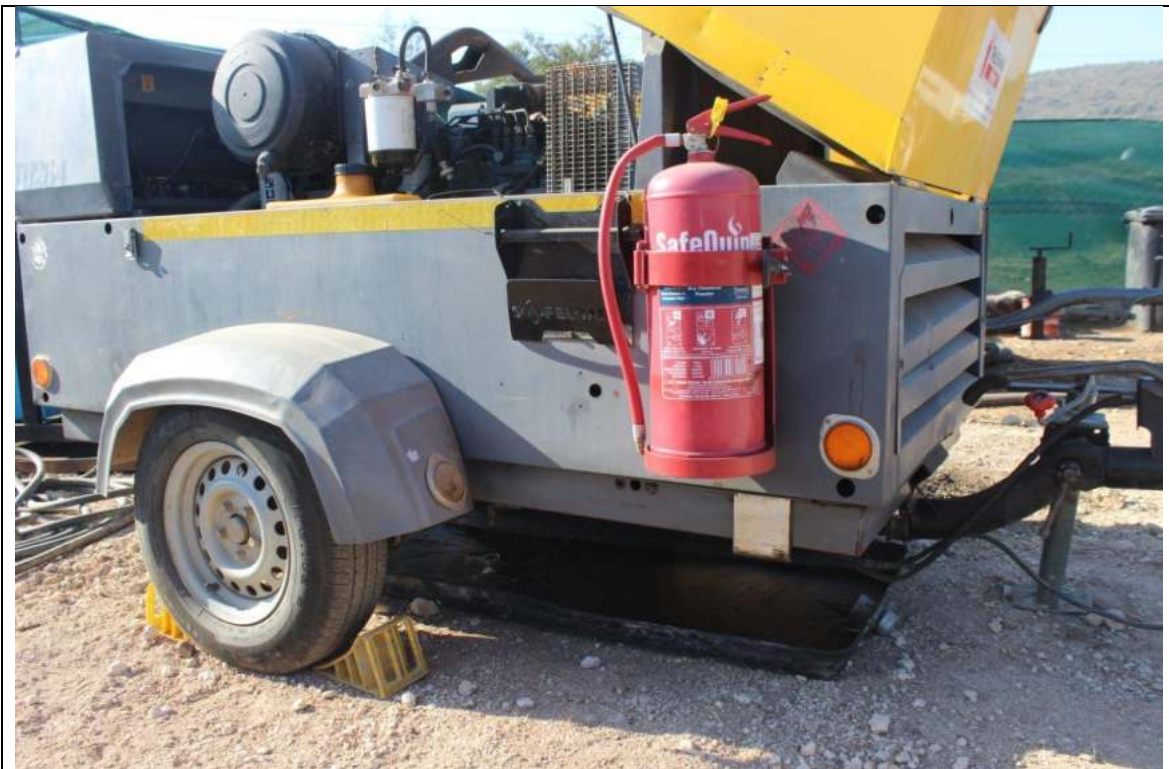
Photo 26: Drip trays under machinery not in use.

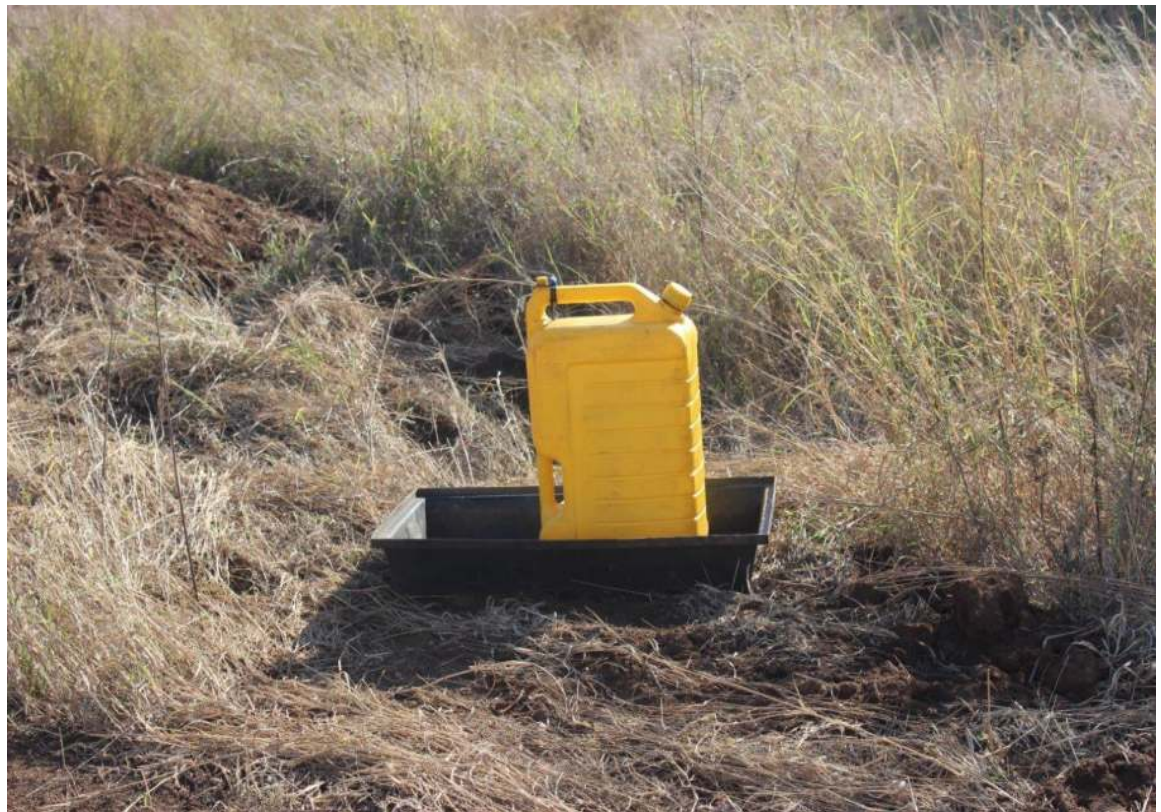
Photo 27: Drip trays under jerry cans not in use

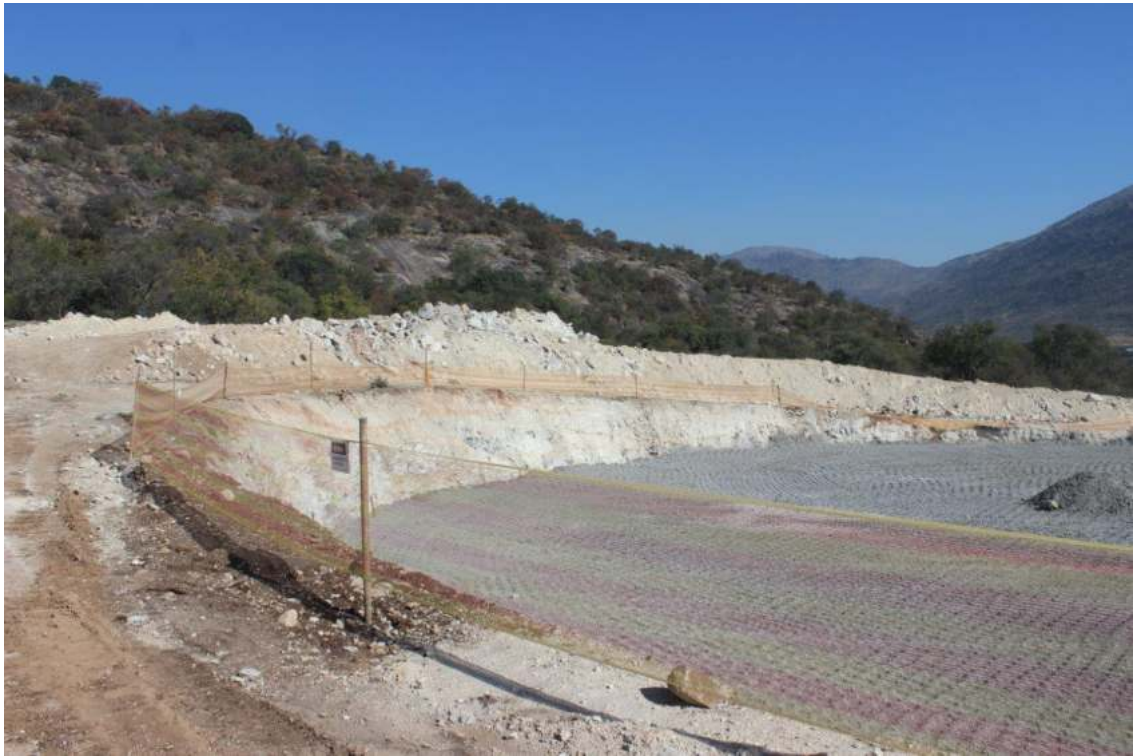
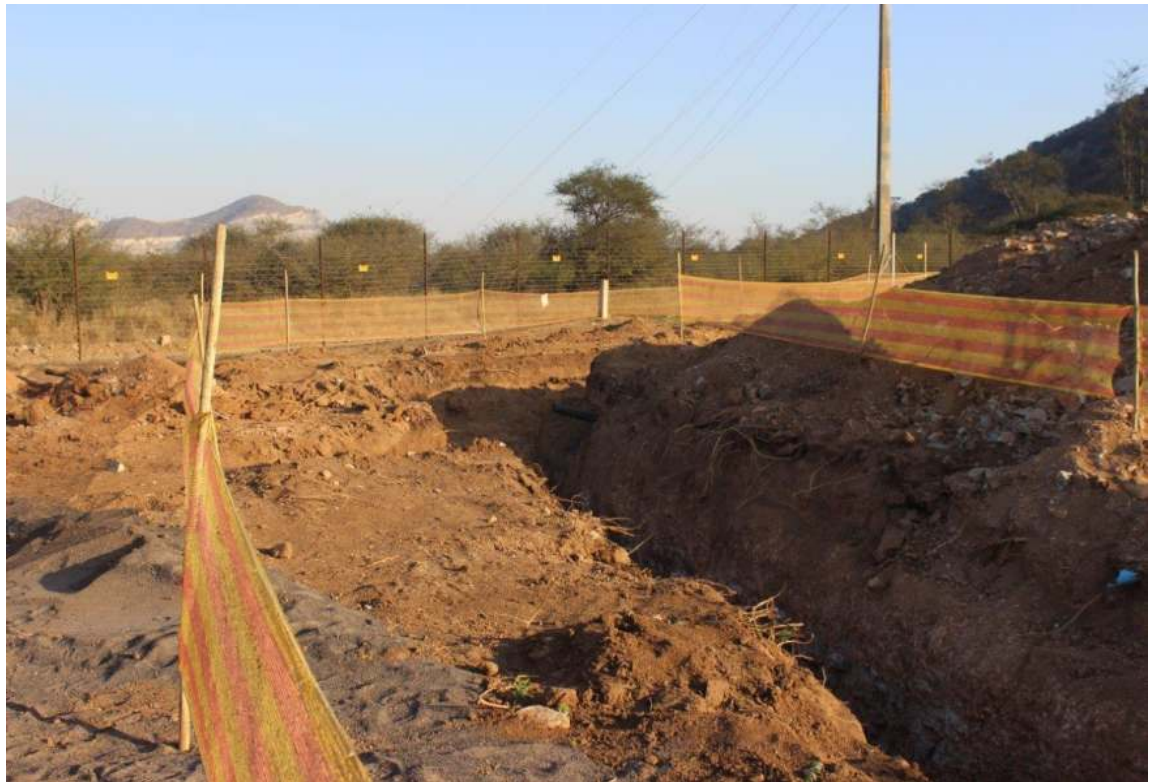
Photo 28: Construction footprint areas demarcated with reflector netting

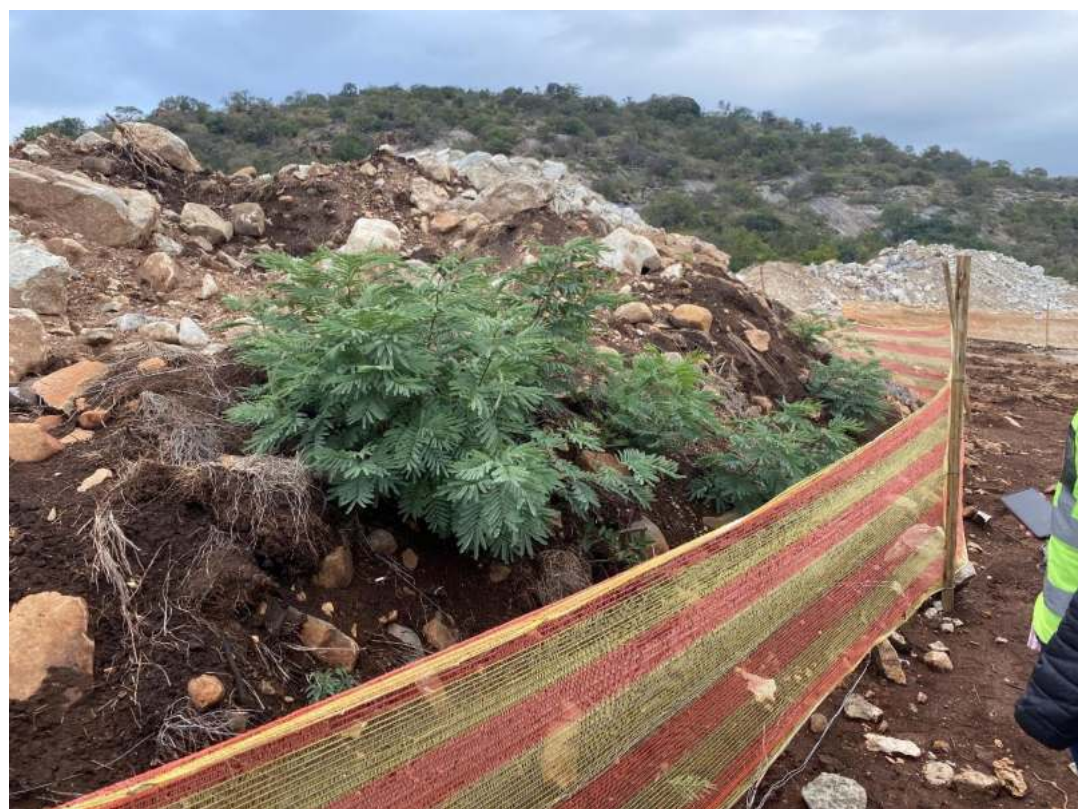
- During the audit undertaken in June 2023 minimal Alien and Invasive species were found along the pipeline route as well as at the Spitskop Pump Station. The removal of alien and invasive species was noted as a work in progress, no alien and invasive species was found along the pipeline trench however small clusters could be found at the pipes that have not yet been installed.
- During the current audit, spill kits could be found at the Spitskop Pump Station and at the Reservoir Site. However, no spill kit was found at the Pipe Jacking Area at Lion Smelter.
- The ablution facilities are serviced on a weekly basis by Talisman Hire. Proof of these services was provided to the audit team. However, Proof of service was not provided to the audit team for the month of June 2023.

Photo 41: Minimal Alien and Invasive Species found
