Lebalelo Water User Association
SE2 pipeline and associated infrastructure
Tenth Construction Environmental Audit Report
DFFE Reference Number: 14/12/16/3/3/1/2442

July 2023

Tenth Construction Environmental Audit Report

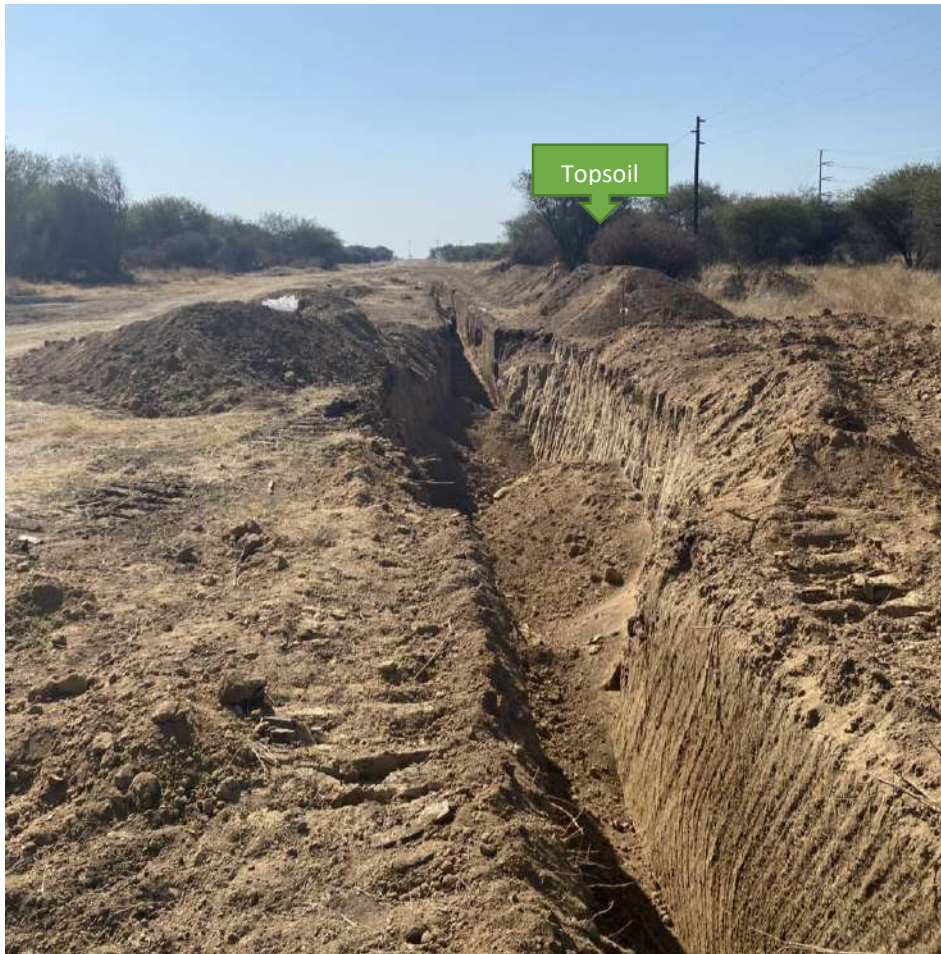
Photo 14: Stockpile of topsoil on site.

2			The first 300 mm of soil must be stockpiled separate from the soil excavated deeper than 300 mm	2	Excavated soil is stored adjacent to the pipeline trench. Topsoil and subsoil are stored separately. Backfilling of soil has commenced on site at the portion of the pipeline near the Steelpoort Industrial Park. Photographic evidence can be found in Annexure C: Photo 14 and 15.	LWUA to take cognisance that all topsoil and subsoil must be stockpiled separately on either side of the trench and backfilled in the correct order.
3			The proposed pipeline system must be divided up into 100 m intervals. Each interval's soil must be stockpiled and filled back up (in the correct order) to avoid long periods of stockpiling.	2	Topsoil and subsoil are stored separately. Backfilling of soil has commenced on site at the portion of the pipeline near the Steelpoort Industrial Park. Photographic evidence can be found in Annexure C: Photo 14 and 15.	None

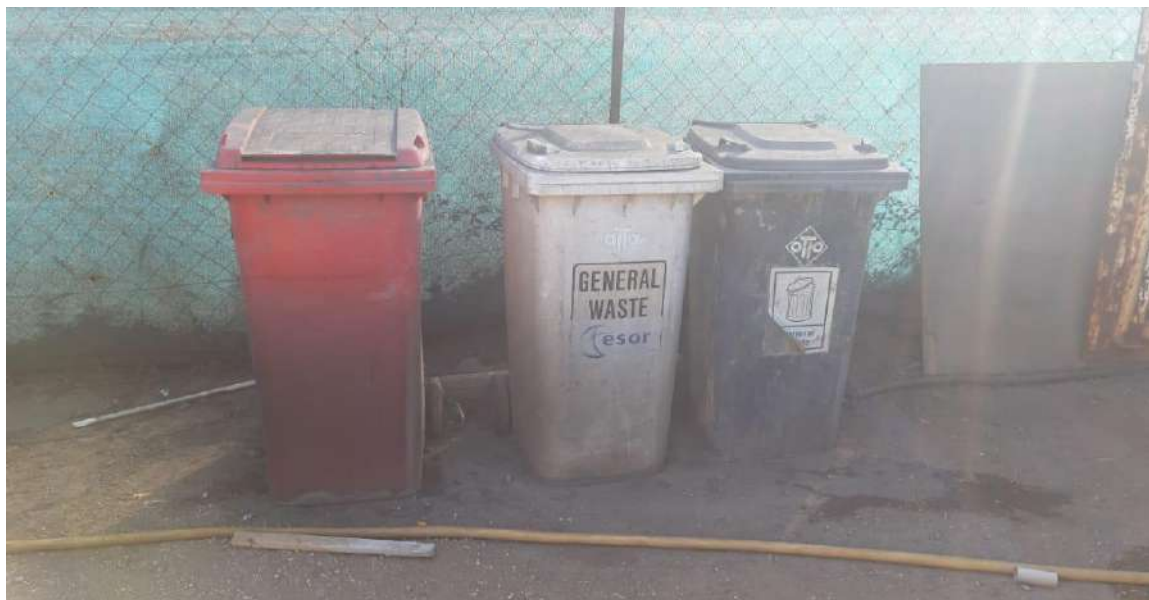
Photo 20: Waste Management on site (Pipe Jacking near Lion Smelter)

- Waste bins have been provided at the Spitskop Pump Station, along the SE2 pipeline route and at the Reservoir Site. These bins have been marked for a specific waste stream as to ensure re-cycling and reuse where possible. The waste bins at the Reservoir and Pipe Jack were found to be overflowing.

- Housekeeping in terms of waste management was noted to be an improvement, however sandbags were observed on the pipeline route. It is suggested that all waste be removed from site and disposed of appropriately.

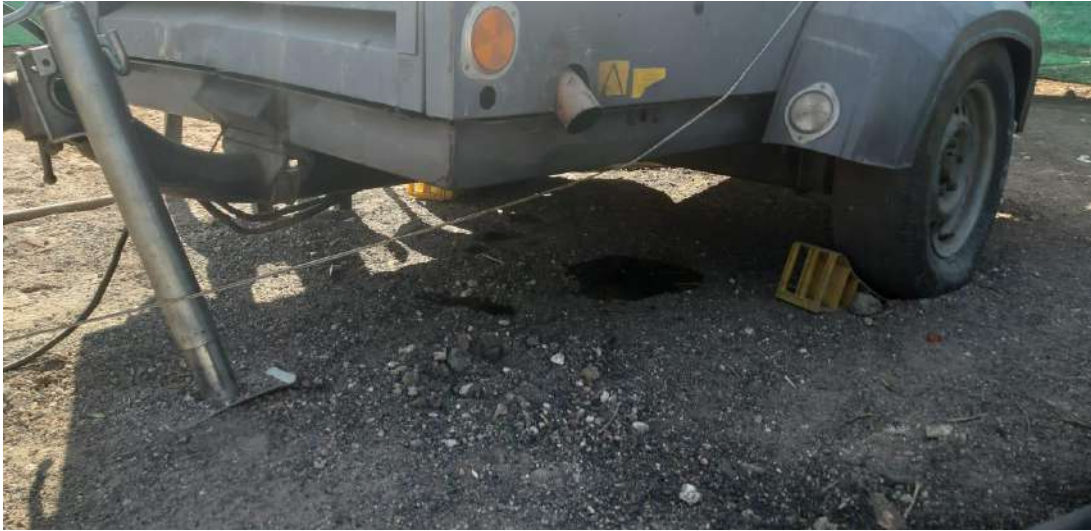
Photo 22: Hydrocarbon spill

- No spill kit was observed at the Dwarsrivier Pipe Jack.
- A hydrocarbon spill was observed at the Dwarsrivier Pipe Jack underneath a compressor that was not in use.

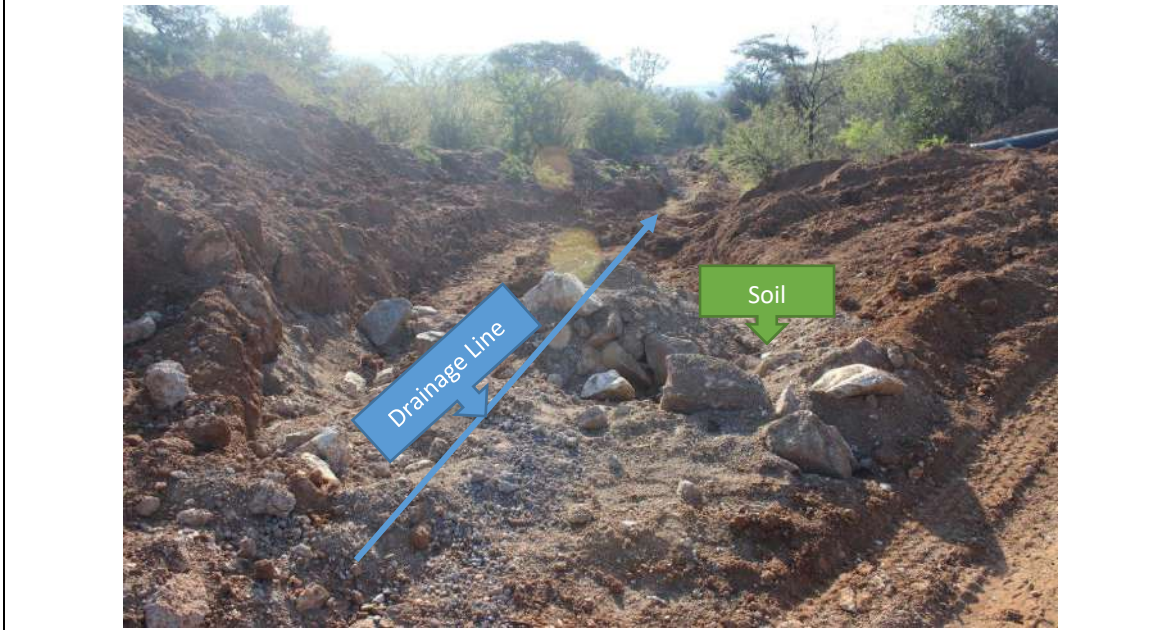
Photo 24: Soil stored in the drainageline and sandbags washed away

- During the December, January, February, March, April, May, June and this audit (July) it was observed that topsoil was stockpiled within drainage lines. The contractor implemented erosion protection measures such as sandbags along the drainage line in January/February. During this audit (July 2023), topsoil was found to be still be stored within the drainage line and no erosion protection measures such as sandbags are in place. The contractor was informed he must adhere to its method statement for Stream/river crossings, Document Number: MET-ENV-188, Revision 3. The contractor informed the audit team that due to the heavy rainfall experience during May 2023 they have not been able to complete construction in this area. All soil will be backfilled and rehabilitated accordingly once the construction is completed and this area will not be disturbed further once rehabilitation is complete.

4			All removed soil and material stockpiles must be protected from erosion, stored on flat areas where run-off will be minimised, and be surrounded by bunds.	0	Most topsoil have been stored on flat areas where run-off will be minimal. During the December, January, February, March, April, May, June and this audit (July) it was observed that topsoil was stockpiled within drainage lines. The contractor implemented erosion protection measures such as sandbags along the drainage line in January/February. During this audit (July 2023), topsoil was found to be stored within the drainage line and no erosion protection measures such as sandbags are in place. The contractor was informed he must adhere to its method statement for Stream/river crossings, Document Number: MET-ENV-188, Revision 3. The contractor informed the audit team that due to the heavy rainfall experience during May 2023 they have not been able to complete construction in this area. All soil will be backfilled and rehabilitated accordingly once the construction is completed and this area will not be disturbed further once rehabilitation is complete. Photographic evidence can be found in Annexure C: Photo 24.	LWUA to take cognisance that stockpiles must be protected from erosion, placed on flat areas and surrounded by bunds

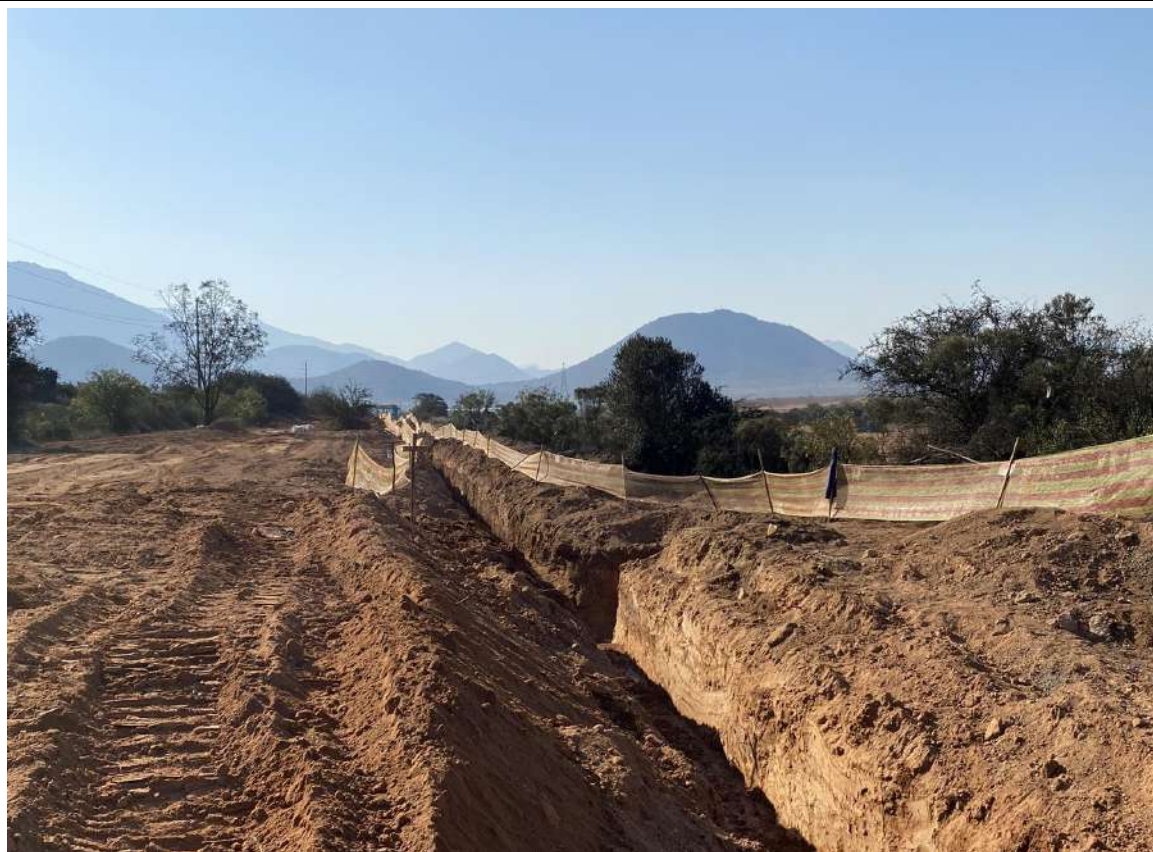
Photo 25: Construction activities within pipeline servitude

7			These designated stockpile areas must be viewed as temporary and kept for backfill material.	2	At the time of this audit (July 2023) backfilling activities have commenced on site at the portion of the pipeline near the Steelpoort Industrial Park. Photographic evidence can be found in Annexure C: Photo 15.	LWUA to take cognisance that stockpiles are only temporary and must be used as backfill material.
8			Maintain soil quality and minimise damage to the soil structure during the time the material is stockpiled.	2	Soil stockpiles were intact and no driving has taken place on topsoil stockpiles. Photographic evidence can be found in Annexure C: Photo 14 and 15.	LWUA to take cognisance that soil quality must be maintained and measures implemented to minimise damage to the soil structure during the time the material is stockpiled.
9			All construction access must make use of the existing roads that can be found in and around the project area.	2	Access to the Spitskop Pump Station and the Pipeline Route is done using existing roads. Construction activities along the pipeline route is done within the pipeline servitude. No new roads were identified at the time of this audit (July 2023). Photographic evidence can be found in Annexure C: Photo 25.	LWUA to take cognisance that existing roads must be used.

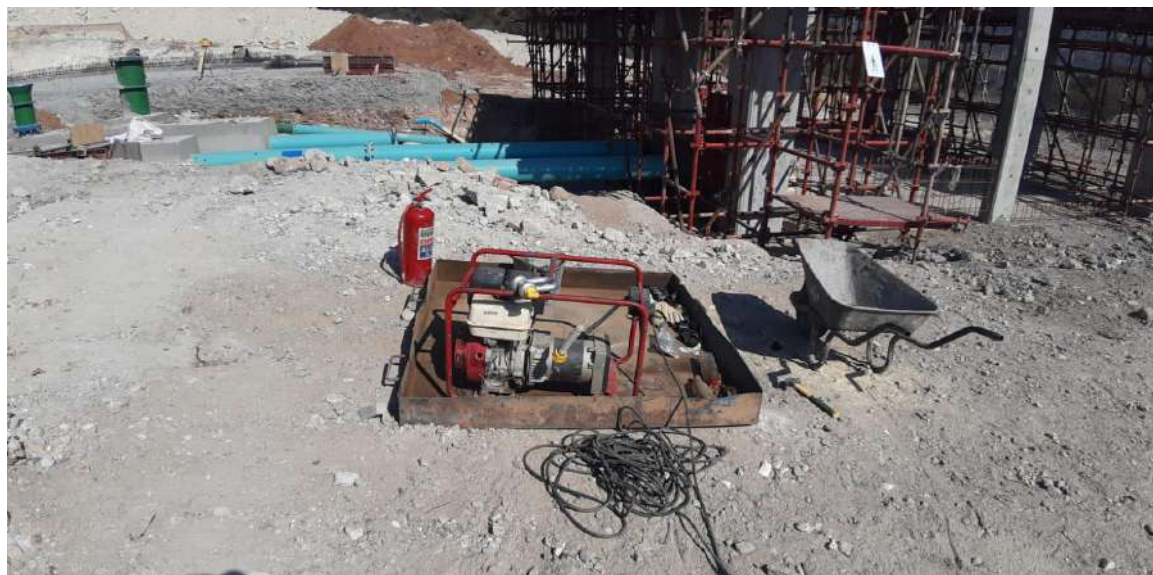
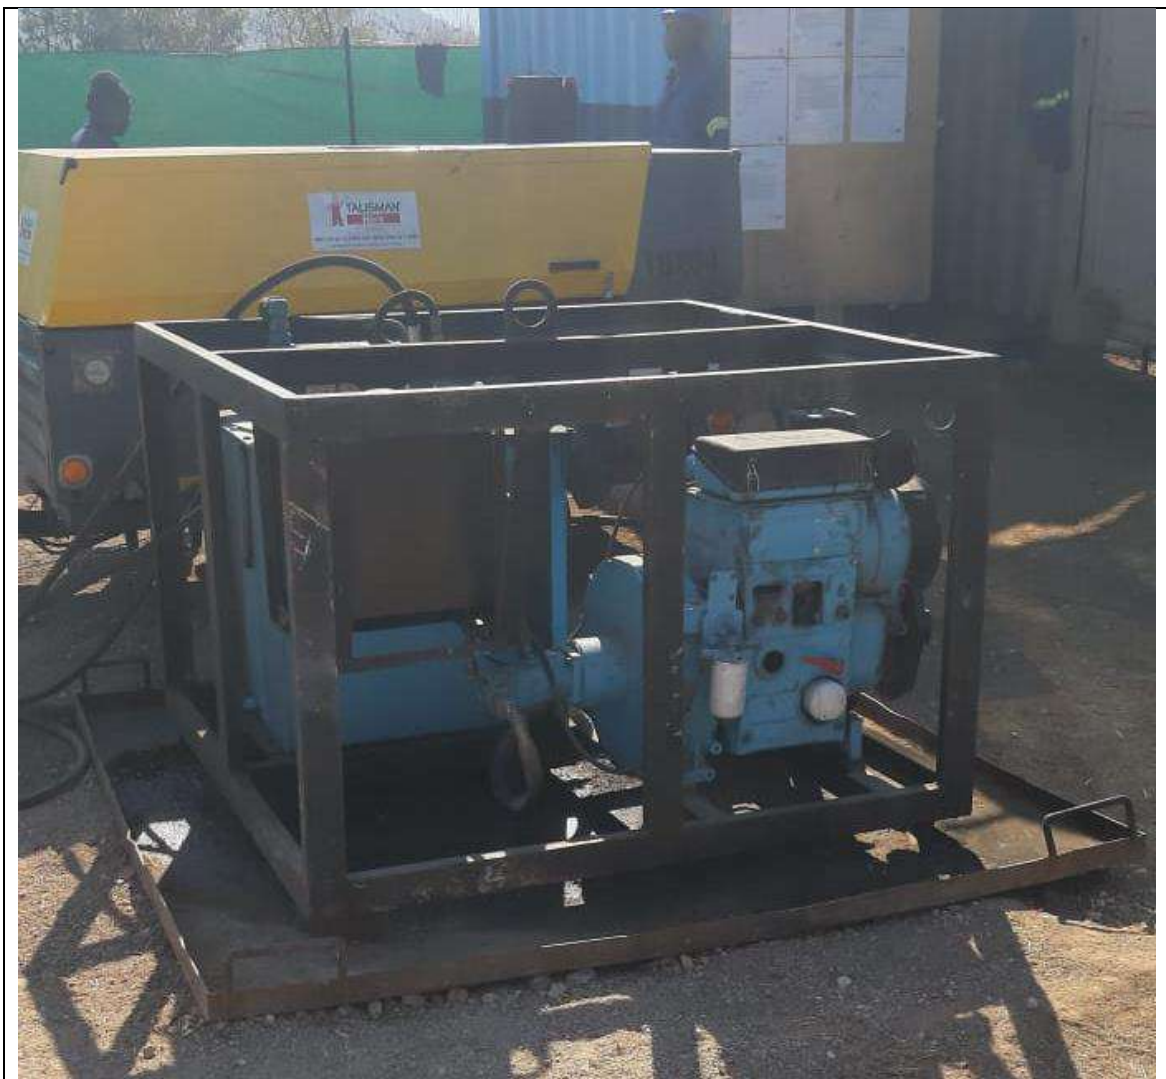
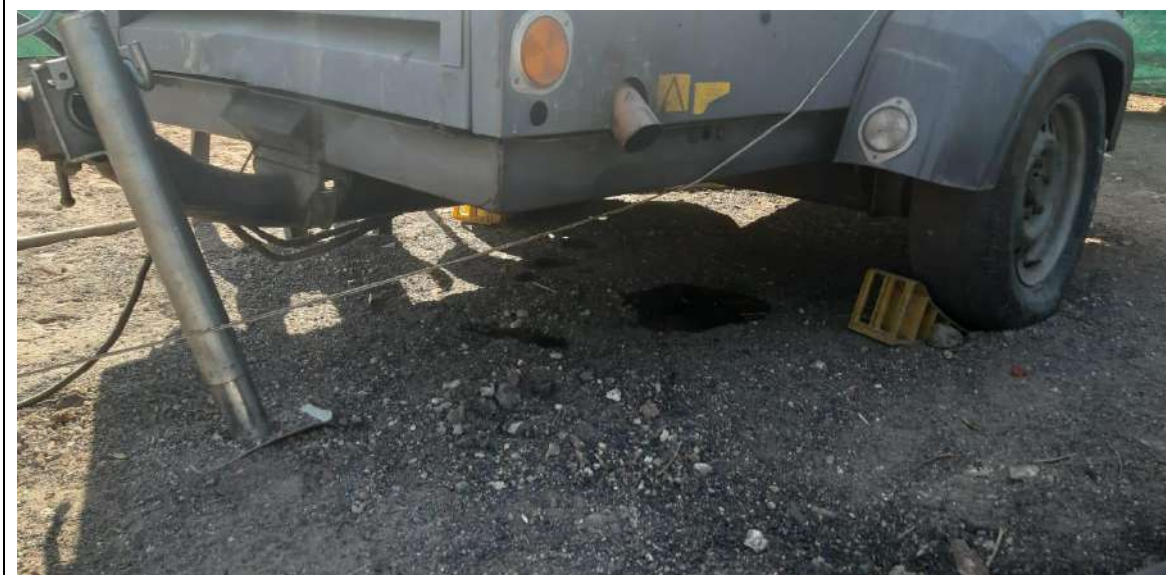
Photo 26: Drip trays under machinery not in use as well as no drip trays visible under machinery not in use.

- Some diesel and jerry cans were found to not be correctly stores within dip-trays or bunded areas. Machinery not in use was also found to not have drip trays placed underneath them.

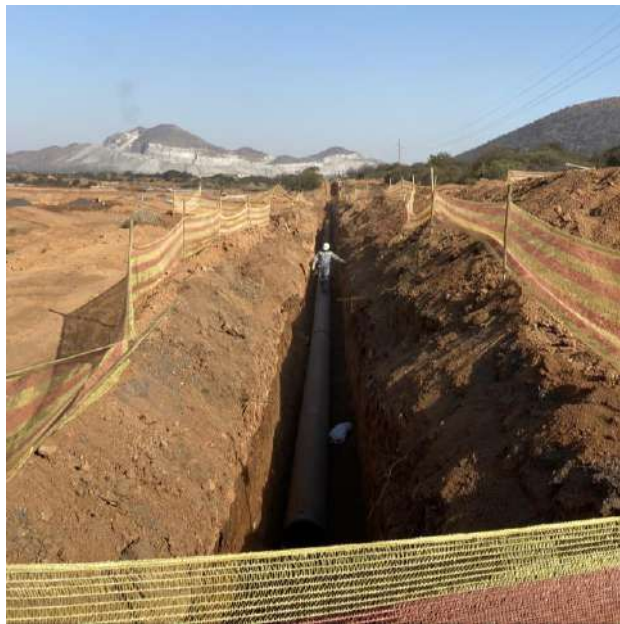
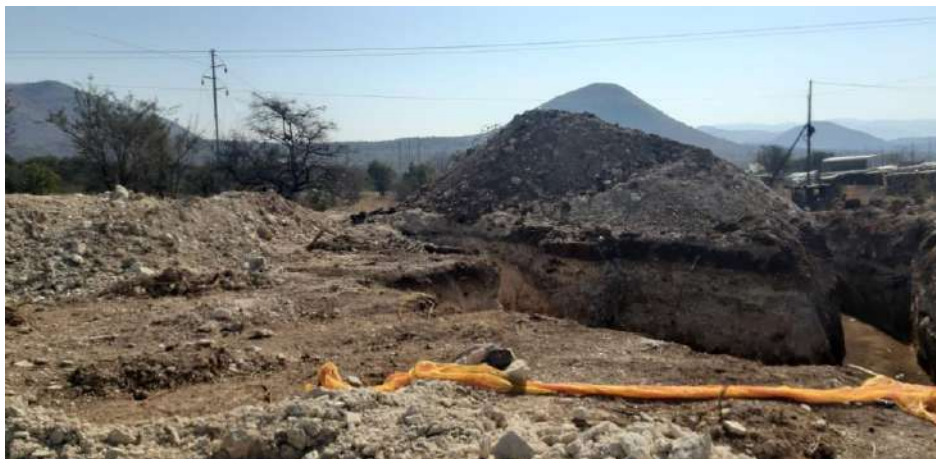
Photo 28: Construction footprint areas demarcated with reflector netting as well as construction areas not properly demarcated.

- During the July 2023 Audit, the wetland and associated buffer was not clearly marked.
- During the audit undertaken in July 2023 it was observed that only some active construction sites have been demarcated with high visibility orange and yellow barrier netting. Sections of the pipeline was observed to not be demarcated with high visibility orange and yellow barrier netting.

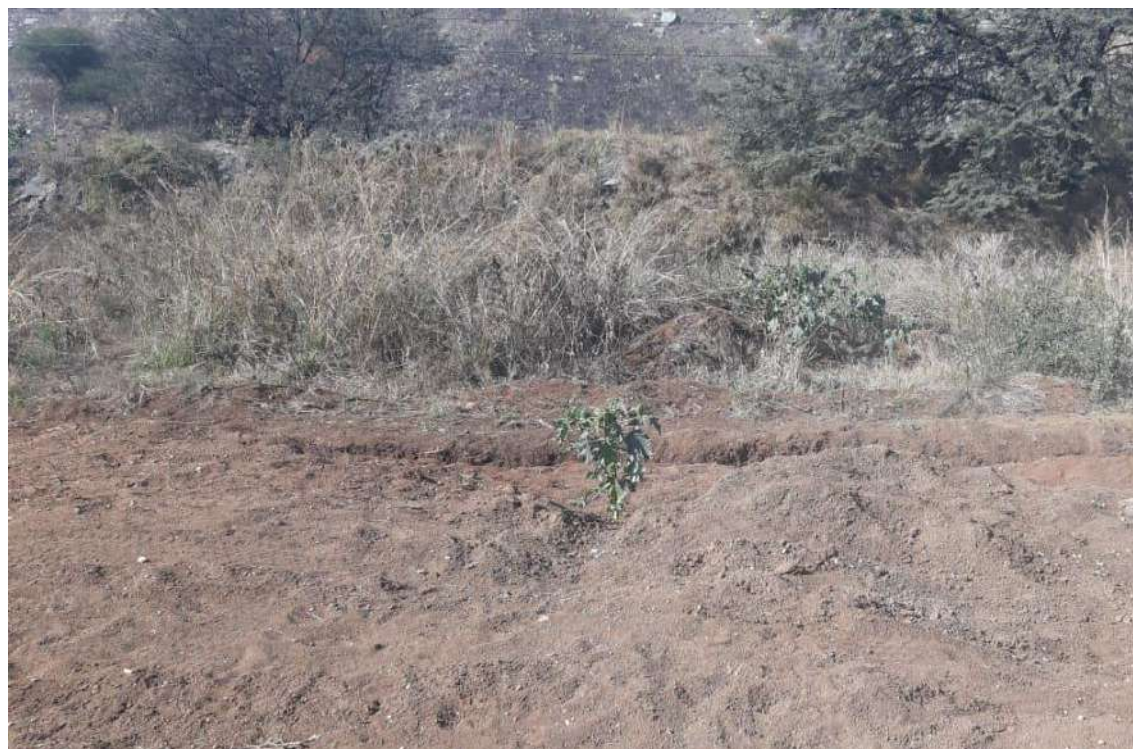
Photo 41: Minimal Alien and Invasive Species found

- During the audit undertaken in July 2023 minimal alien and invasive species were found along the pipeline route as well as at the Spitskop Pump Station. The removal of alien and invasive species was noted as a work

in progress, no alien and invasive species was found along the pipeline trench however small clusters could be found at the pipes that have not yet been installed.
