Lebalelo Water User Association
SE2 pipeline and associated infrastructure
Eleventh Construction Environmental Audit Report
DFFE Reference Number: 14/12/16/3/3/1/2442

Eleventh Construction Environmental Audit Report

August 2023

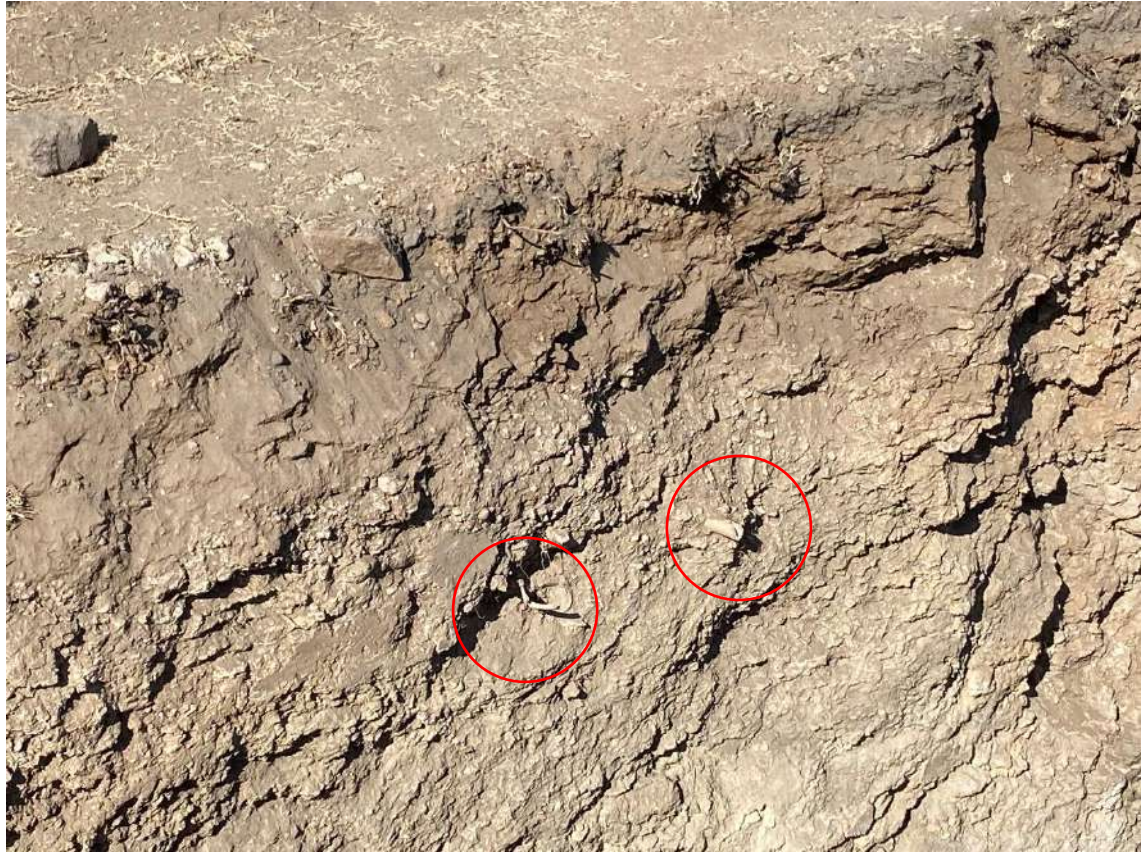
Photo 24: Bones discovered in Steelpoort Industrial Park Trench Excavation

The construction team has found bones during excavation activities of the pipeline trench within the Steelpoort Industrial Park yesterday (07 August 2023). Coordinates: 24°52'9.40"S, 30° 7'4.80"E. It is uncertain if the bones are human remains or other. Refer to the Google Earth image and photographs below.

- All construction activities at the site have ceased and the immediate vicinity barricaded;
- An archaeologist has been appointed to investigate and to confirm if the bones are human remains or other.

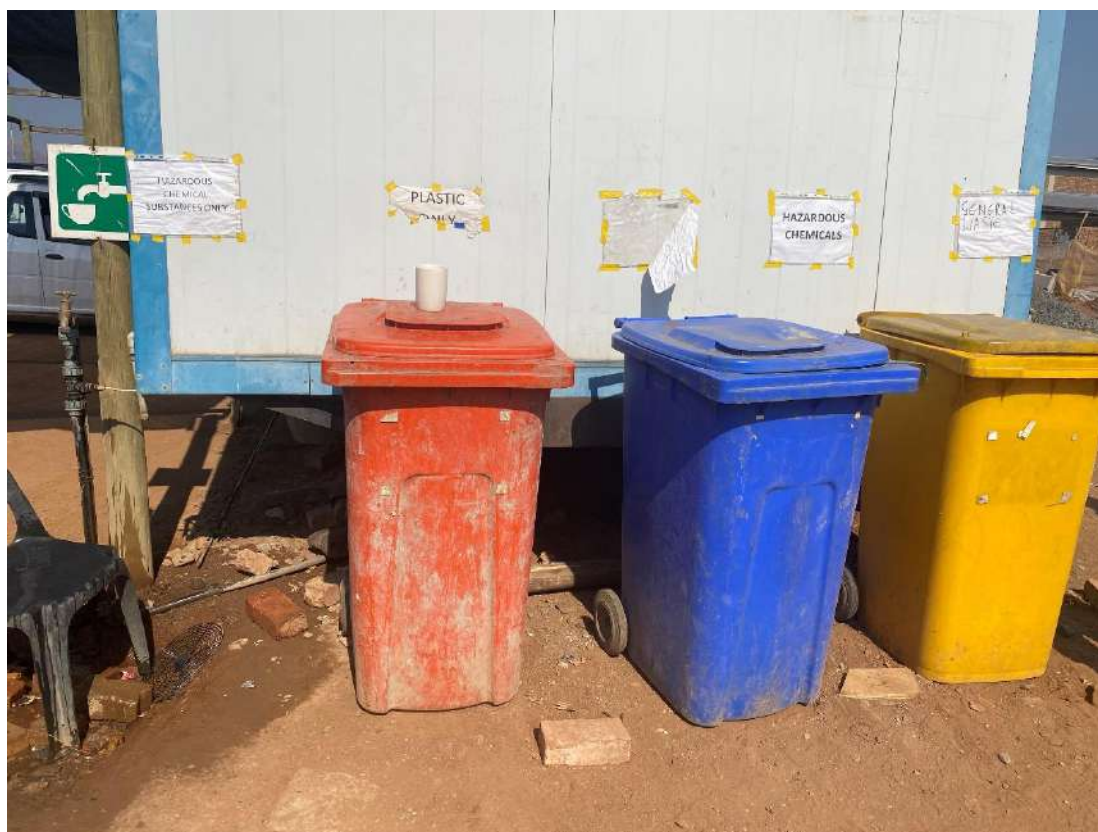
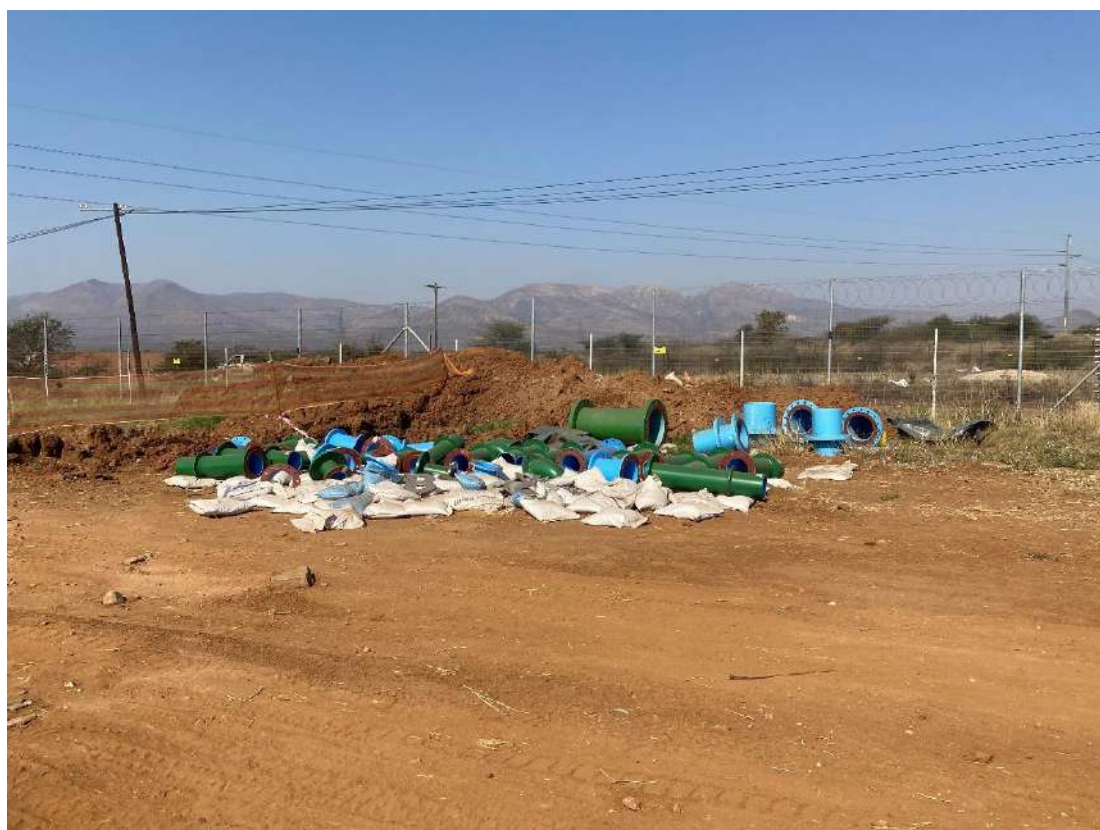
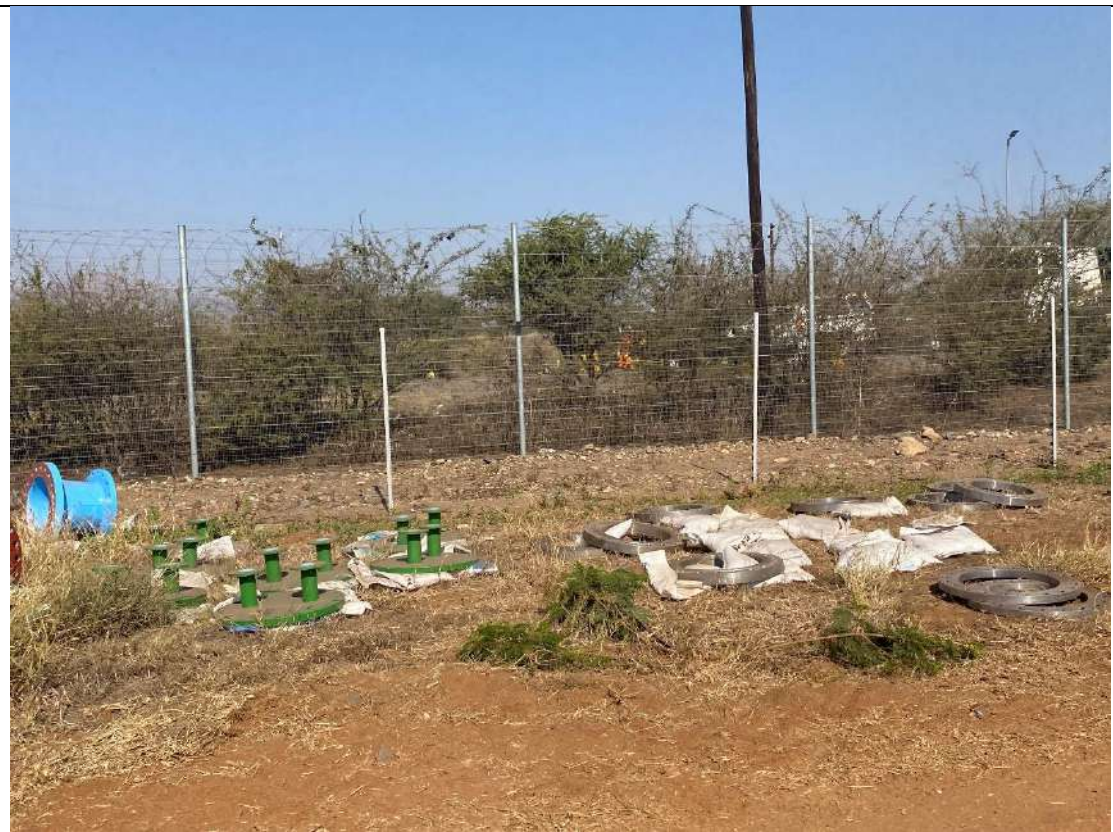
Photo 26: Spitskop Pump Station Waste Management

- Waste bins have been provided at the Spitskop Pump Station, along the SE2 pipeline route, at the active Pipejacking Areas and at the Reservoir Site. These bins have been marked for a specific waste stream to ensure re-cycling and reuse where possible. During the August 2023 audit, wear and tear on the signages of the waste bins was noted at the pump station. The audit team recommended that these signs are replaced as to ensure all labels are easily identifiable.

- Poor housekeeping was noted at the Spitskop Pump Station. The observation was specifically around sandbags used to safely store the pipes that were not stored appropriately. It is suggested that all waste be removed from site and disposed of appropriately.

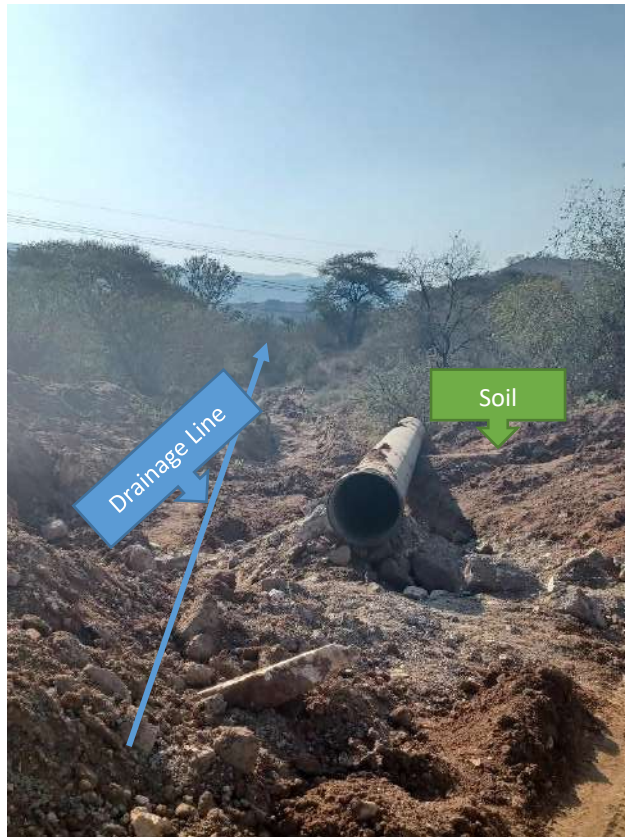
Photo 31: Soil stored in the drainageline and sandbags washed away

- During the December, January, February, March, April, May, June, July and this audit (August) it was observed that topsoil was stockpiled within drainage lines. The contractor implemented erosion protection measures such as sandbags along the drainage line in January/February. During this audit (August 2023), topsoil was found to still be stored within the drainage line and no erosion protection measures such as sandbags are in place. The contractor was informed he must adhere to its method statement for Stream/river crossings, Document Number: MET-ENV-188, Revision 3. The contractor informed the audit team that due to the heavy rainfall experience during May 2023 they have not been able to complete construction in this area. All soil will be backfilled and rehabilitated accordingly once the construction is completed and this area will not be disturbed further once rehabilitation is complete.

4			All removed soil and material stockpiles must be protected from erosion, stored on flat areas where run-off will be minimised, and be surrounded by bunds.	0	Most topsoil have been stored on flat areas where run-off will be minimal. During the December, January, February, March, April, May, June, July and this audit (August) it was observed that topsoil was stockpiled within drainage lines. The contractor implemented erosion protection measures such as sandbags along the drainage line in January/February. During this audit (August 2023), topsoil was found to be stored within the drainage line and no erosion protection measures such as sandbags are in place. The contractor was informed he must adhere to its method statement for Stream/river crossings, Document Number: MET-ENV-188, Revision 3. The contractor informed the audit team that due to the heavy rainfall experience during May 2023 they have not been able to complete construction in this area. All soil will be backfilled and rehabilitated accordingly once the construction is completed and this area will not be disturbed further once rehabilitation is complete. Photographic evidence can be found in Annexure C: Photo 31 and 32.	LWUA to take cognisance that stockpiles must be protected from erosion, placed on flat areas and surrounded by bunds

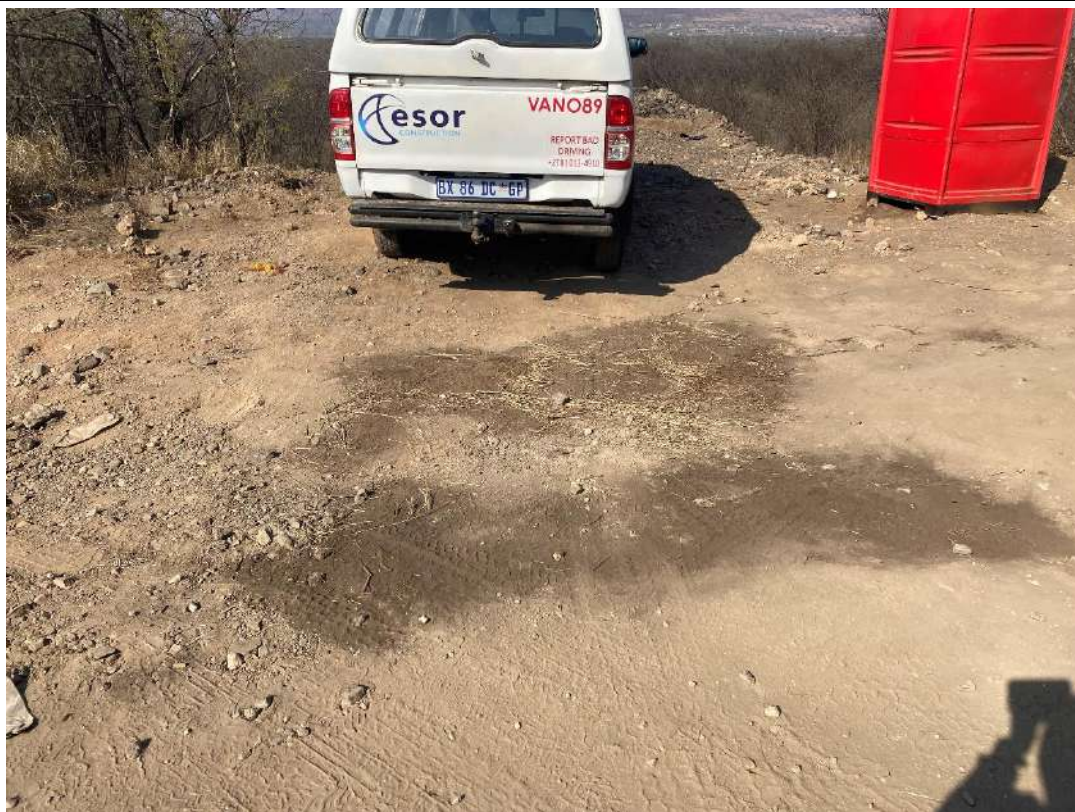
Photo 36: Hydrocarbon spill at Pipe Jacking 2 near Lion Smelter

- During this audit (August) a hydrocarbon spill was observed at the Lion Smelter Pipe Jacking. The spill must be cleaned up and disposed of properly. A spill kit must be kept on site for emergencies.

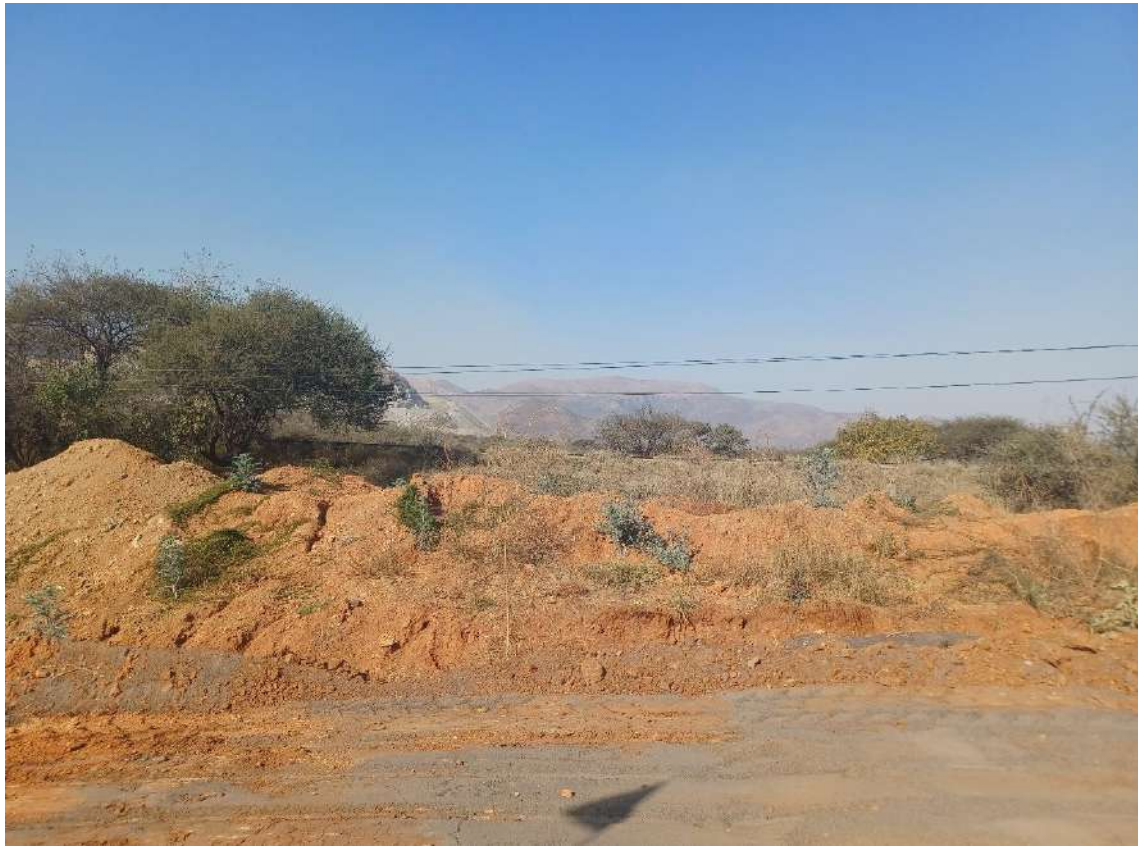
Photo 45: Minimal Alien and Invasive Species found

- During the audit undertaken in August 2023 minimal Alien and Invasive species were found along the pipeline route as well as at the Spitskop Pump Station. The removal of alien and invasive species was noted as a work in progress, no alien and invasive species was found along the pipeline trench however small clusters could be found at the pipes that have not yet been installed.
