Lebalelo Water User Association
SE2 pipeline and associated infrastructure
Twelfth Construction Environmental Audit Report
DFFE Reference Number: 14/12/16/3/3/1/2442

Lebalelo Water User Association

SE2 pipeline and associated infrastructure

Twelfth Construction Environmental Audit Report

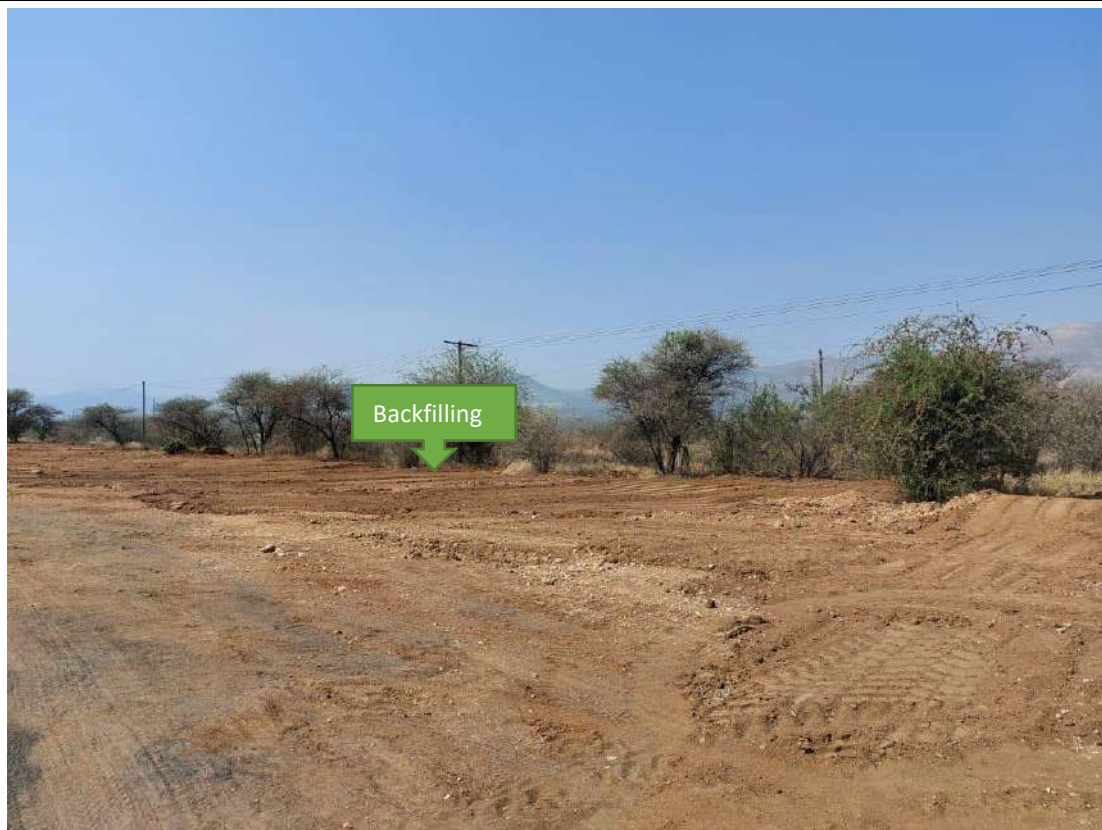
Photo 18: Backfilling of Subsoil on the pipeline route

2			The first 300 mm of soil must be stockpiled separate from the soil excavated deeper than 300 mm	2	Excavated soil is stored adjacent to the pipeline trench. Topsoil and subsoil are stored separately. Backfilling of soil has commenced on site at the portion of the pipeline near the Steelpoort Industrial Park. Photographic evidence can be found in Annexure C: Photo 17 and 18.	LWUA to take cognisance that all topsoil and subsoil must be stockpiled separately on either side of the trench and backfilled in the correct order.
3			The proposed pipeline system must be divided up into 100 m intervals. Each interval's soil must be stockpiled and filled back up (in the correct order) to avoid long periods of stockpiling.	2	Topsoil and subsoil are stored separately. Backfilling of soil has commenced on site at the portion of the pipeline near the Steelpoort Industrial Park. Photographic evidence can be found in Annexure C: Photo 17 and 18.	None

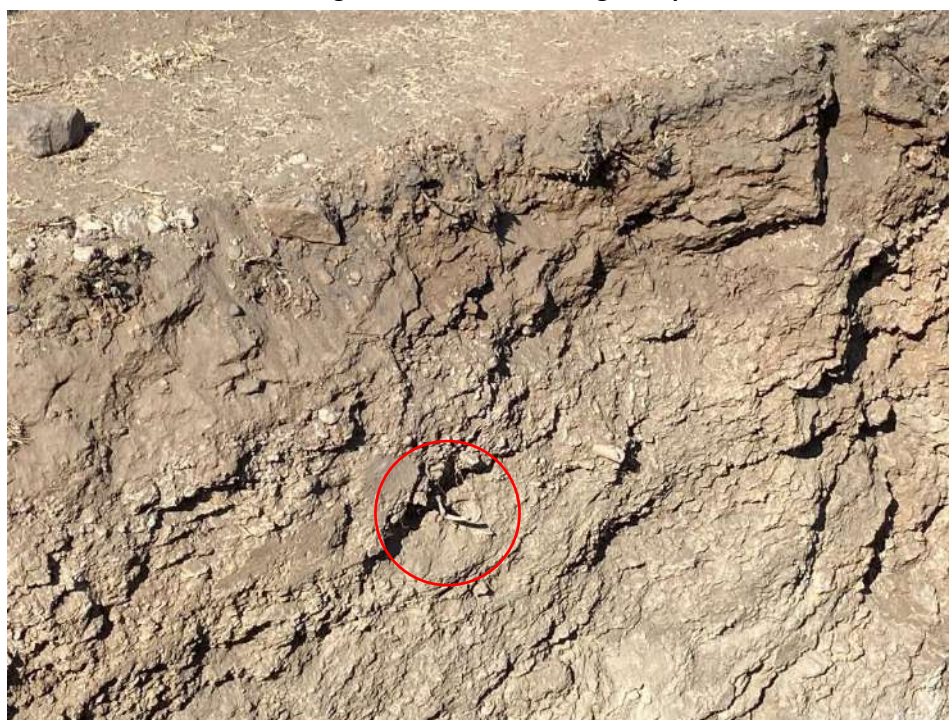
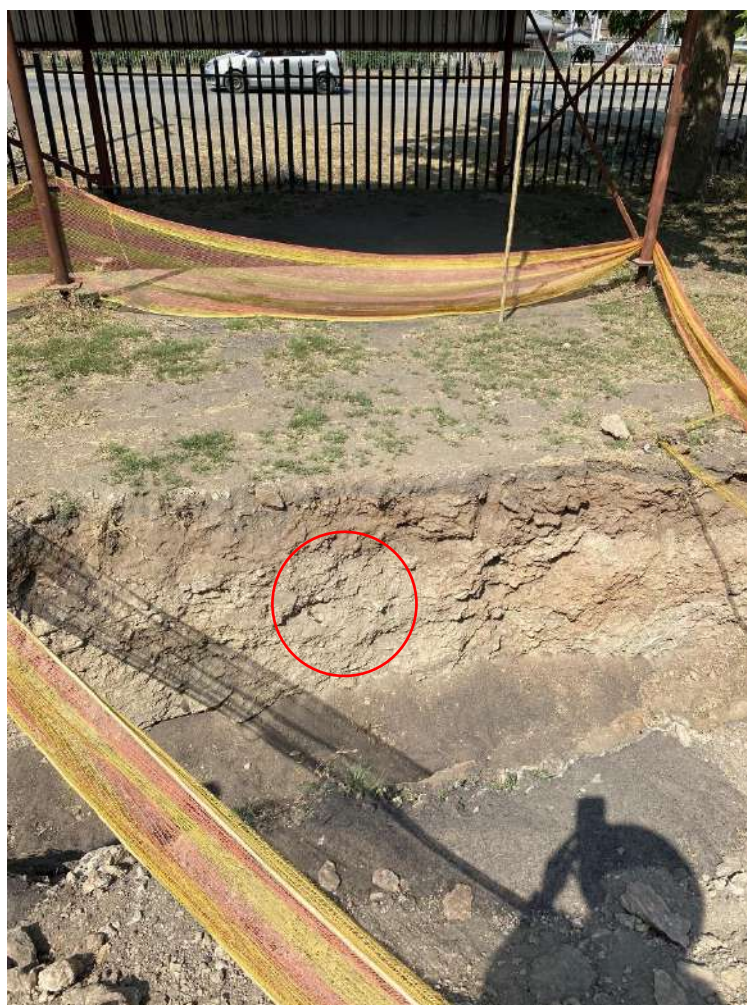
Photo 24: Bones discovered in Steelpoort Industrial Park Trench Excavation

The construction team has found bones during excavation activities of the pipeline trench within the Steelpoort Industrial Park yesterday (07 August 2023). Coordinates: 24°52'5.40"S, 30°7'4.80"E. It is uncertain if the bones are human remains or other. Refer to the Google Earth image and photographs below.

- All construction activities at the site have ceased and the immediate vicinity barricaded;
- An archaeologist has been appointed to investigate and to confirm if the bones are human remains or other.

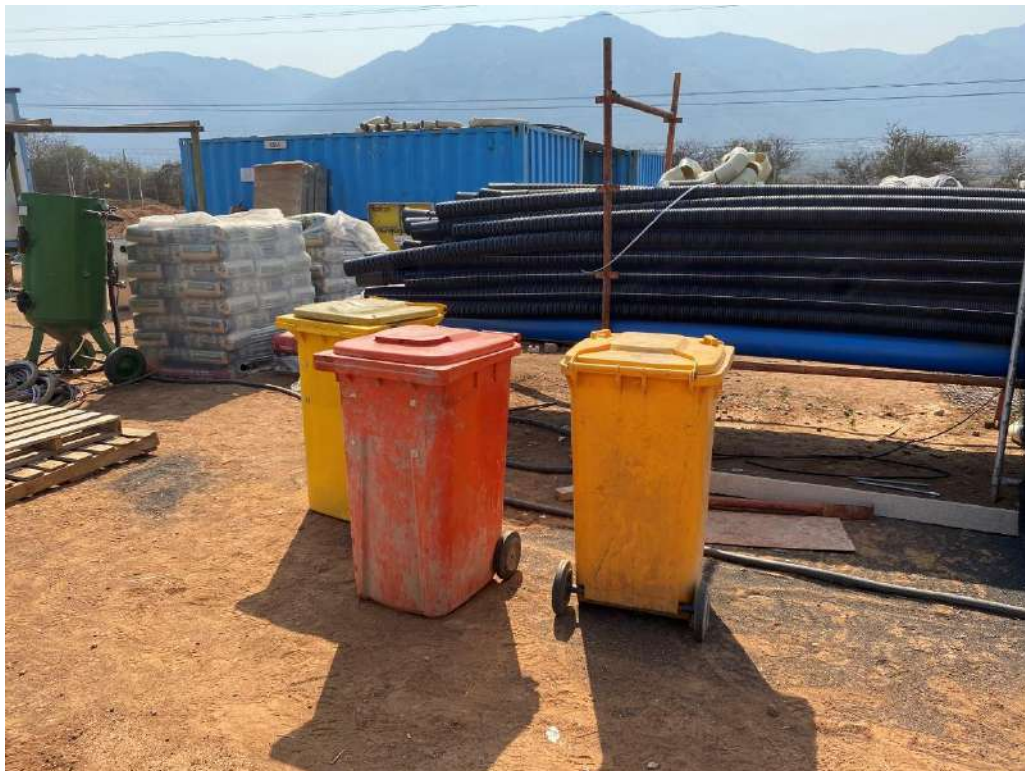
Photo 26: Spitskop Pump Station Waste Management

- Poor housekeeping was noted at the Spitskop Pump Station. The observation was specifically around sandbags used to safely store the pipes that were not stored appropriately. It is suggested that all waste be removed from site and disposed of appropriately. Waste binds were also found to be overflowing at the Reservoir Site.

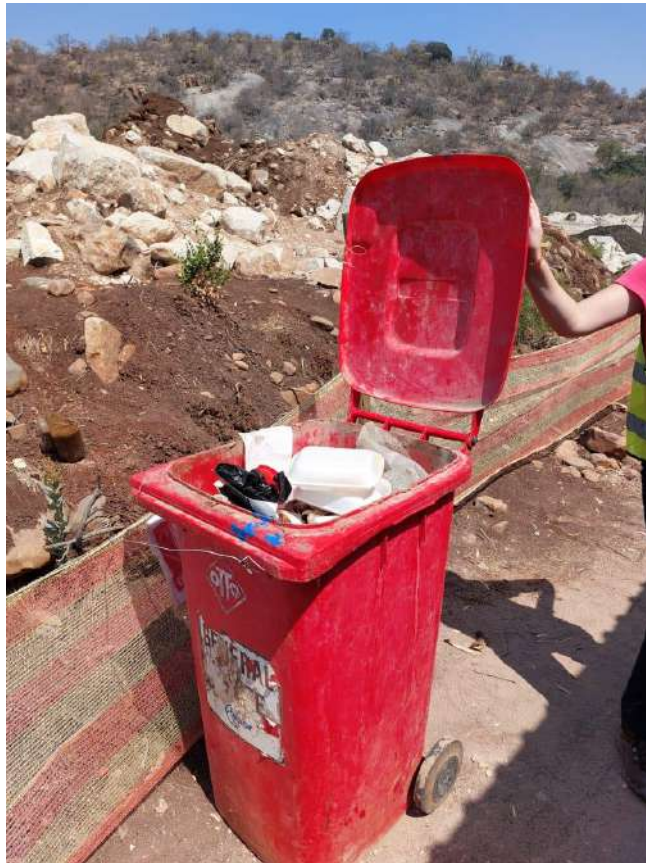
Photo 29: Waste Management at Reservoir site

- Waste bins have been provided at the Spitskop Pump Station, along the SE2 pipeline route, at the active Pipejacking Areas and at the Reservoir Site. These bins have been marked for a specific waste stream to ensure re-cycling and reuse where possible. During the August and September 2023 audit, wear and tear on the signages of the waste bins was noted at the pump station. The audit team recommended that these signs are replaced as to ensure all labels are easily identifiable. Waste binds were also found to be overflowing at the Reservoir Site.

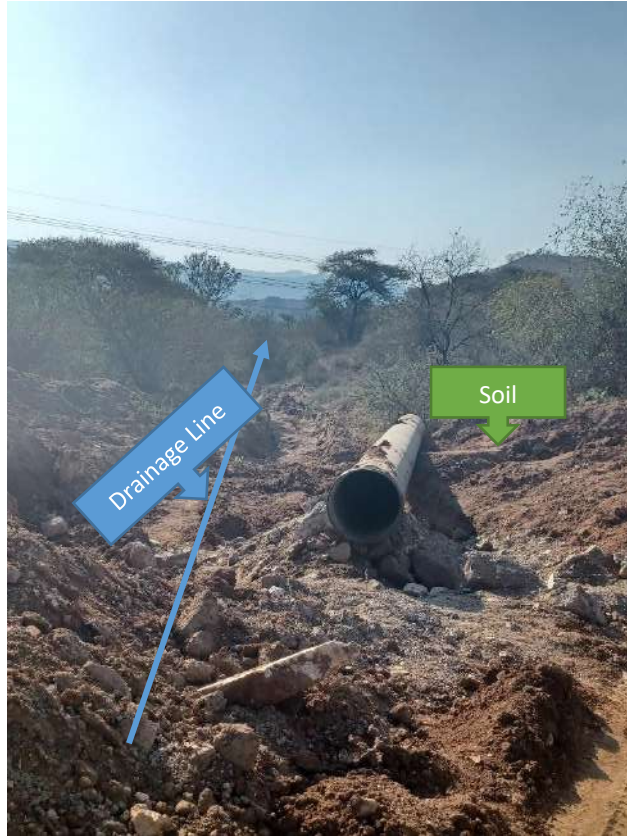
Photo 31: Soil stored in the drainageline and sandbags washed away

- During the December, January, February, March, April, May, June, July, August and this audit (September) it was observed that topsoil was stockpiled within drainage lines. The contractor implemented erosion protection measures such as sandbags along the drainage line in January/February. During this audit (September 2023), topsoil was found to still be stored within the drainage line and no erosion protection measures such as sandbags are in place. A Pipe was also observed to be stored in the drainage line.

4			All removed soil and material stockpiles must be protected from erosion, stored on flat areas where run-off will be minimised, and be surrounded by bunds.	0	Most topsoil have been stored on flat areas where run-off will be minimal. During the December, January, February, March, April, May, June, July, August and this audit (September) it was observed that topsoil was stockpiled within drainage lines. The contractor implemented erosion protection measures such as sandbags along the drainage line in January/February. During this audit (September 2023), topsoil was found to be stored within the drainage line and no erosion protection measures such as sandbags are in place. A Pipe was also found to be placed within the drainage line. The contractor was informed he must adhere to its method statement for Stream/river crossings, Document Number: MET-ENV-188, Revision 3. The contractor informed the audit team that due to the heavy rainfall experience during May 2023 they have not been able to complete construction in this area. All soil will be backfilled and rehabilitated accordingly once the construction is completed and this area will not be disturbed further once rehabilitation is complete. Photographic evidence can be found in Annexure C: Photo 31 and 32.	LWUA to take cognisance that stockpiles must be protected from erosion, placed on flat areas and surrounded by bunds

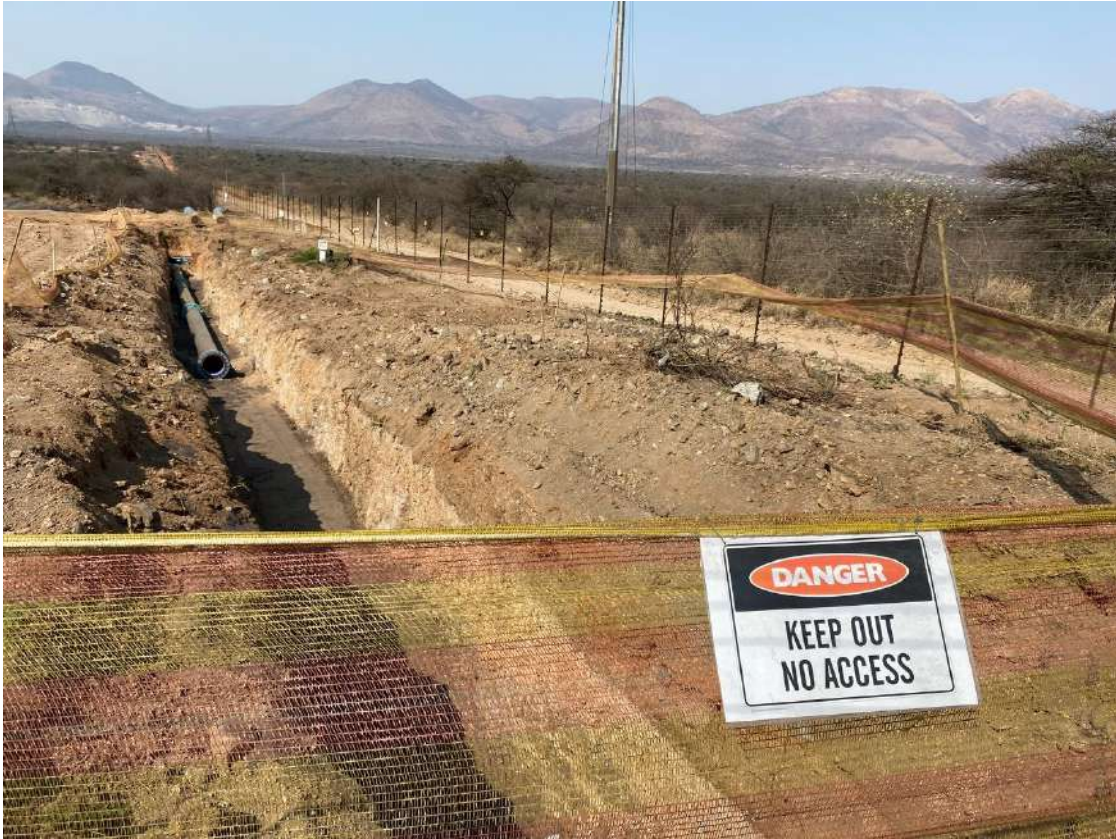
Photo 33: Construction activities within pipeline servitude

7			These designated stockpile areas must be viewed as temporary and kept for backfill material.	2	At the time of this audit (September 2023) backfilling activities have commenced on site at large portions of the pipeline route. Photographic evidence can be found in Annexure C: Photo 18.	LWUA to take cognisance that stockpiles are only temporary and must be used as backfill material.
8			Maintain soil quality and minimise damage to the soil structure during the time the material is stockpiled.	2	Soil stockpiles were intact and no driving has taken place on topsoil stockpiles. Photographic evidence can be found in Annexure C: Photo 17 and 18.	LWUA to take cognisance that soil quality must be maintained and measures implemented to minimise damage to the soil structure during the time the material is stockpiled.
9			All construction access must make use of the existing roads that can be found in and around the project area.	2	Access to the Spitskop Pump Station and the Pipeline Route is done using existing roads. Construction activities along the pipeline route is done within the pipeline servitude. No new roads were identified at the time of this audit (September 2023). Photographic evidence can be found in Annexure C: Photo 33.	LWUA to take cognisance that existing roads must be used.

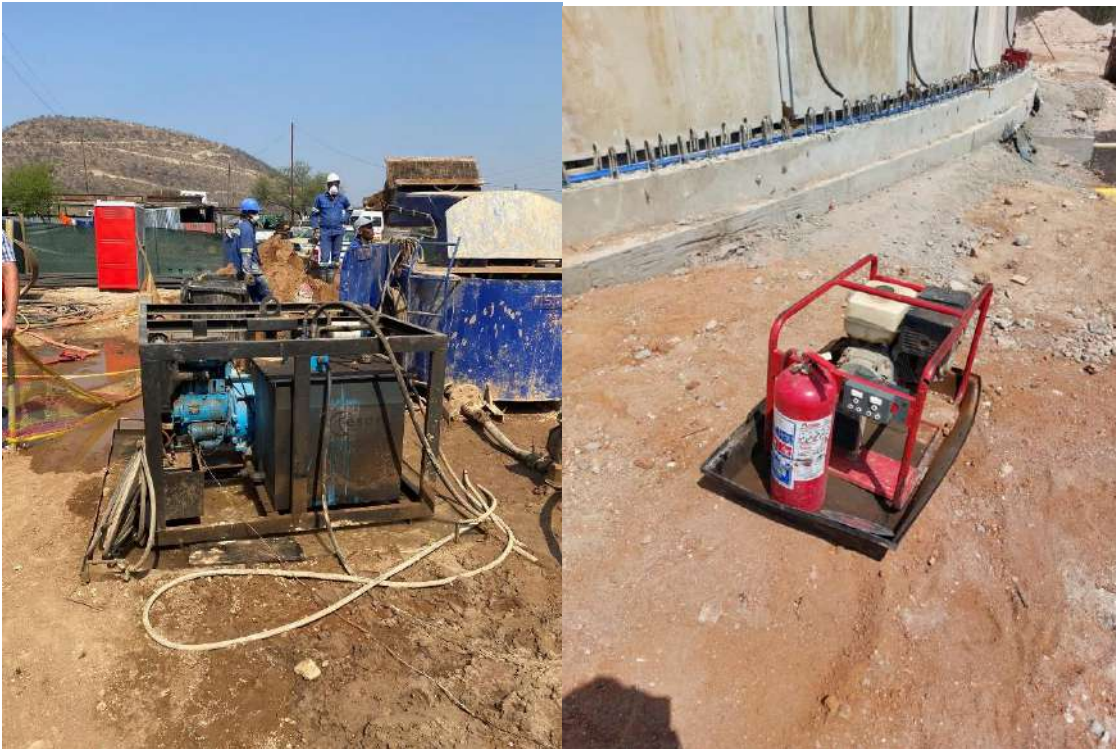
Photo 34: Drip trays used on site

- During the September audit the human remains have not been reburied and a heritage consultant has not been appointed.
- During the audit undertaken in September 2023 it was observed that drip-trays are placed under machinery that is not in use. However, some machinery such as pumps and compressors were found to be operated without being placed on drip trays, especially in the wetland area.
- During the audit undertaken in September 2023 minimal Alien and Invasive species were found along the pipeline route as well as at the Spitskop Pump Station. The removal of alien and invasive species was noted as a work in progress, and small clusters could be found at the trench areas that have not been completely backfilled.
