Lebalelo Water User Association
SE2 pipeline and associated infrastructure
Thirteenth Construction Environmental Audit Report
DFFE Reference Number: 14/12/16/3/3/1/2442

Thirteenth Construction Environmental Audit Report

October 2023

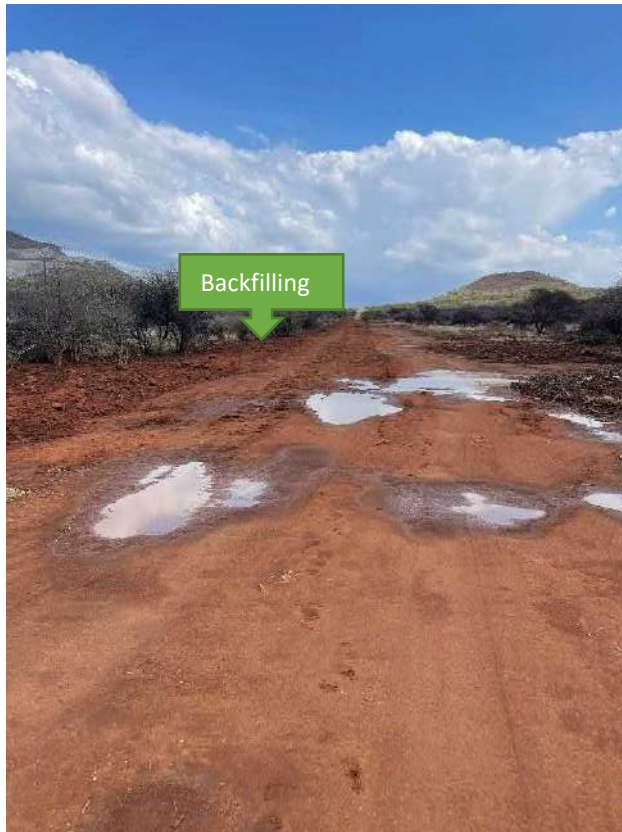
Photo 18: Backfilling of Subsoil on the pipeline route

2			The first 300 mm of soil must be stockpiled separate from the soil excavated deeper than 300 mm	2	Excavated soil is stored adjacent to the pipeline trench. Topsoil and subsoil are stored separately. Backfilling of soil has commenced on site at the portion of the pipeline between the Lion Smelter and the Steelpoort Industrial Park. Photographic evidence can be found in Annexure C: Photo 17 and 18.	LWUA to take cognisance that all topsoil and subsoil must be stockpiled separately on either side of the trench and backfilled in the correct order.
3			The proposed pipeline system must be divided up into 100 m intervals. Each interval's soil must be stockpiled and filled back up (in the correct order) to avoid long periods of stockpiling.	2	Topsoil and subsoil are stored separately. Backfilling of soil has commenced on site at the portion of the pipeline between the Lion Smelter and the Steelpoort Industrial Park. Photographic evidence can be found in Annexure C: Photo 17 and 18.	None

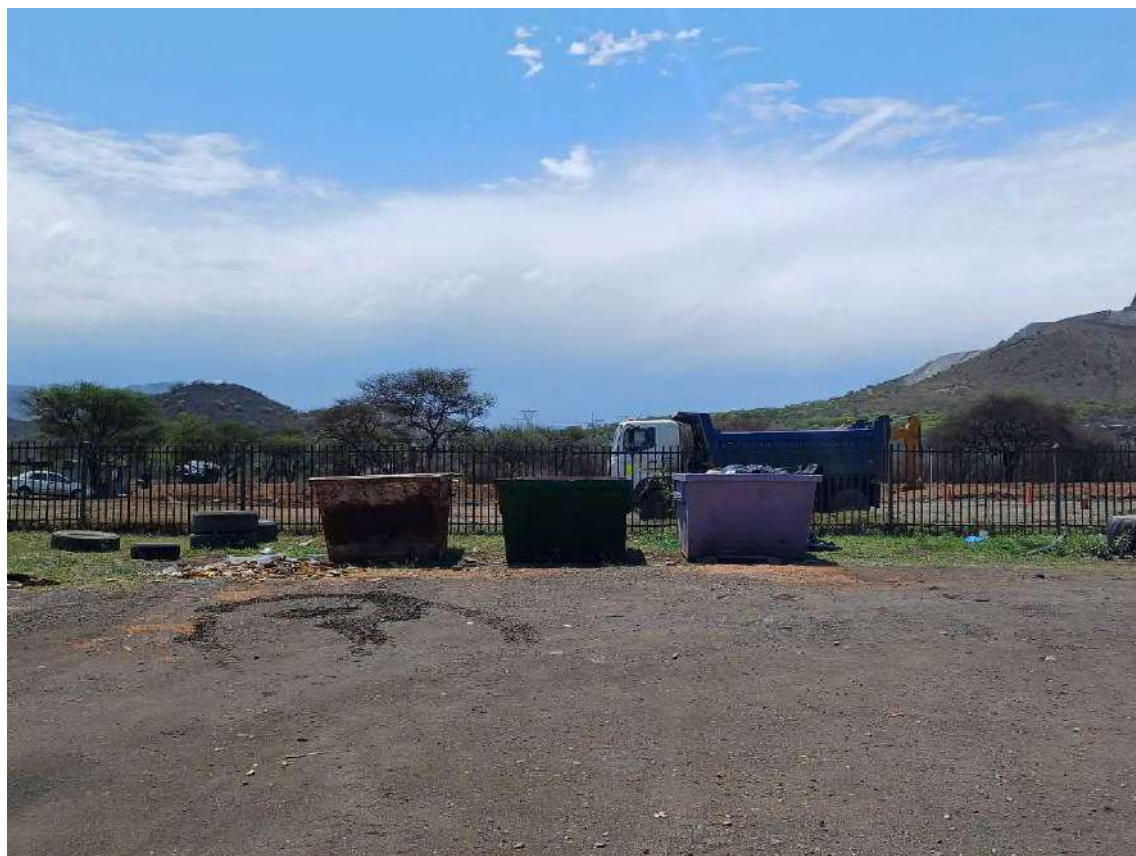
Photo 28: Waste Management on site (Pipe Jacking 2 near Lion Smelter)

- Poor housekeeping was noted along the pipeline route. The observation was specifically around waste stockpiled along the route and a waste bin overflowing at the Pipejacking 2 area near Lion Smelter. It is suggested that all waste be removed from site and disposed of appropriately.

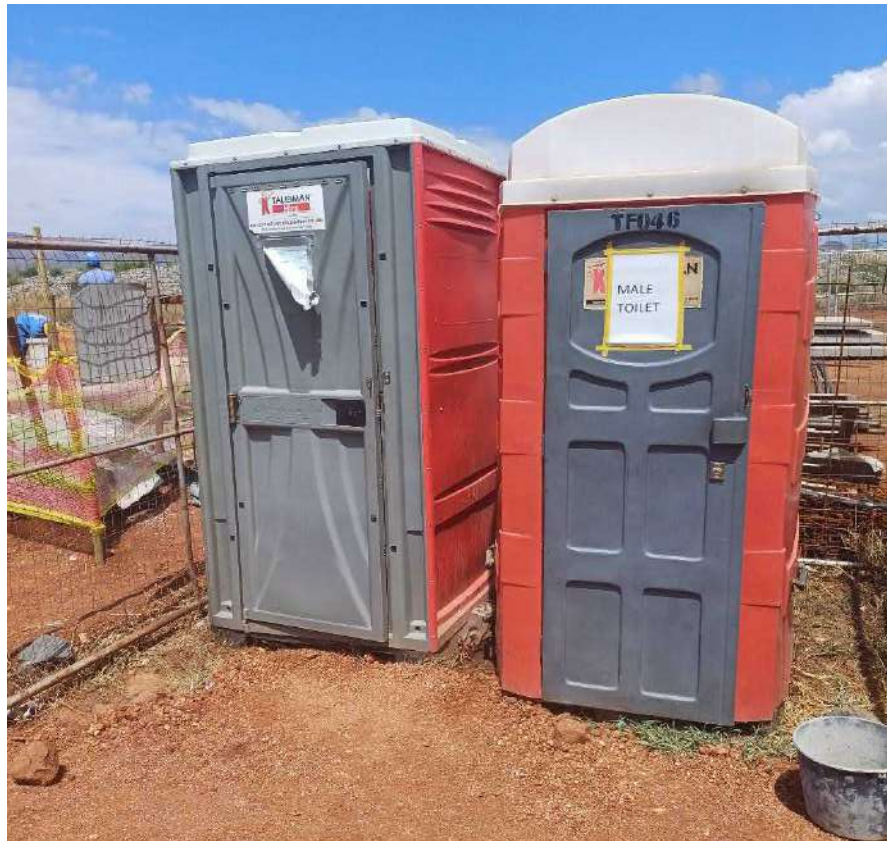
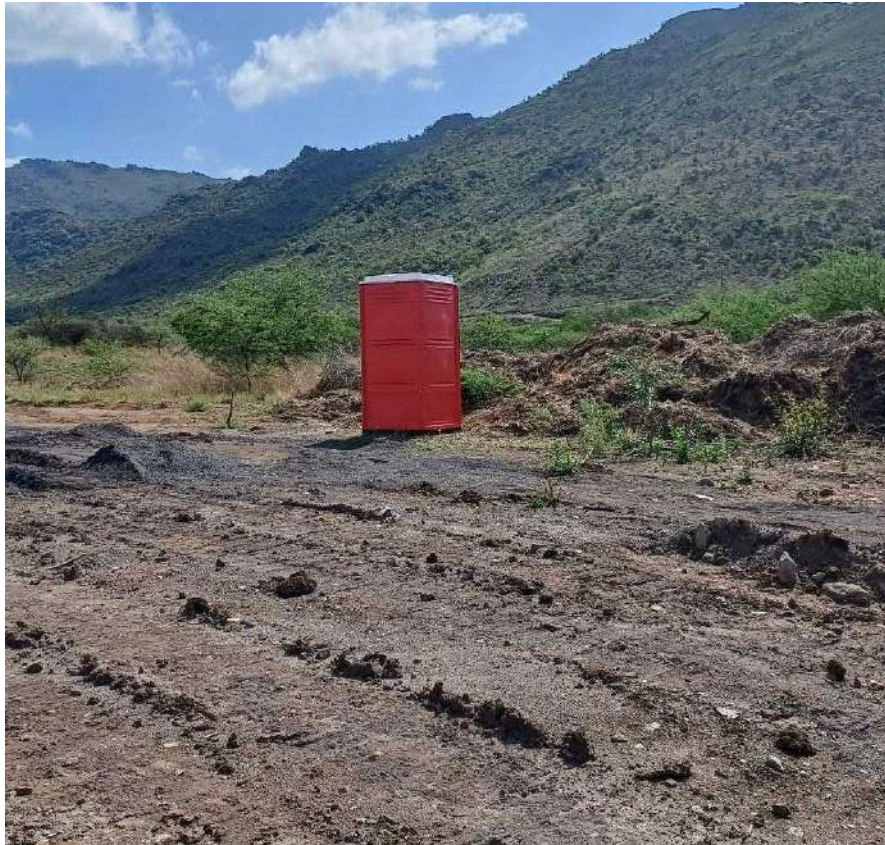
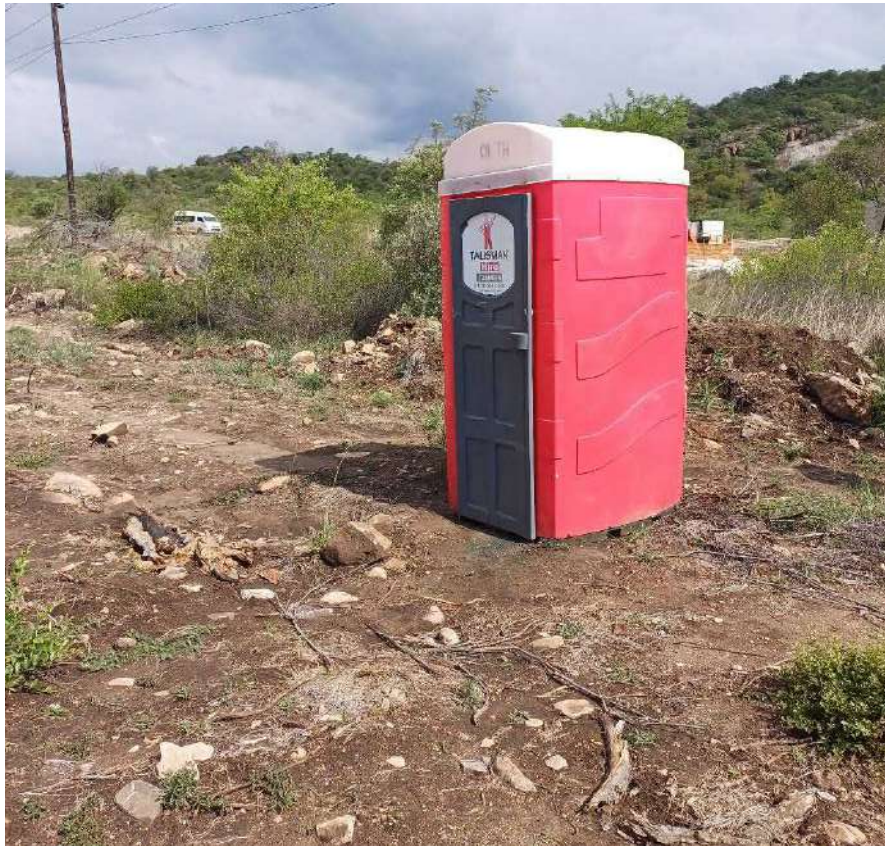
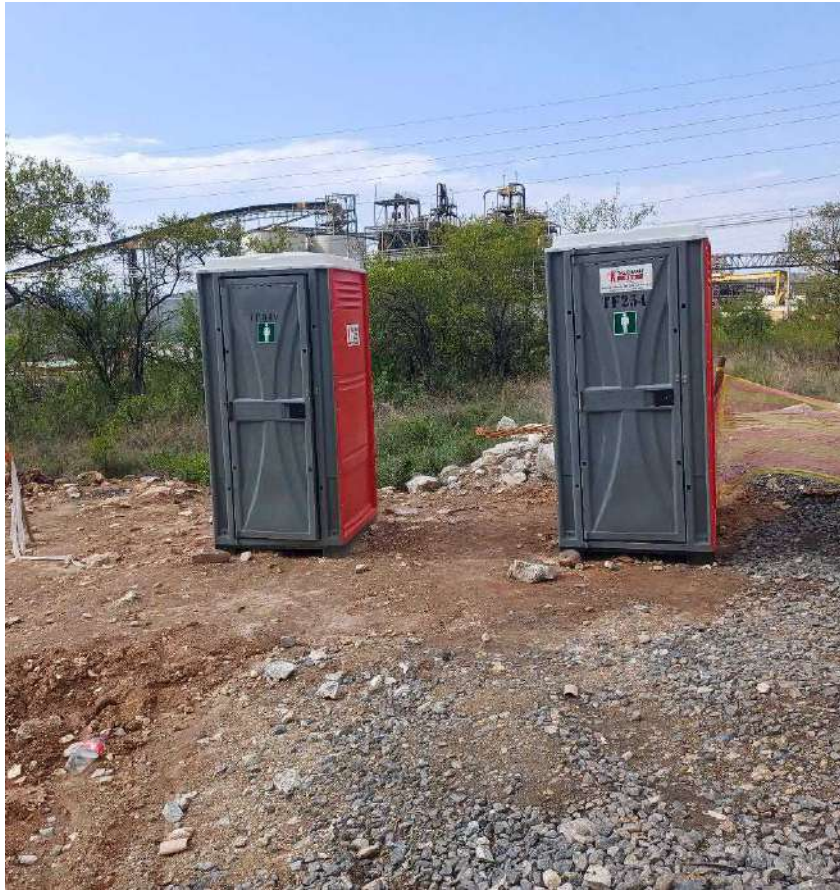
Photo 38: Ablution facilities

- Chemical toilets were observed along the pipeline route currently being constructed; however, it was noted during this audit that two active construction areas did not have ablution facilities for the workers. LWUA is advised that chemical toilets should move daily with construction activities and must be located outside sensitive areas.

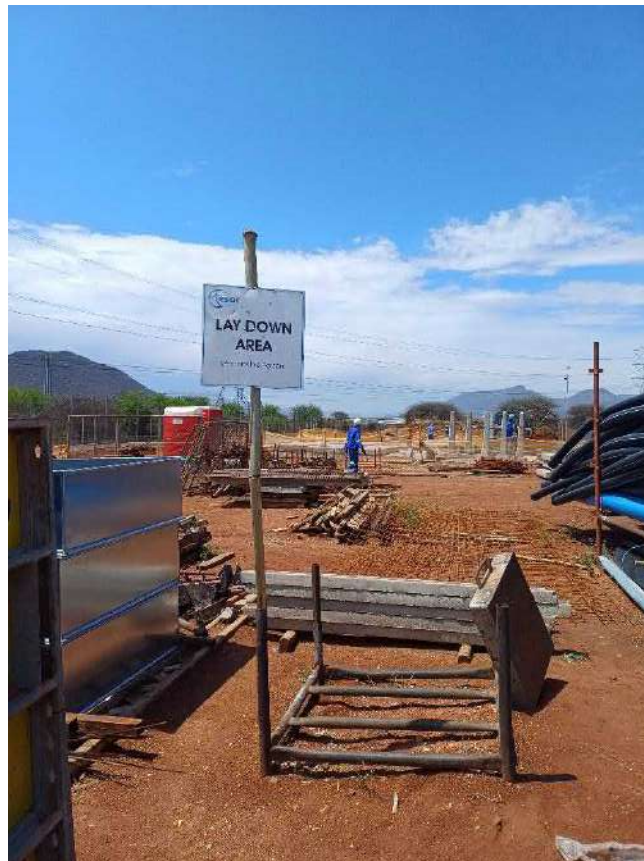
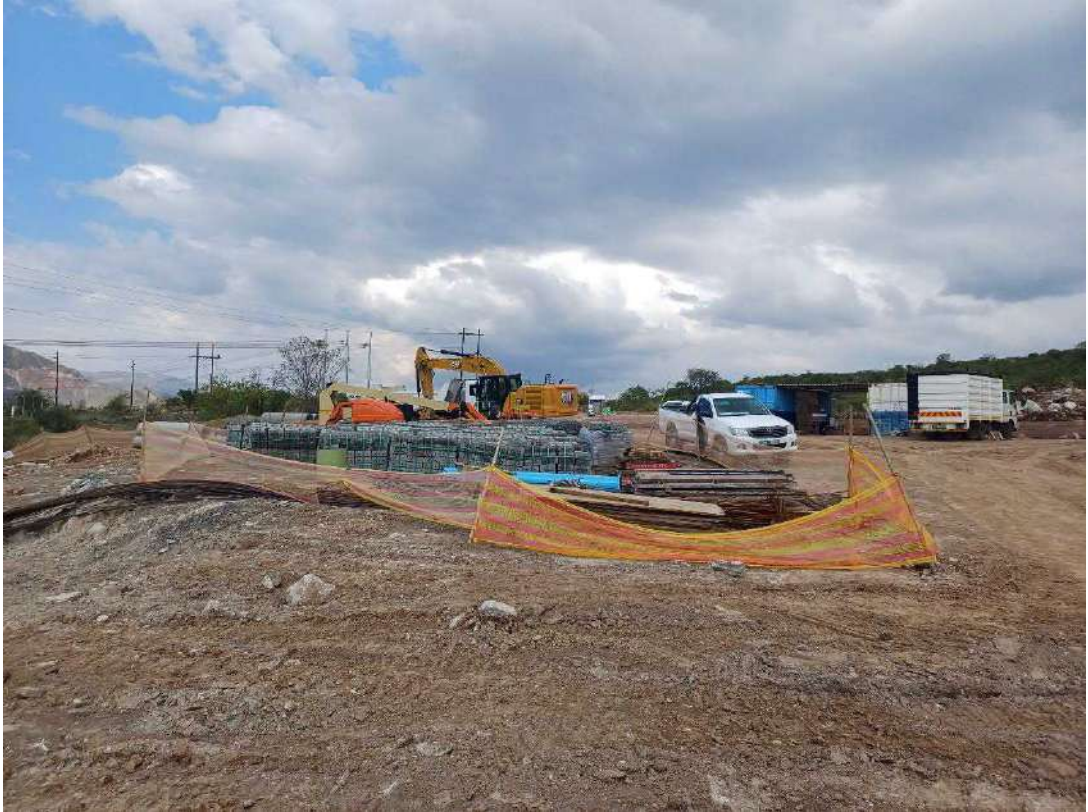
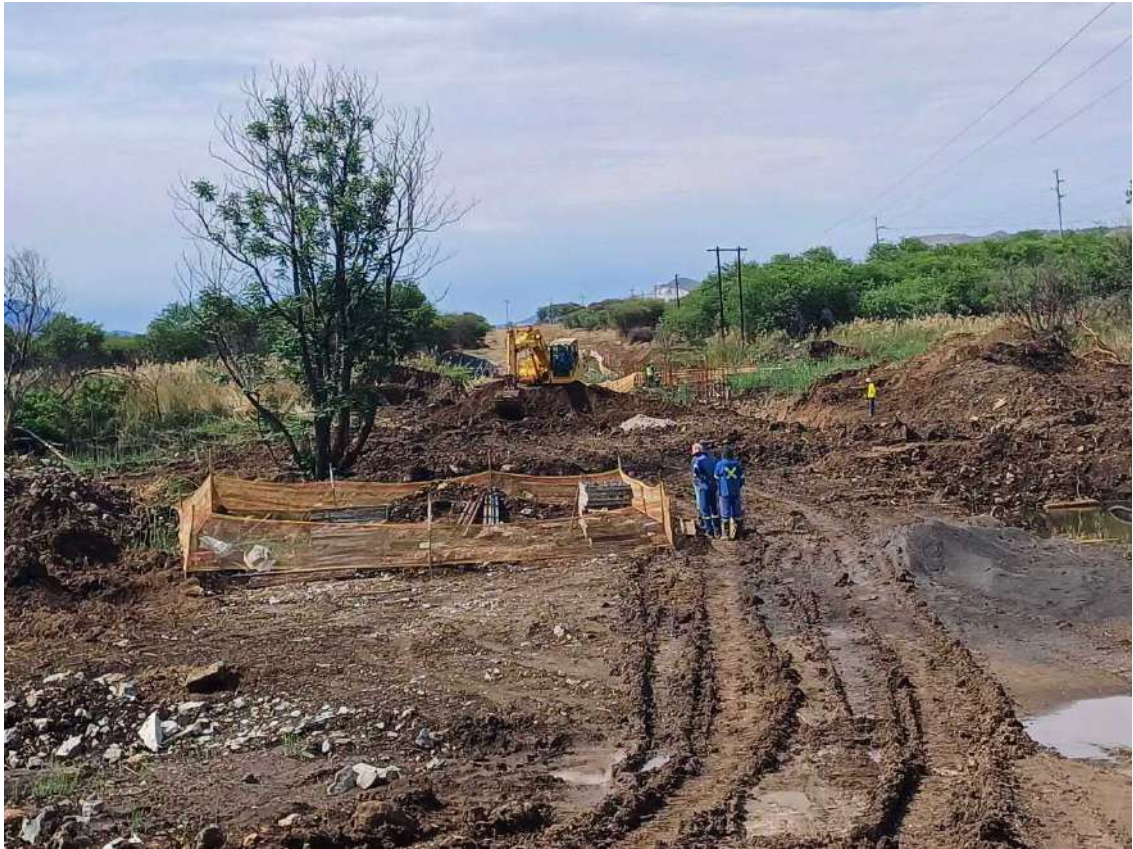
Photo 39: Laydown Areas

- At the time of this audit the contractors camp, laydown and storage area were located within the wetland areas or the wetland buffer areas. A tin of grease was noted within the laydown area within the wetland.
