**Lebalelo Water User Association**  
**SE2 pipeline and associated infrastructure**  
**Seventeenth Construction Environmental Audit Report**  
**DDFE Reference Number: 14/12/16/3/3/1/2442**

## SE2 pipeline and associated infrastructure

### Seventeenth Construction Environmental Audit Report

February 2024

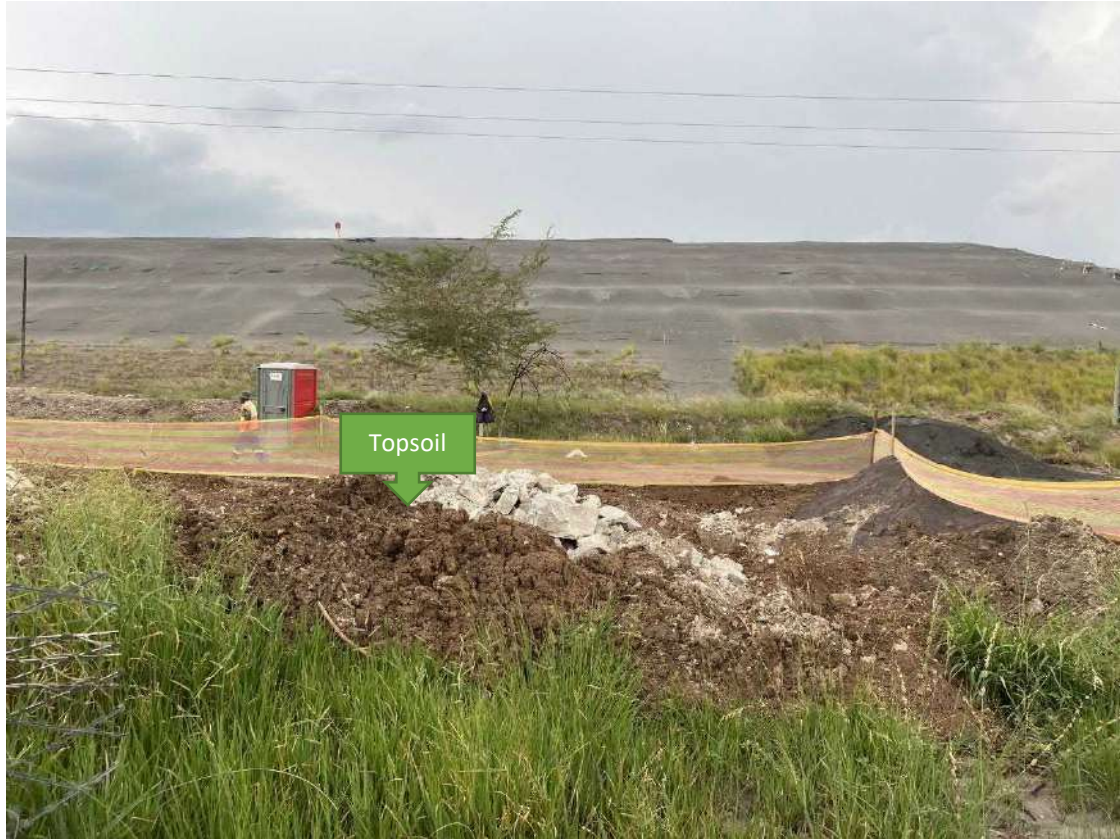
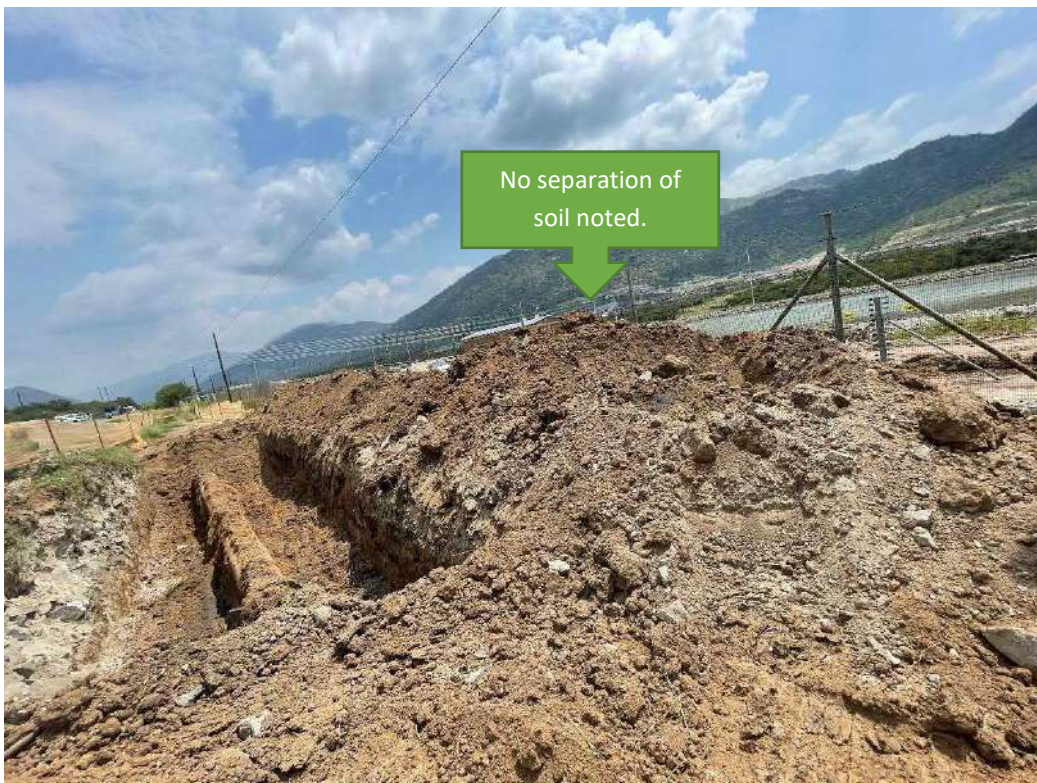
Photo 17: Stockpile of soil on site.

- The excavation of the pipeline route has commenced and soil excavated are stored adjacent to the excavation. A portion of the pipeline has been backfilled and soil was noted to be placed correctly. Portions of the pipeline route which have been recently excavated near the two rivers mine was noted to not separate topsoil and subsoil on site.

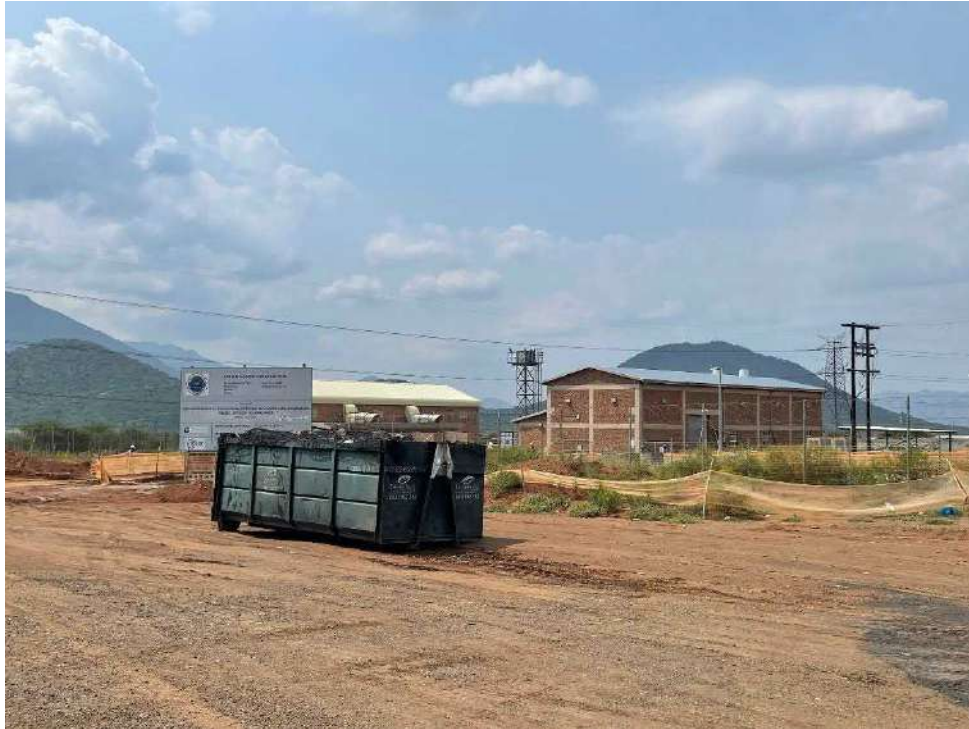
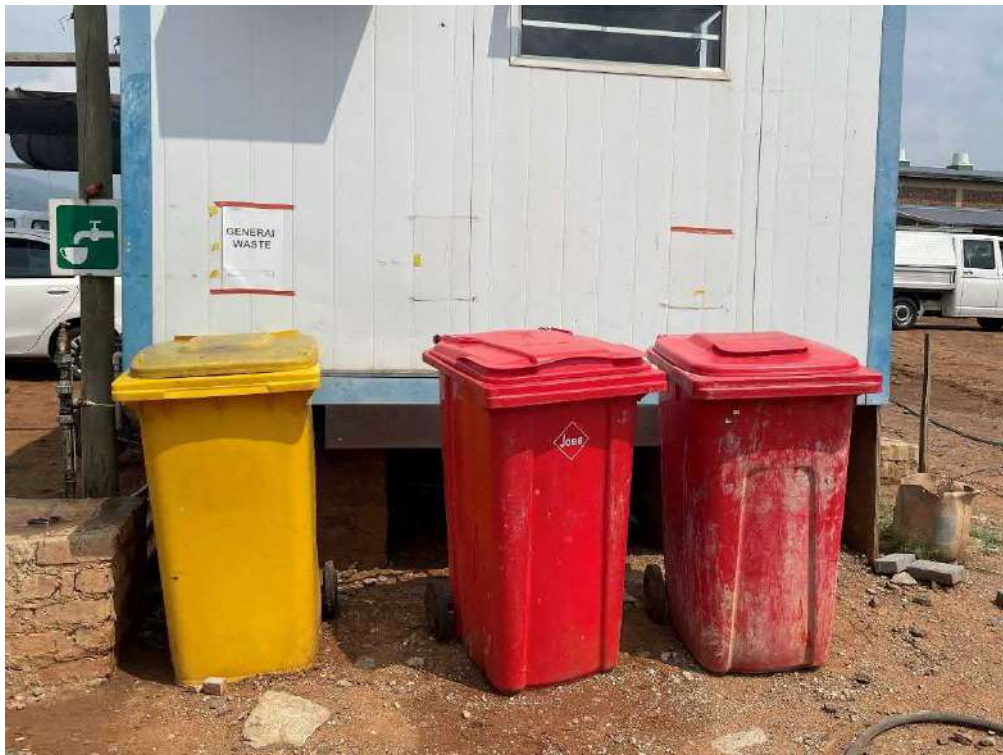
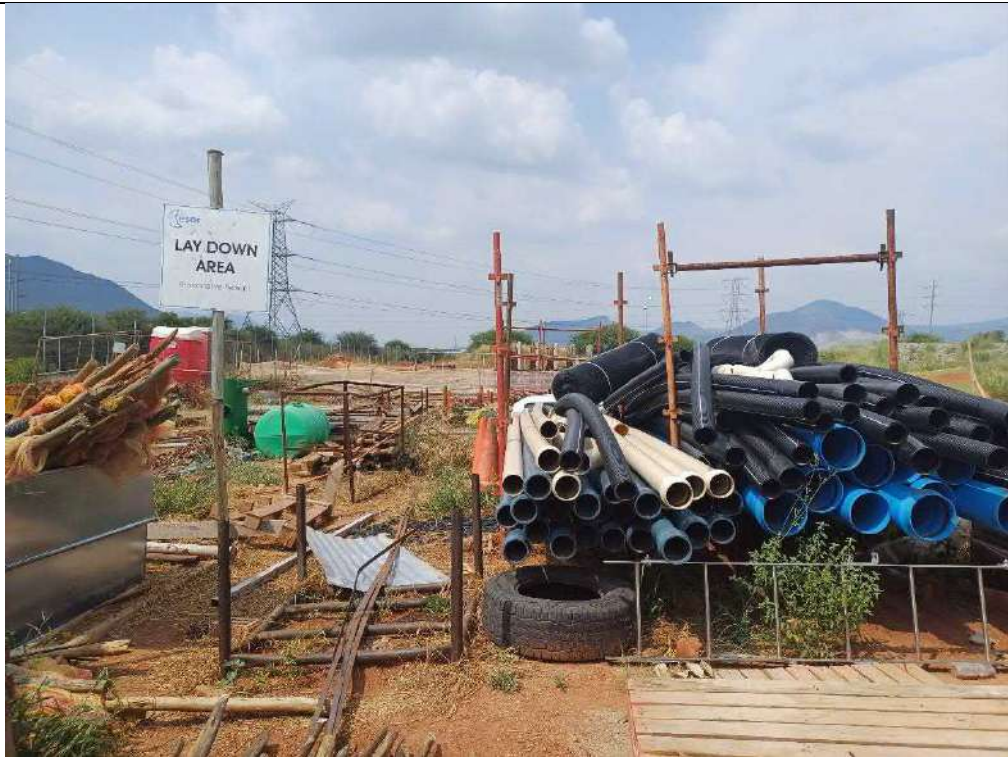
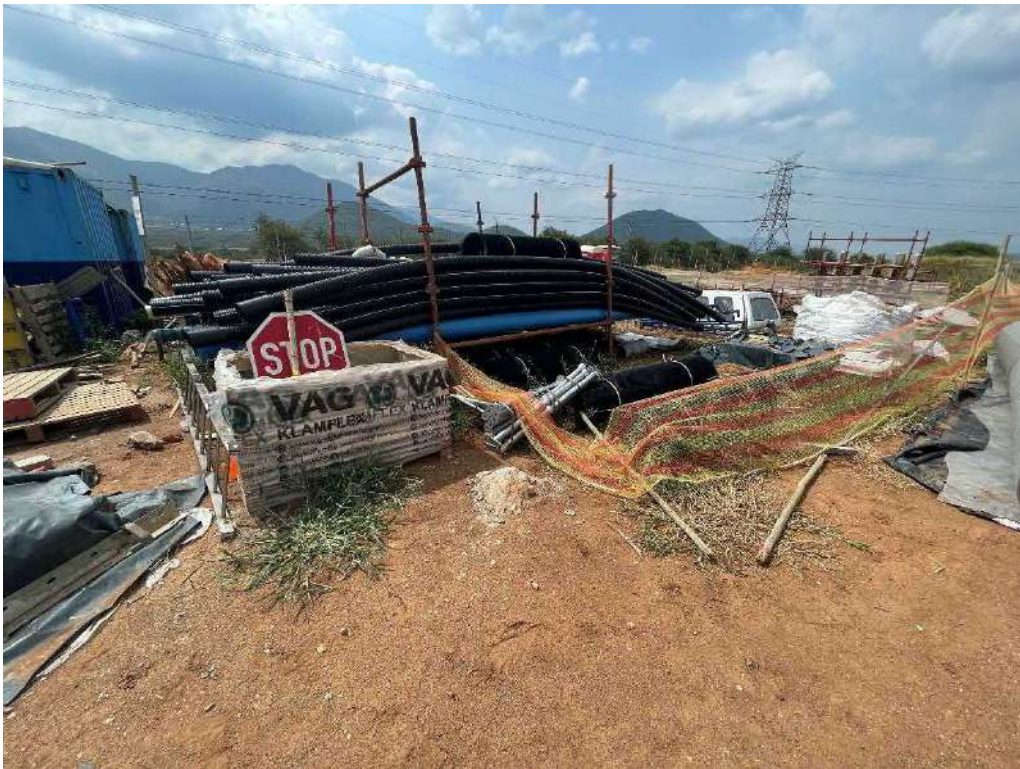
Photo 26: Spitskop Pump Station Waste Management

- Waste bins were noted as part of this audit.
  - Spitskop Pump Station:
    - Waste bins were noted as well as a skip which was covered with a net to prevent waste form being blown away.

- The signage for the specific waste streams was not clearly marked due to wear and tear, it was indicated that new signs are put in place.
  - Pipeline Route:

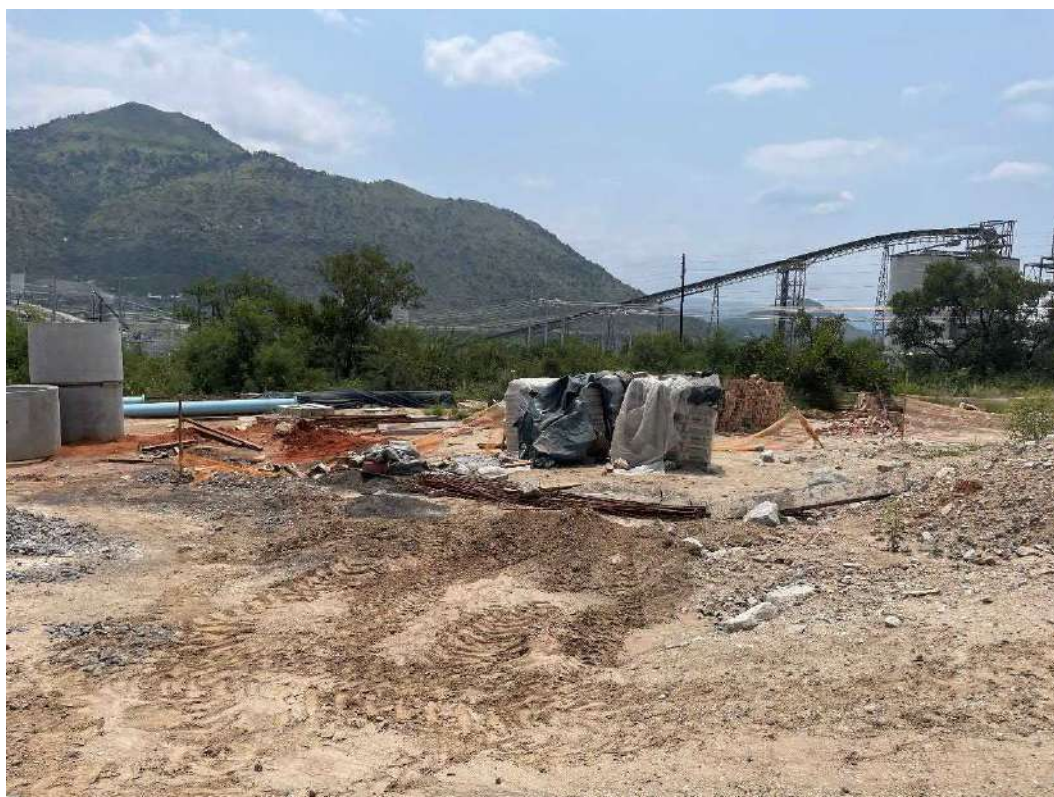
Photo 28: Waste Management on site

- No waste bin was noted along the pipeline route at active construction sites and at the Wetland area
  - Reservoir Site:
    - A waste bin was noted at the reservoir site which was marked for the specific waste stream. Poor Housekeeping was noted as a work in progress

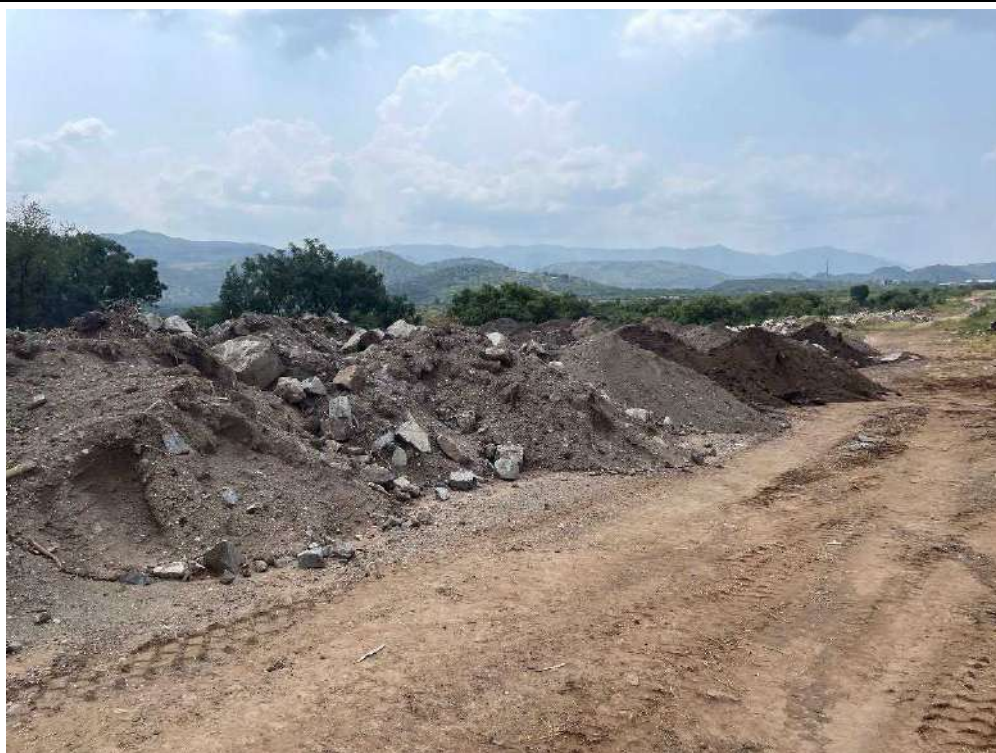
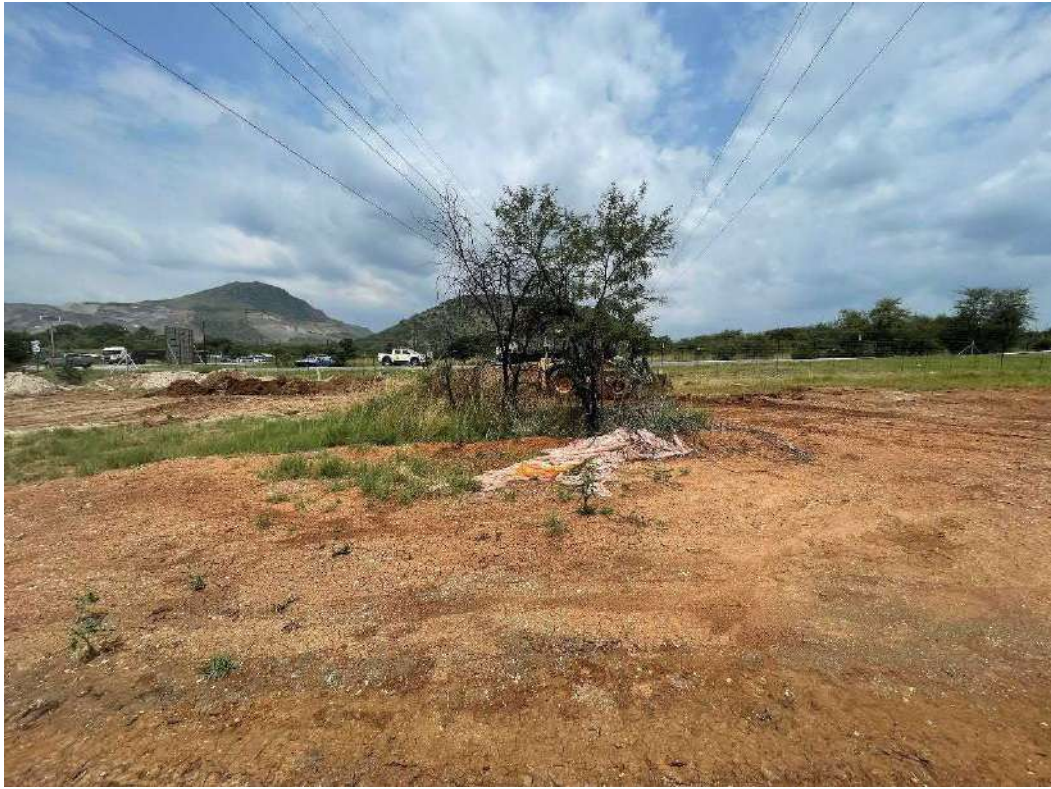
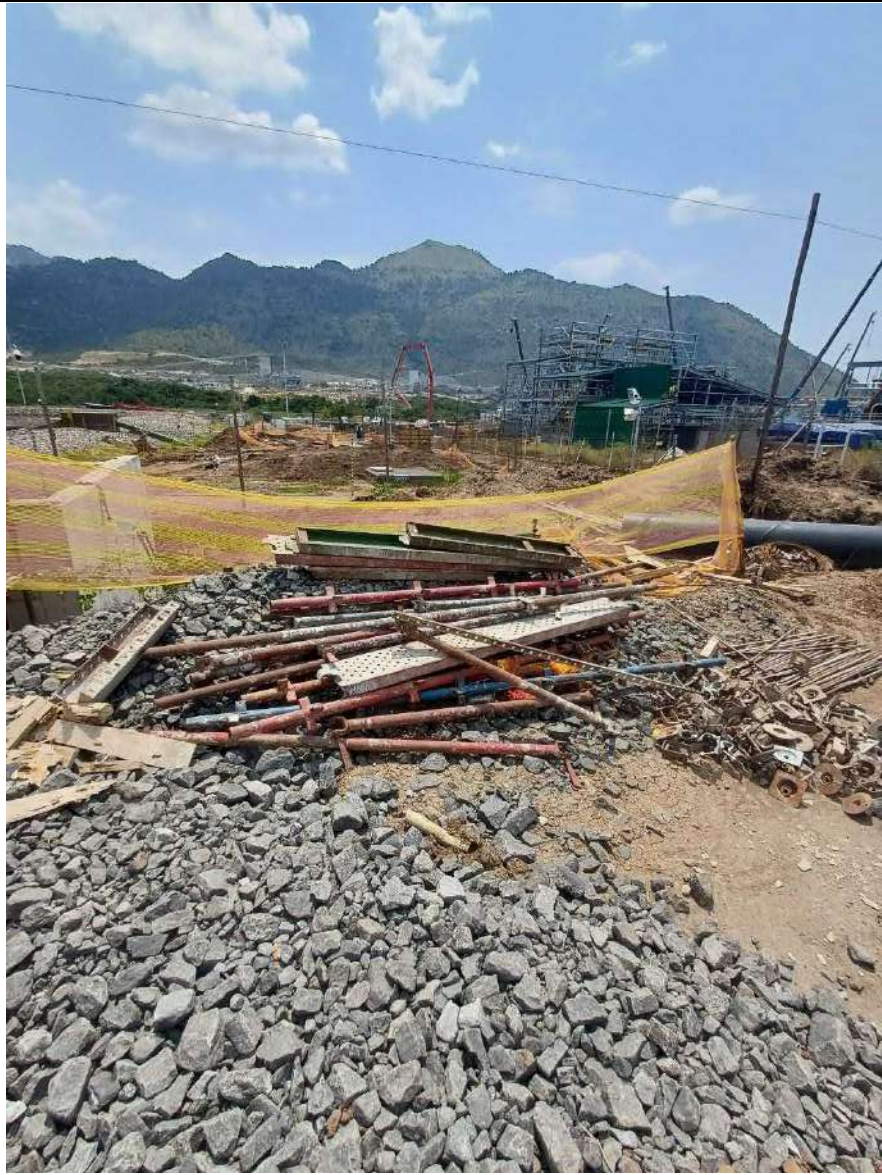
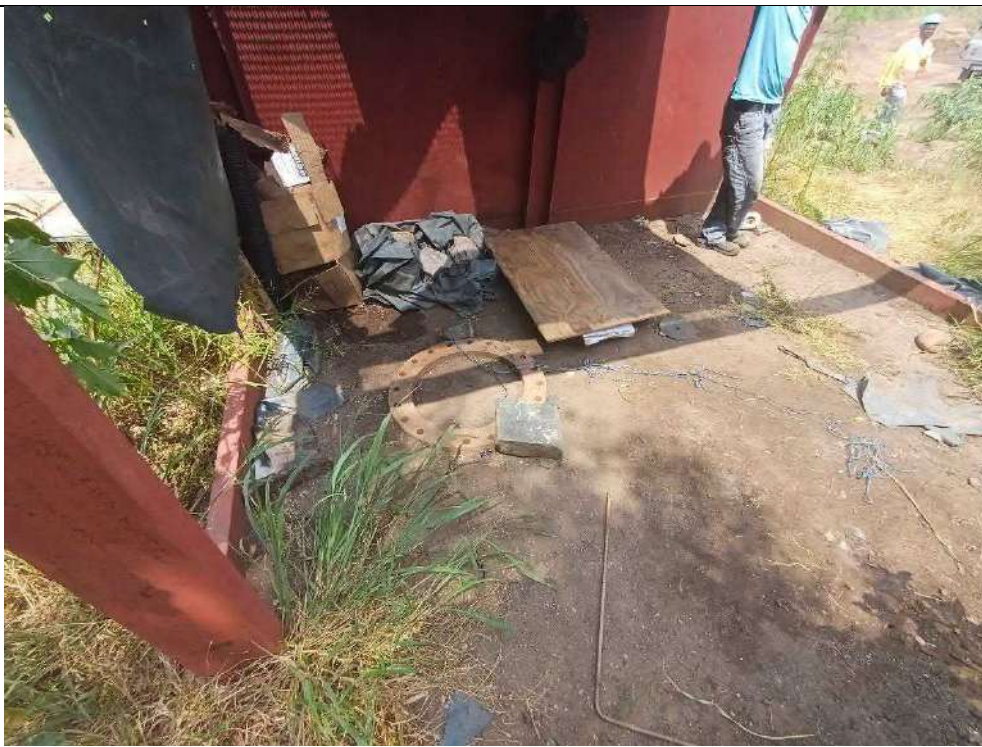
Photo 29: Waste Management along pipeline route

- Poor housekeeping was noted along the pipeline route. The observation was specifically around waste stockpiled along the route. It is suggested that all waste be removed from site and disposed of appropriately.

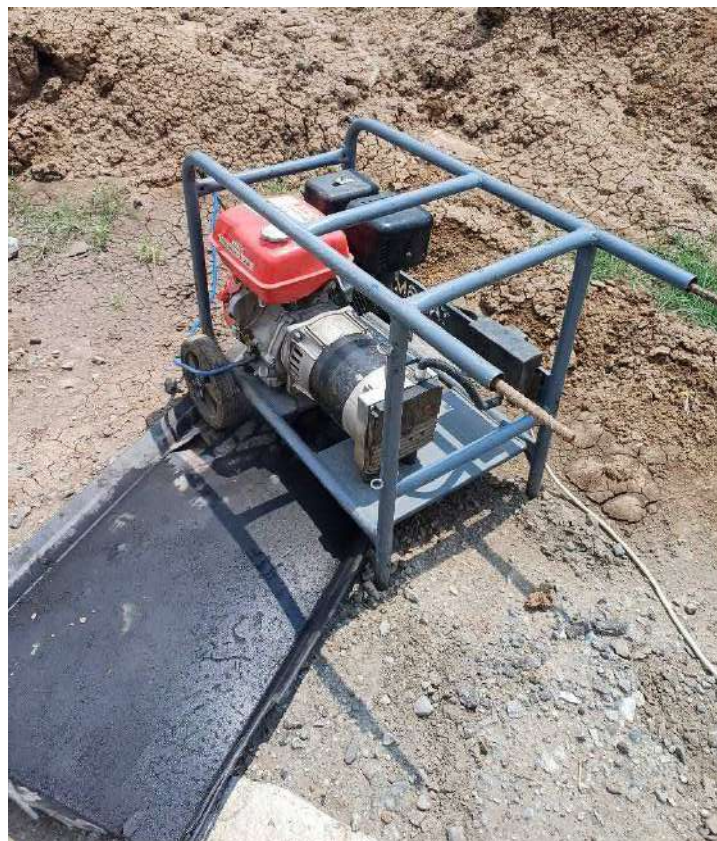
**Photo 34: Use of Drip trays on site**

- A hydrocarbon spill was observed at the Reservoir during the February Audit. It was indicated that this needs to be managed as per the spill management plan in place.
- It was observed that drip trays are placed under some equipment on site, however some generators/pumps were noted to be operated without drip trays.
- Alien and Invasive species were found along the pipeline route as well as at the Spitskop Pump Station.
- No chemical toilets were observed along the pipeline route currently being constructed.
- Approval was granted for the clearance of a corridor area of 25m (inclusive of the servitude). Currently approximately a 17m corridor is cleared for construction of the pipeline. However, at the wetland area, vegetation clearance must be limited to the servitude (15m). Currently the clearance in the wetland area is 30 m.

**Drip Trays in Use**

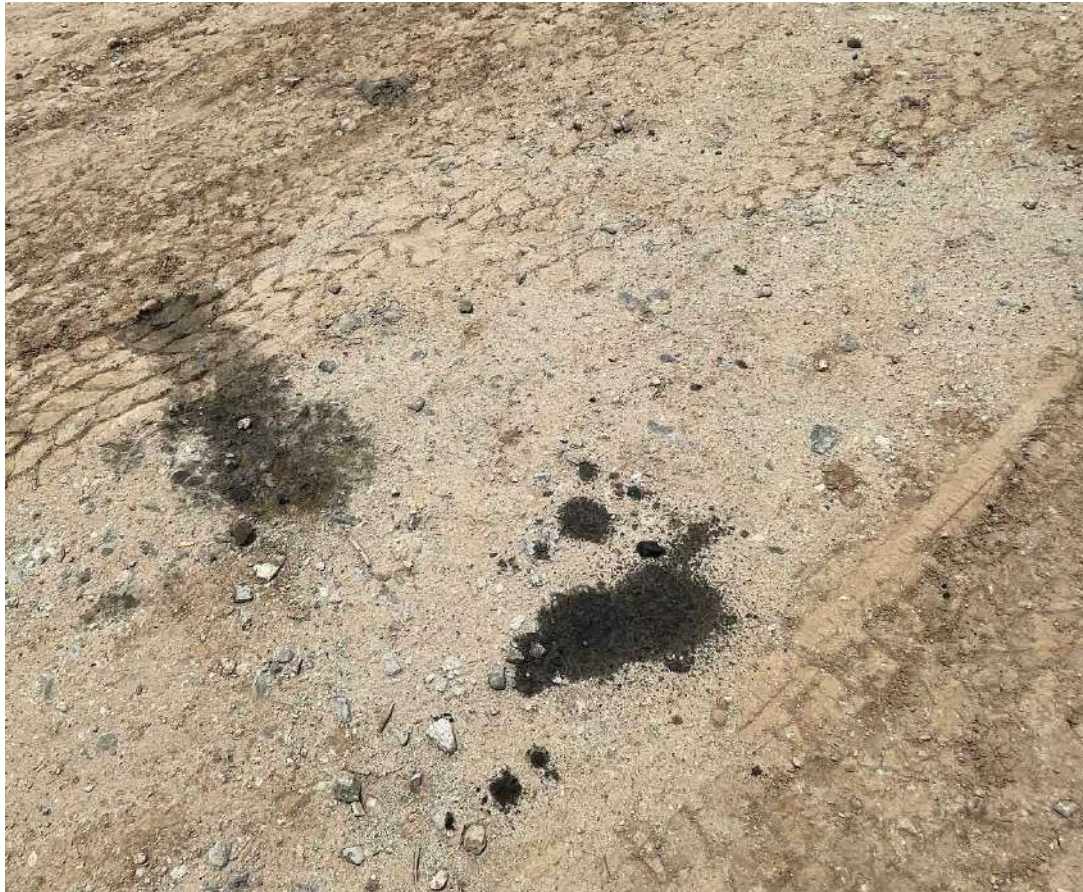
**Possible Hydrocarbon Spill**

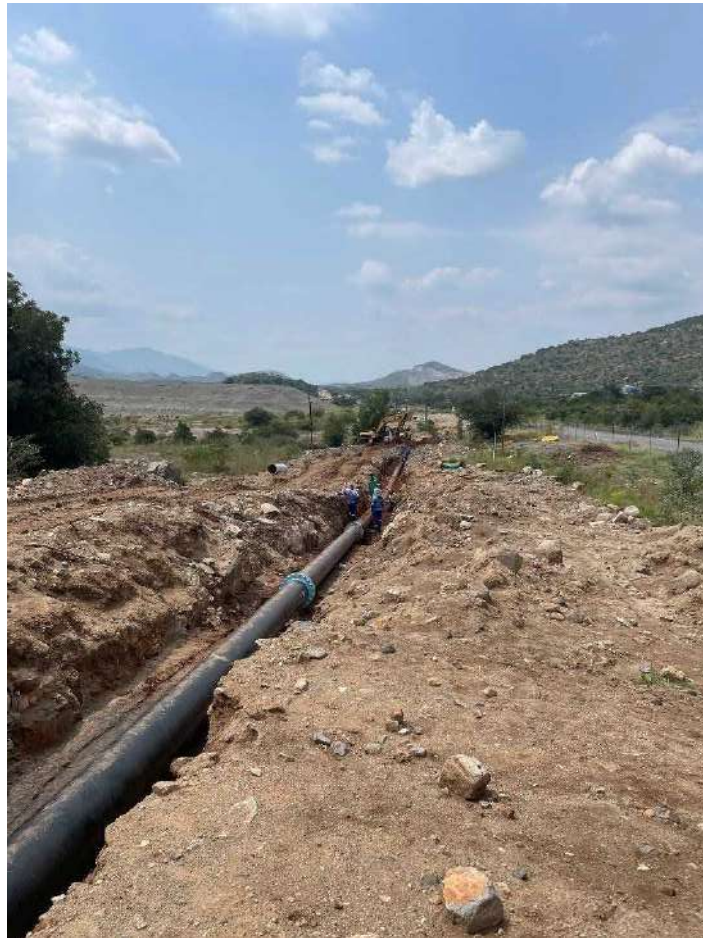
**Pipeline Route (No Chemical Toilet Observed)**

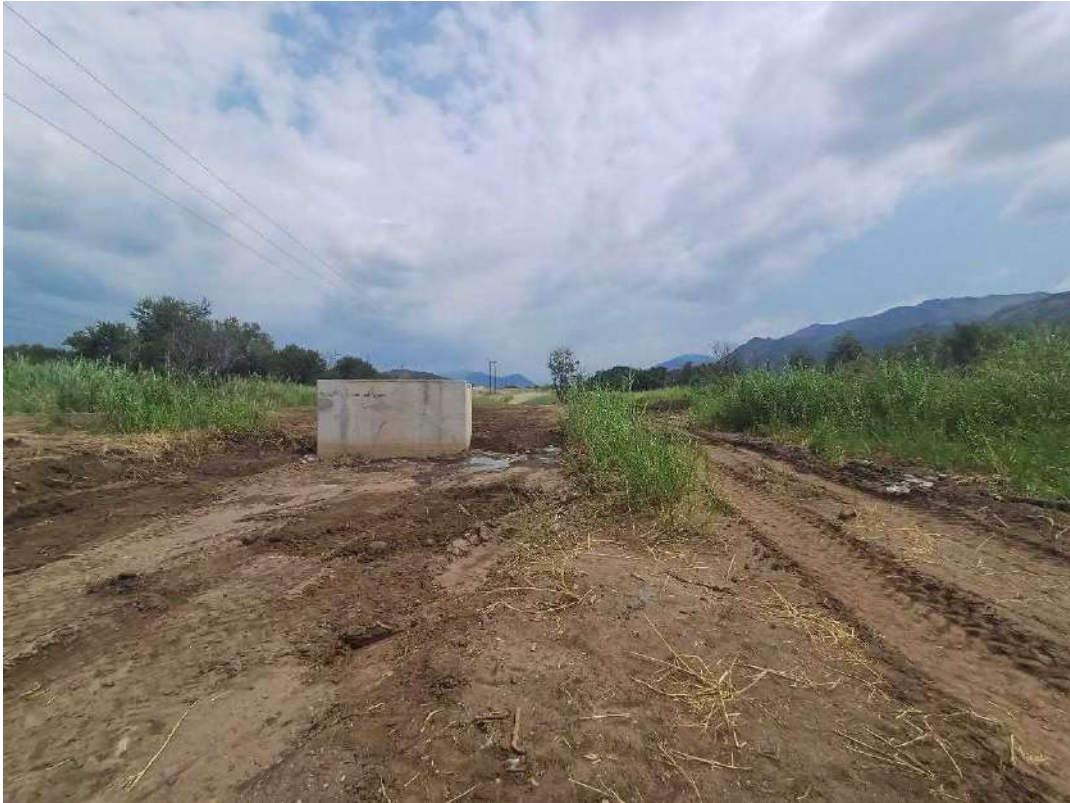
**Construction Activities**

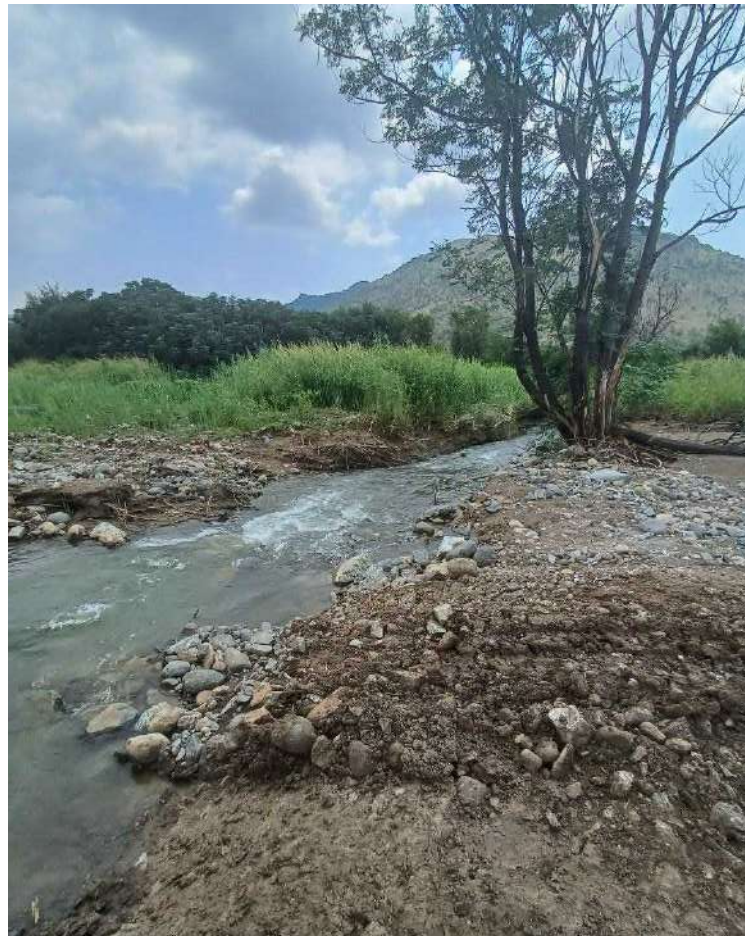
**River channel re-established after construction**
