Project Reference Number: 131-001

DFFE Reference Number: 14/12/16/3/3/1/2442

LEBALELO WATER USER ASSOCIATION

**SE2 PIPELINE AND ASSOCIATED INFRASTRUCTURE:
EIGHTEENTH CONSTRUCTION ENVIRONMENTAL
AUDIT REPORT
MARCH 2024**

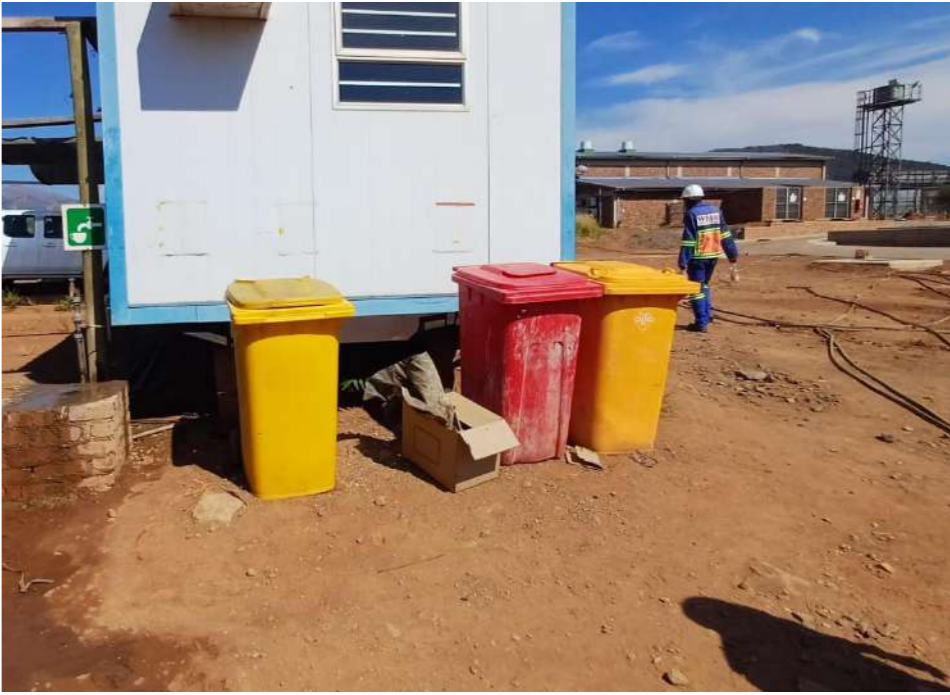
Document & Condition Number	Condition / Commitment	Findings	Photographic Evidence
1. Environmental Authorisation Condition 46 2. EMPr Condition 35 3. EMPr Condition 45 4. EMPr Condition 47 5. EMPr Condition 49 6. EMPr Condition 50 7. EMPr Condition 82 8. EMPr Condition 87	<ol style="list-style-type: none"> An integrated waste management approach must be implemented that is based on waste minimisation and must incorporate reduction, recycling, re-use and disposal where appropriate. Any solid waste must be disposed of at a landfill licensed in terms of Section 20 (b) of the National Environmental Management Waste Act, 2008 (Act No. 59 of 2008). Waste management must be a priority and all waste must be collected and stored adequately. It is recommended that all waste be removed from site on a weekly basis to prevent rodents and pests entering the site. Ensure the correct handling, storage and operation of general waste generated on the construction site. The Contractor should supply sealable and properly marked domestic waste collection bins and all solid waste collected shall be disposed of at a licensed disposal facility. Waste management must be a priority and all waste must be collected and stored effectively. Refuse bins will be emptied and secured. Temporary storage of domestic waste shall be in covered waste skips. Maximum domestic waste storage period will be 10 days. Remove general waste generated frequently as to prevent the development of a breeding habitat for nuisance pests such as flies and attracting rodents and baboons. All waste generated on site during construction must be adequately managed. Separation and recycling of different waste materials should be supported. Make sure all excess consumables and building materials / rubble is removed from site and deposited at an appropriate waste facility. 	<p style="text-align: center;">Spitskop Pump Station:</p> <p>Waste bins were noted at the Spitskop Pump Station. The signage for the specific waste streams was not clearly marked due to wear and tear, it was indicated that new signs to be put in place.</p>

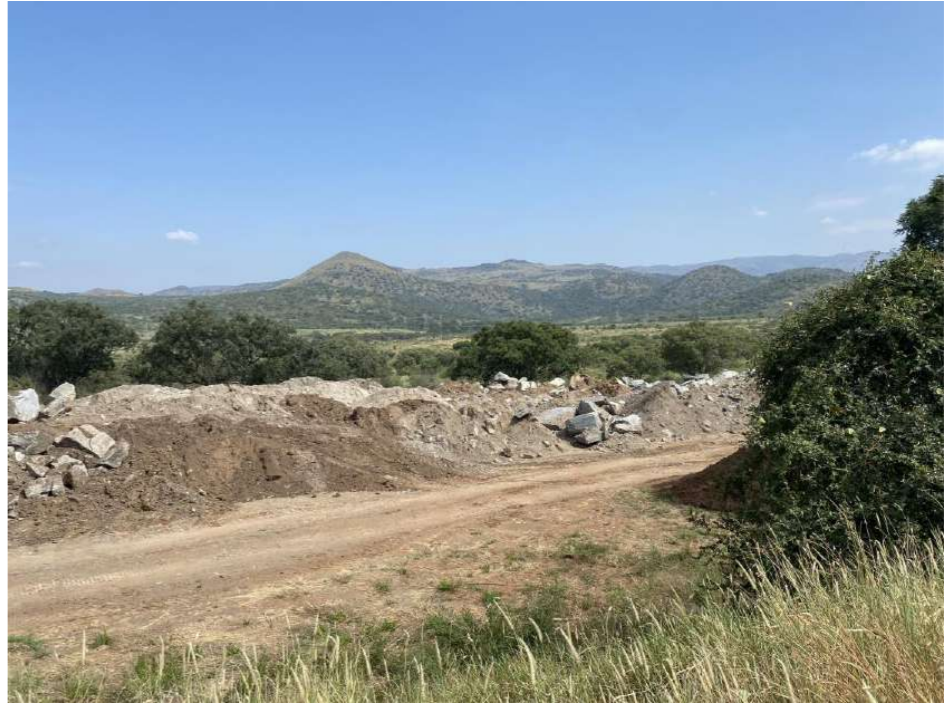
<p style="text-align: center;">Pipeline Route:</p> <p>Poor housekeeping was noted along the pipeline route. The observation was specifically around waste stockpiled along the route. It is suggested that all waste be removed from site and disposed of appropriately.</p> <p>During the current audit, rock material that emanated from the excavations was still stockpiled along the pipeline route. It is the intention of the Contractor to procure a crusher and undertaken the crushing of the rock on site and the resultant material will be managed by the appointed crusher management company.</p>

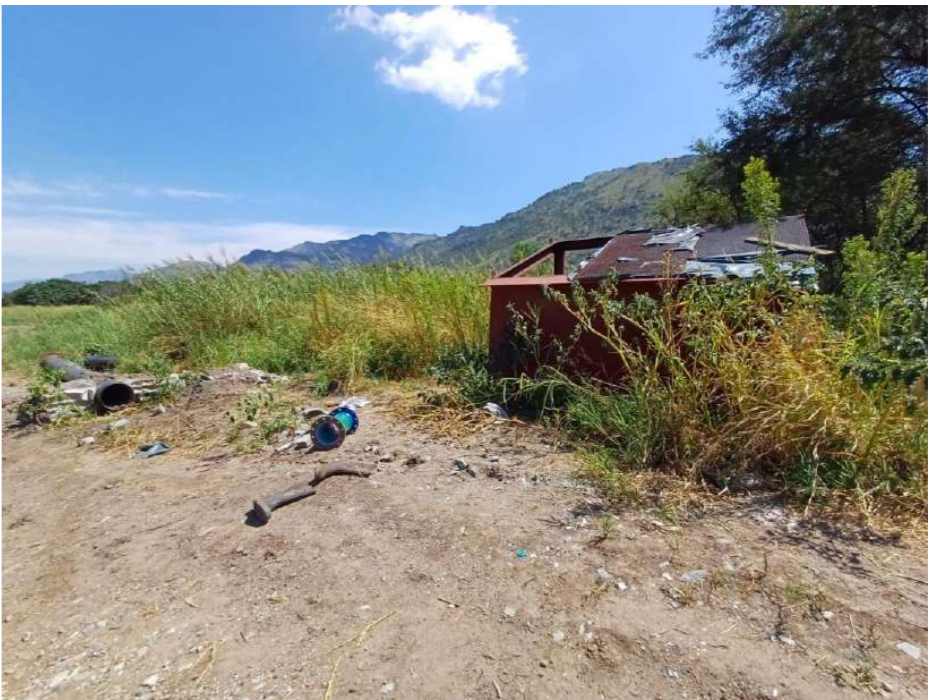
<p><u>Wetland Area:</u> Poor housekeeping was noted in the wetland area, the observation was specifically around old PPE and the contractors camp shed left within the wetland area.</p>

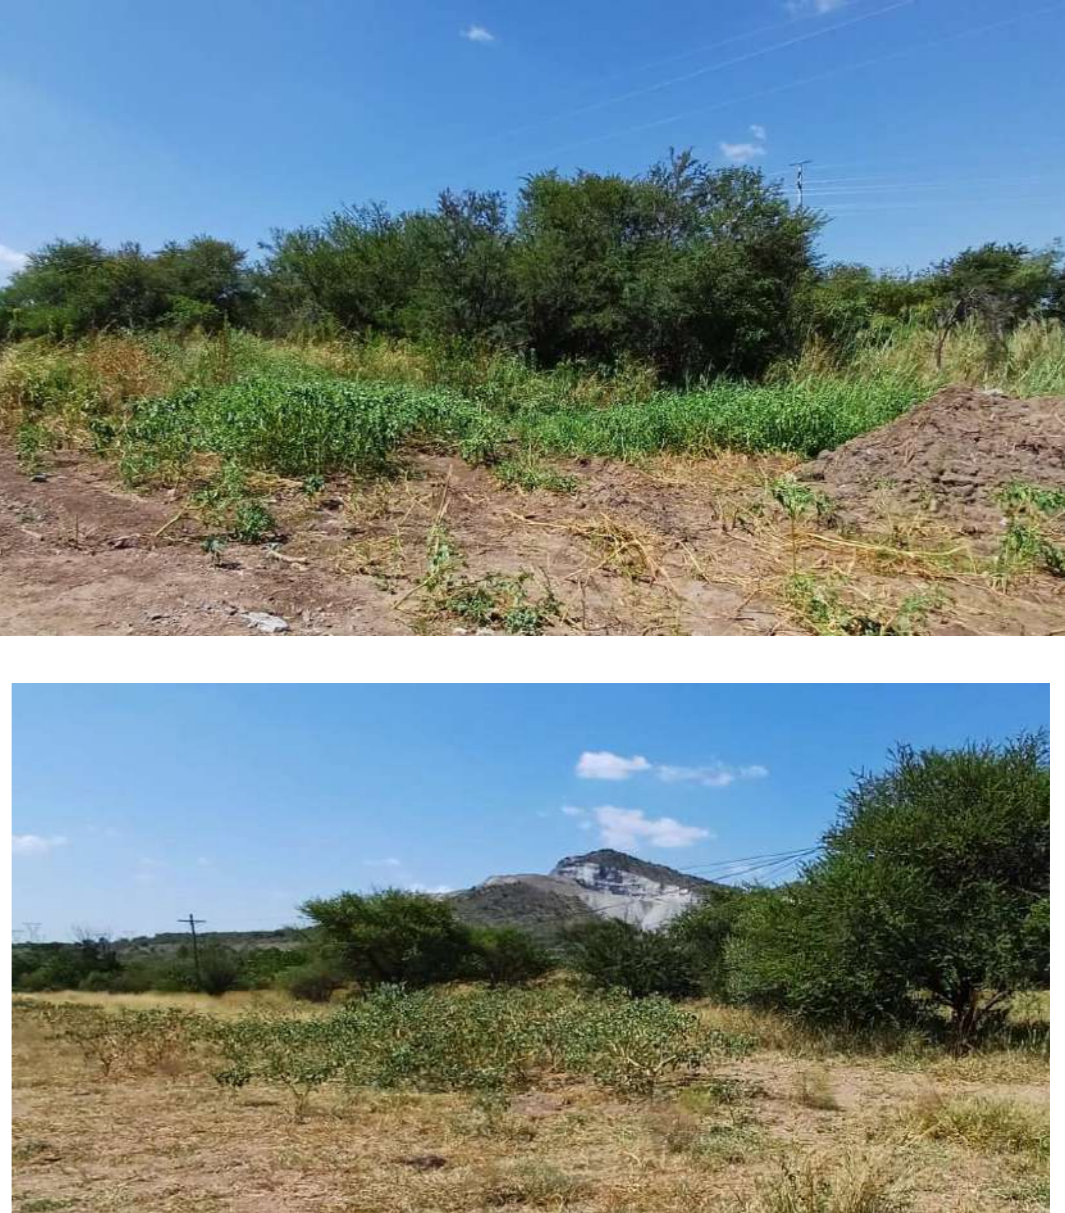
Document & Condition Number	Condition / Commitment	Findings	Photographic Evidence
1. EMPr Condition 36 2. EMPr Condition 74	1. Compilation of and implementation of an alien vegetation management plan. 2. Promptly remove all alien and invasive plant species that may emerge during construction (i.e. weedy annuals and other alien forbs) must be removed.	<p>During the audit undertaken in March 2024 Alien and Invasive species were found along the pipeline route as well as at the Spitskop Pump Station.</p>

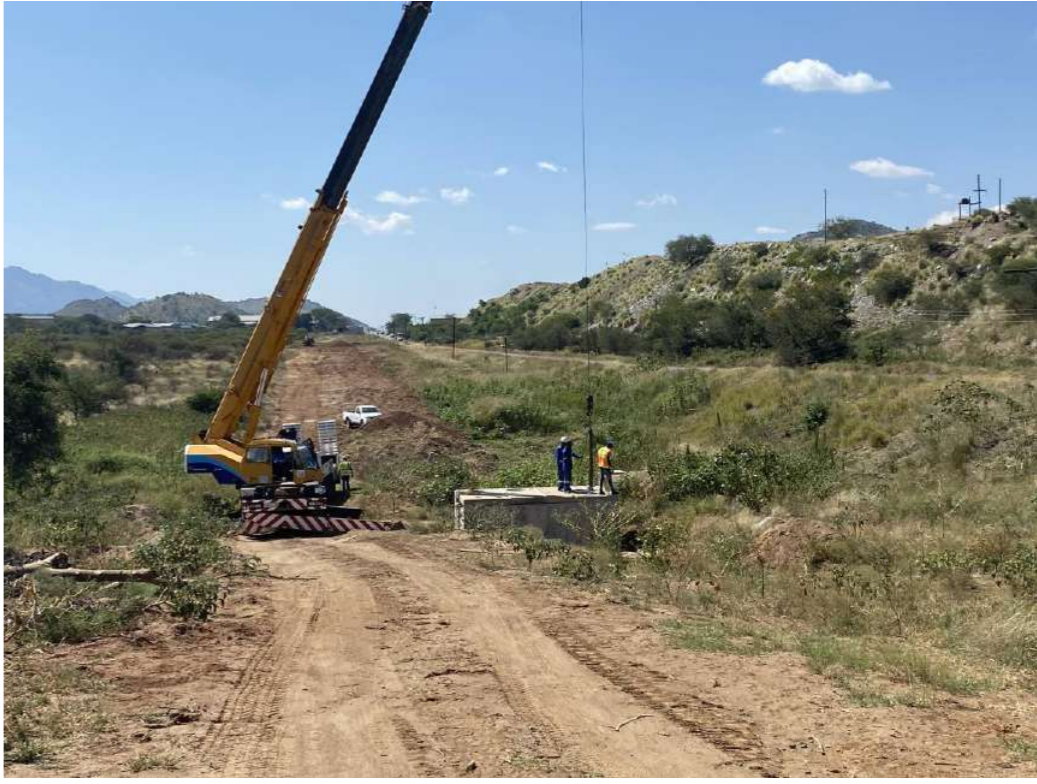
Document & Condition Number	Condition / Commitment	Findings	Photographic Evidence
1. EMPr Condition 46 2. EMPr Condition 80 3. EMPr Condition 91	<ol style="list-style-type: none"> A minimum of one toilet must be provided per 10 persons. Portable toilets must be pumped dry to ensure the system does not degrade over time and spill into the surrounding area Adequate sanitary facilities and ablutions on the servitude must be provided for all personnel throughout the project area. Use of these facilities must be enforced (these facilities must be kept clean so that they are a desired alternative to the surrounding vegetation). Provide appropriate sanitation facilities during construction and service them regularly. These must be beyond the wetland and buffer area. 	<p>No chemical toilets were observed at some locations along the pipeline route currently being constructed.</p>

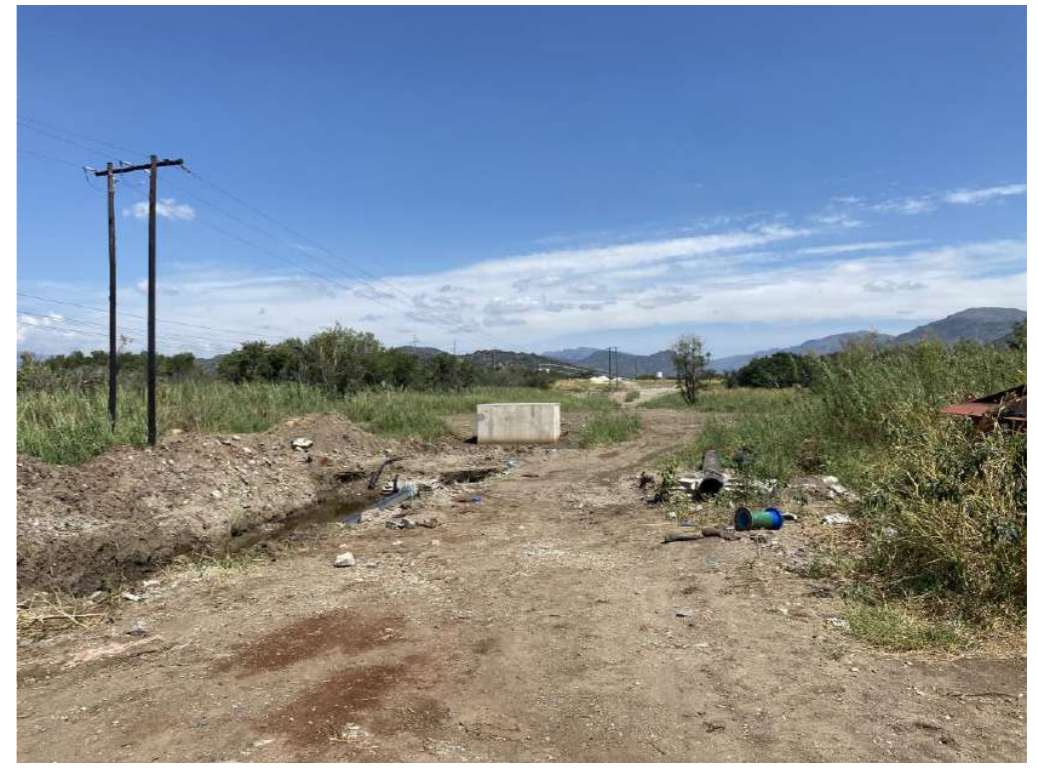
1. EMPr Condition 56 2. EMPr Condition 58 3. EMPr Condition 78	<ol style="list-style-type: none"> Reduce the disturbance footprint and the unnecessary clearing of vegetation on either side of the trench as far as possible when traversing wetlands. Load wetland spatial data onto a GPS and use it to mark out the positions where the pipeline will enter and exits the prescribed buffer on the boundary of a wetland. Try to reduce the disturbance footprint and the unnecessary clearing of vegetation on either side of the trench as far as possible when traversing wetlands. Minimize unnecessary clearing of vegetation. 	<p>Construction activities started within the buffer or boundary of the wetland in July 2023, however the clearance of vegetation was measuring as approximately 30 m. The EMPr states that clearance of vegetation must be limited to a 25m corridor along the pipeline route, and 15m (servitude) in the wetland area and associated buffer zone of 15m.</p>

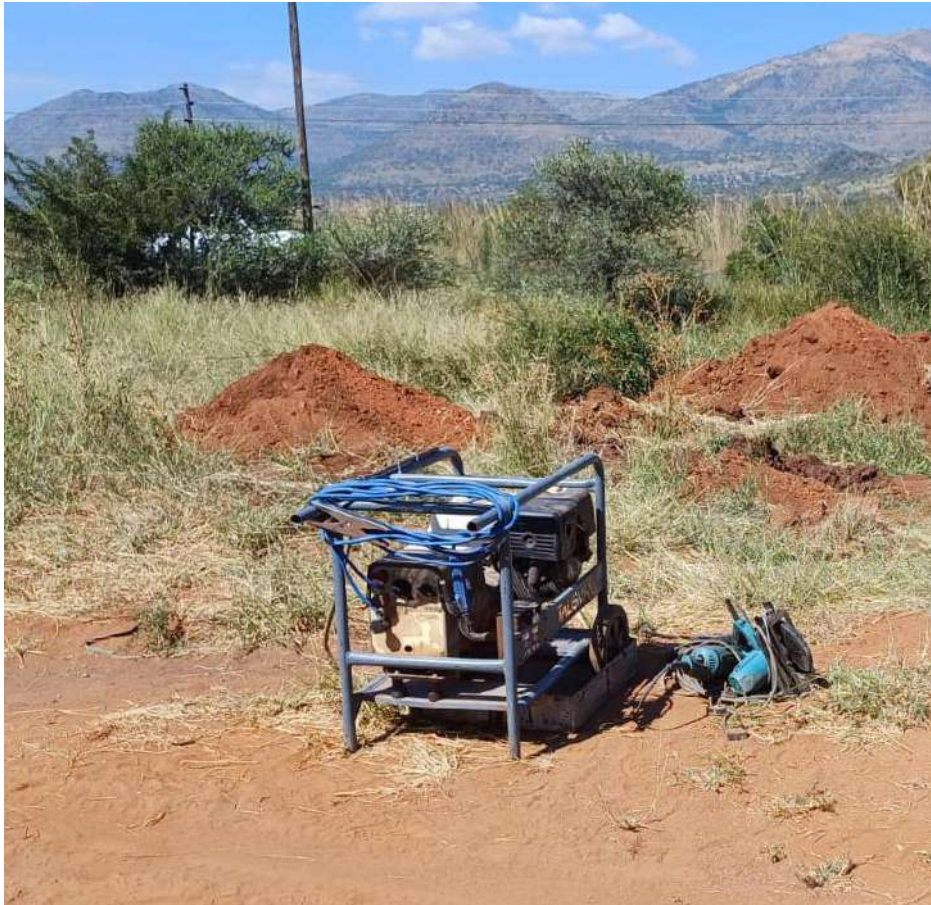
Photo 34: Use of Drip trays on site

Drip Trays in Use

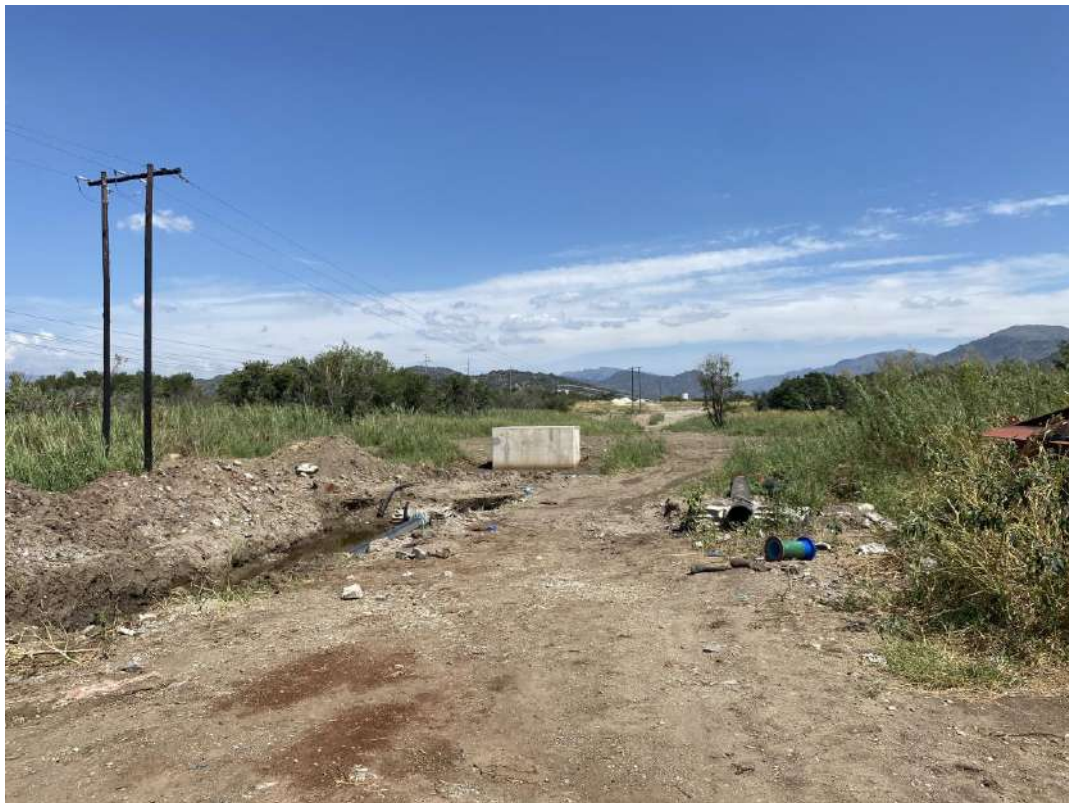
Photo 43: Wetland area

Construction Activities

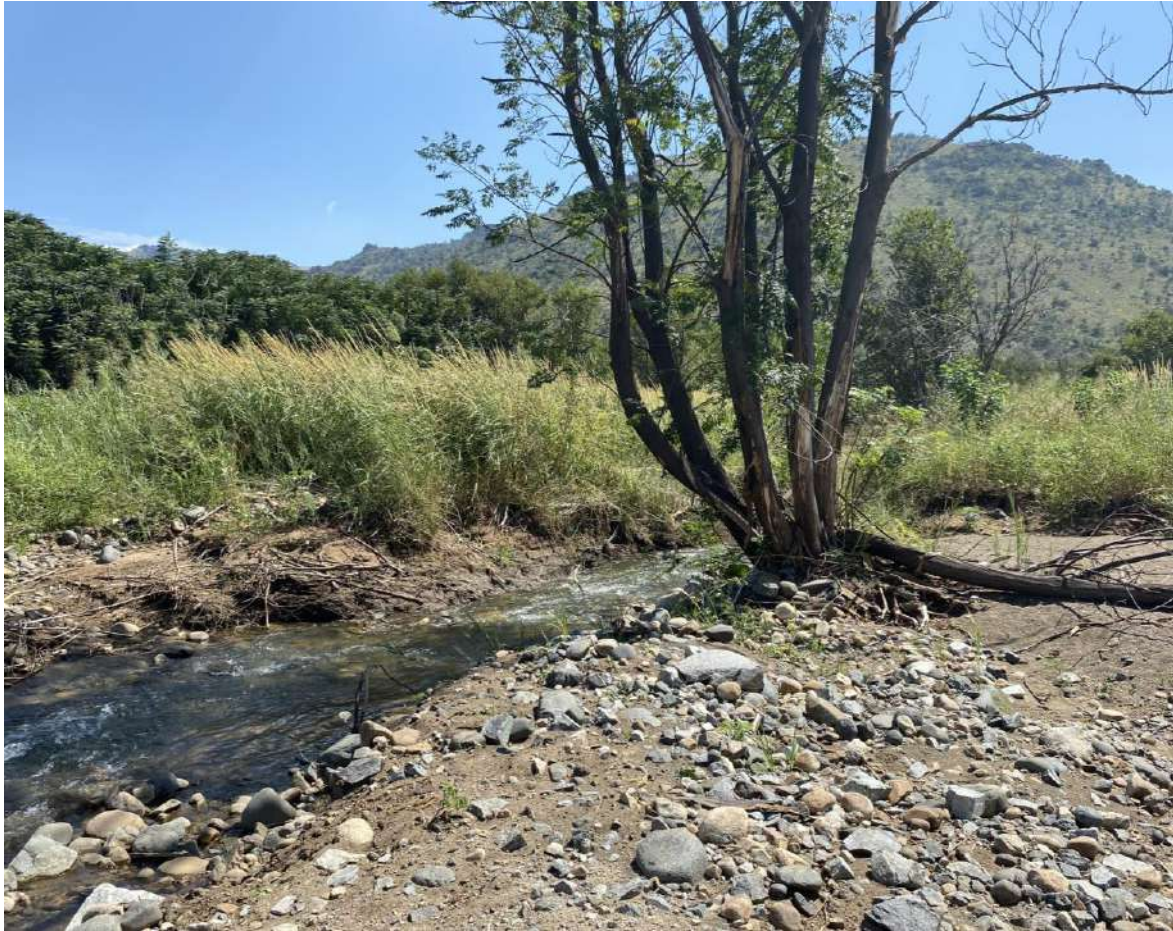
River channel re-established after construction

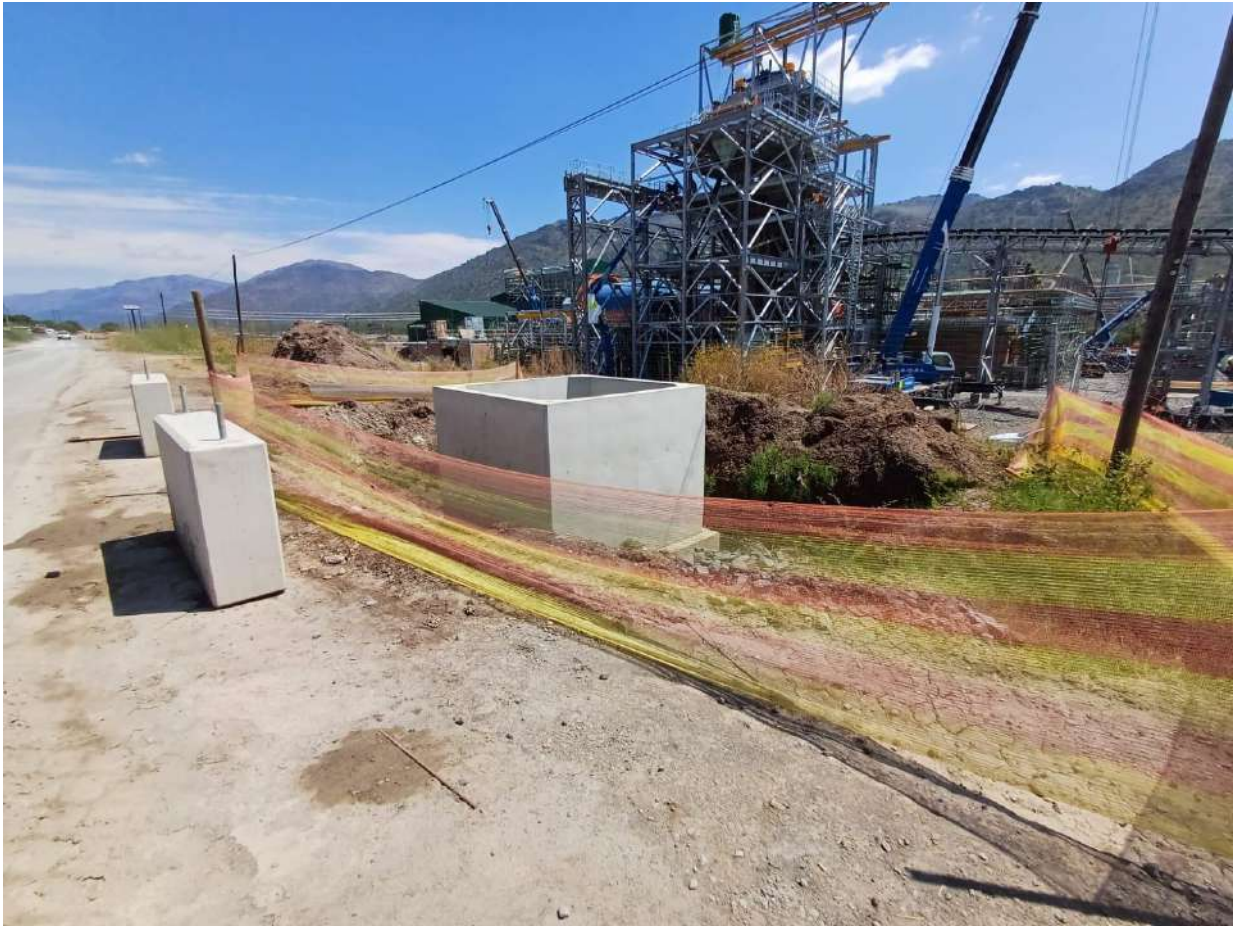
Photo 48: Deep hole excavation at man hole site
