**DFFE Reference Number: 14/12/16/3/3/1/2442**

**SE2 PIPELINE AND ASSOCIATED INFRASTRUCTURE:** PRE-CLOSE OUT ENVIRONMENTAL AUDIT REPORT **JUNE 2024**

**PROJECT NAME:** SE2 PIPELINE AND ASSOCIATED INFRASTURE

**REPORT DETAIL:** PRE-CLOSE OUT CONSTRUCTION AUDIT REPORT

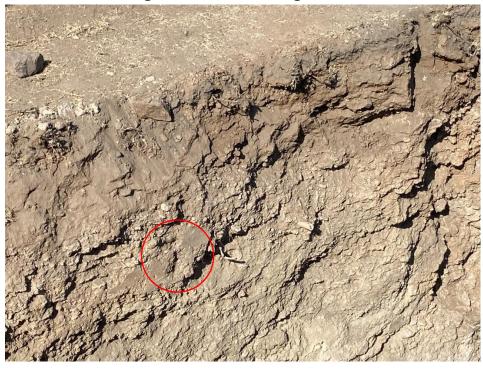
# Photo 24: Bones discovered in Steelpoort Industrial Park Trench Excavation

#### The image below is from the August 2023 Audit

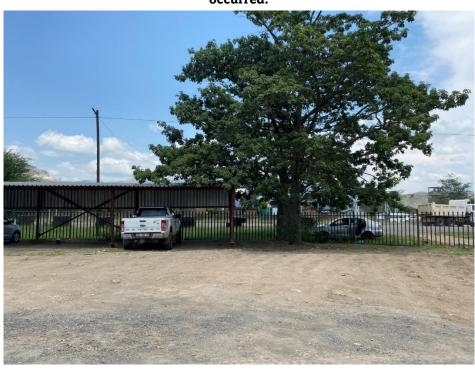
The picture below is from the January 2024 Audit. The bones have been exumed and backfilling has occurred.

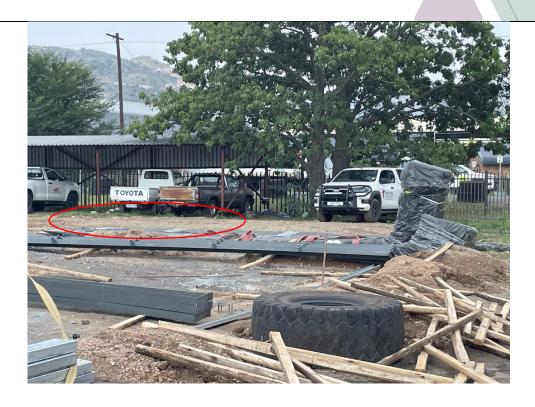
The picture below is from the February 2024 Audit. The area is closed out.

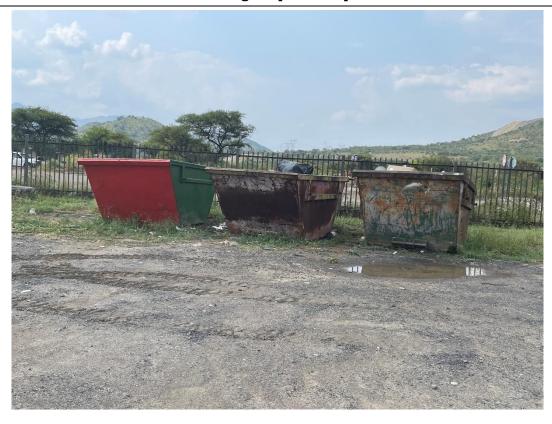
Photo 28: Waste Management on site

Document & Condition / Commitment	Findings	Photographic Evidence				
	Wetland Area:  Poor housekeeping was noted in the wetland area, the observation was specifically around old pipes and demolished concrete structures.					
	Reservoir  A waste bin was not noted at the reservoir site however waste was stored in a designated area.

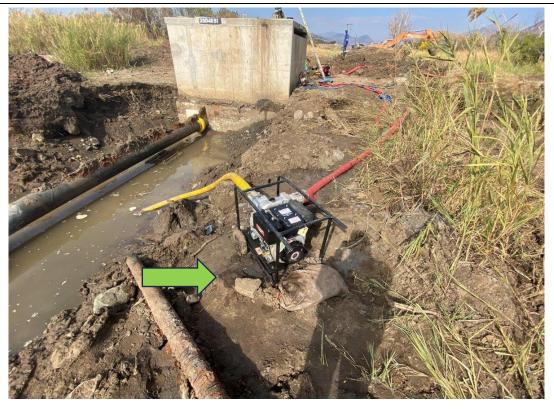
Photo 36: No drip trays being used on site

Document & Con Condition Number	dition / Commitment	Findings	Photographic Evidence
EMPr Condition     S3      Adhere to the presonactivities. Restrict a storage areas, ceme wetlands and their part of the presonactivities. Restrict a storage areas, ceme wetlands and their part of the presonactivities. Restrict a storage areas, ceme wetlands and their part of the presonactivities. Restrict a storage areas, ceme wetlands and their part of the presonactivities.		During this audit undertaken in June 2024, Construction activities re-commenced due to a malfunction of the pipes. resulting in peeling of the internal coating. A generator was noted to be placed on excavated soils which could result in potential spillages and contamination of soils.	Cesor
EMPr Condition 53      Manual 1. All chemicals and to must be stored in a must be stored in a must be stored.    All chemicals and to must be stored in a must be stored in a must be stored.	oxicants to be used for the construction bunded area	During the audit undertaken in June 2024, drip trays were noted not to be used for the pumps
