**Lebalelo Water User Association**  
**Clapham Dam Upgrades and associated infrastructure**  
**Final Environmental Management Programme**

January 2022

Project Ref: 131-002

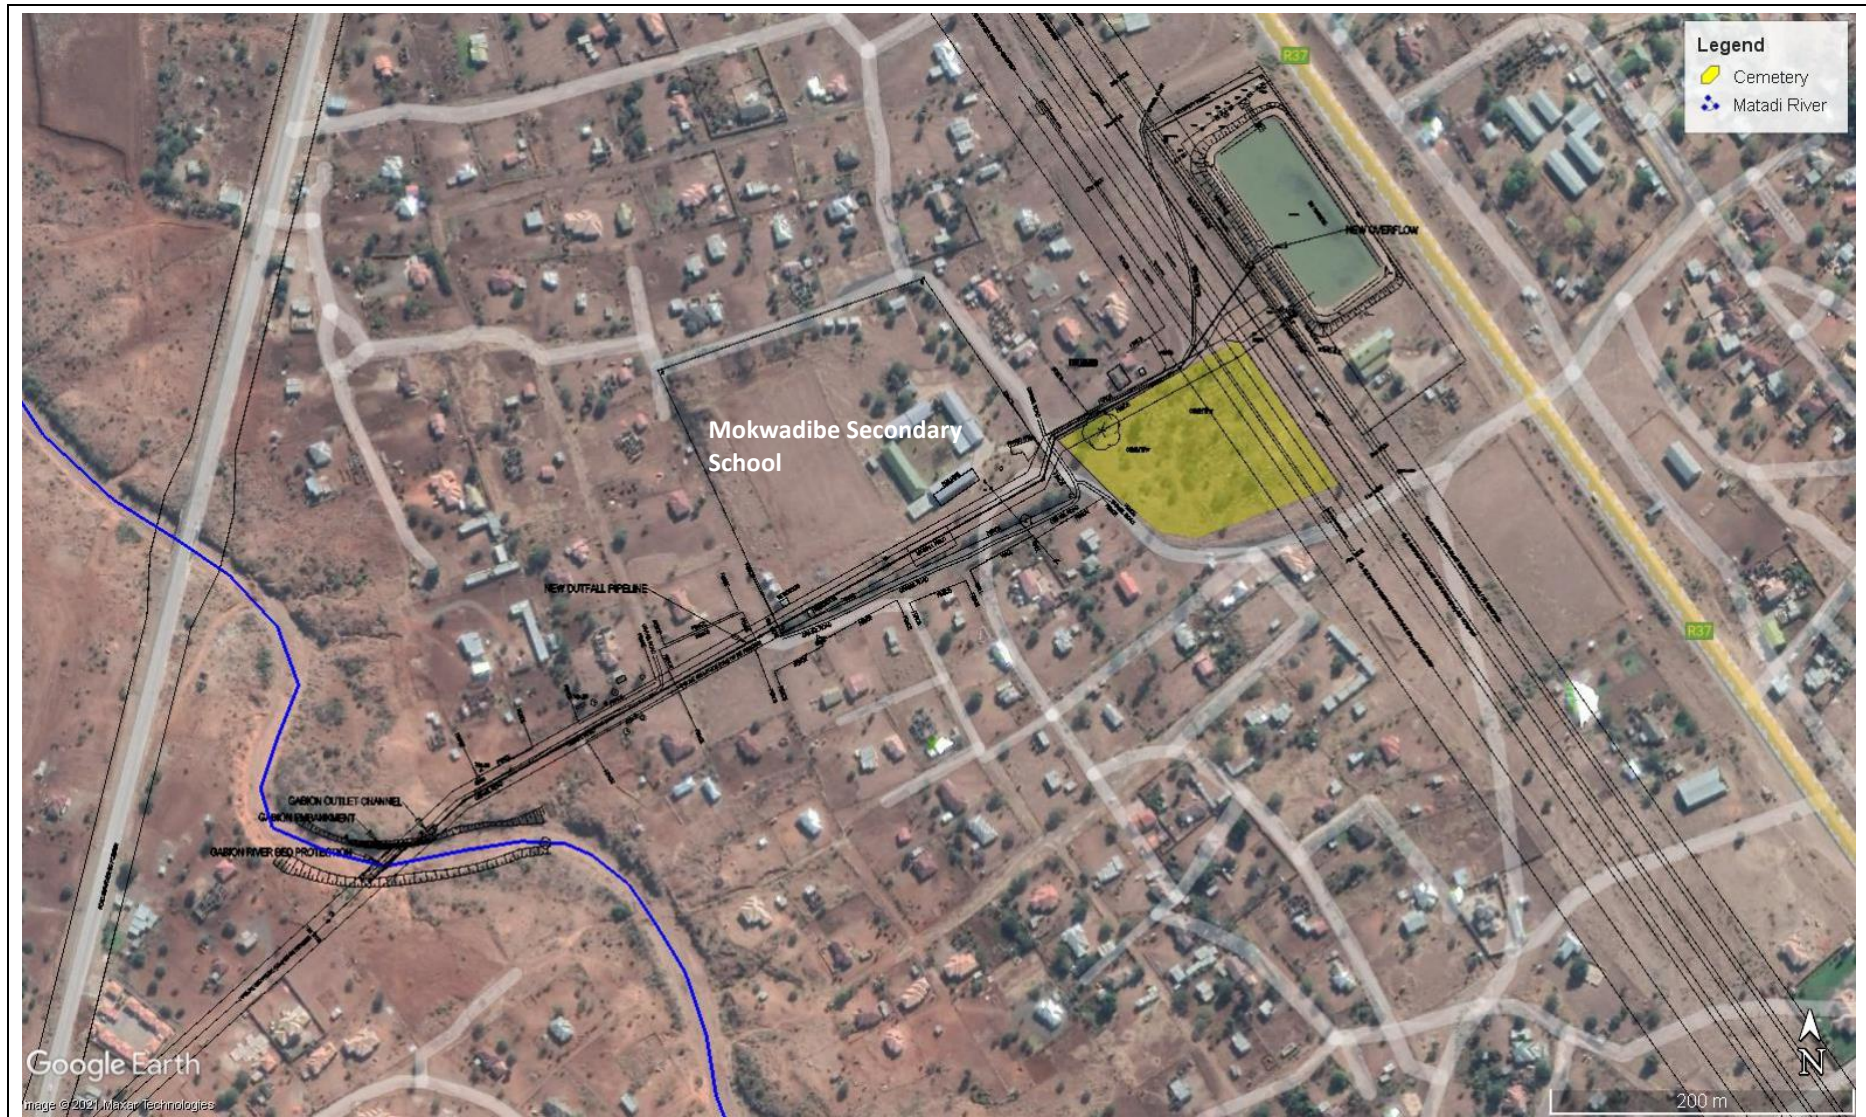
<p><b>CLAPHAM DAM UPGRADES AND ASSOCIATED INFRASTRUCTURE</b></p> <p><b>SENSITIVE FEATURES</b></p>	<p><b>Figure 3.1</b></p>
---	---	--------------------------

The following sensitive areas in proximity of the proposed Clapham Dam upgrades and associated infrastructure project have been identified:

- Matadi River; and
- Cemetery.

Figure 3.1: Sensitive features around Clapham Dam and the proposed infrastructure

Refer to Figure 3:1 for the location of the sensitive features.
